HYDROGEN
Safety Panel

**Report on the
June 2019
Hydrogen
Explosion and Fire
Incident in Santa
Clara, California**

June 2021
PNNL-31015-1

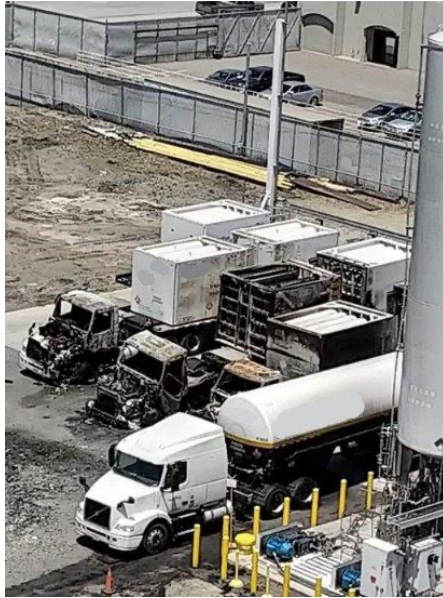
Figure 5. Fueling Tractor-Trailer Damage Overview

As illustrated in Figures 5¹⁴ and 6,¹⁵ the front module in the incident trailer suffered extensive and irreparable burn and overpressure damage, as did the three tractor cabs parked in front of the trailers. The other fuel modules had much less damage. The LH2 tanker truck only had paint damage and surface charring. The large stationary LH2 storage tank for the facility was not damaged.

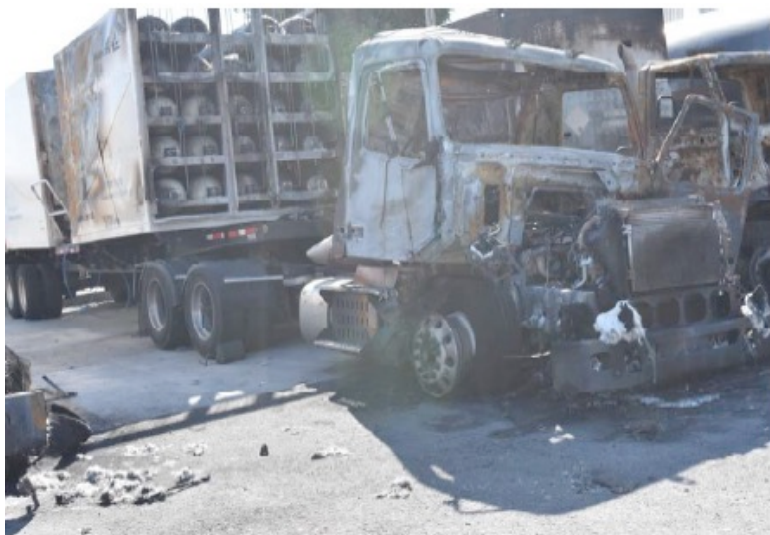
Figure 7. Incident Trailer Cab and Front Module

Figure 7¹⁶ shows the extent of damage to the incident trailer cab (including ruptured fuel tank) and front module, which had its forward wall panel blown off.

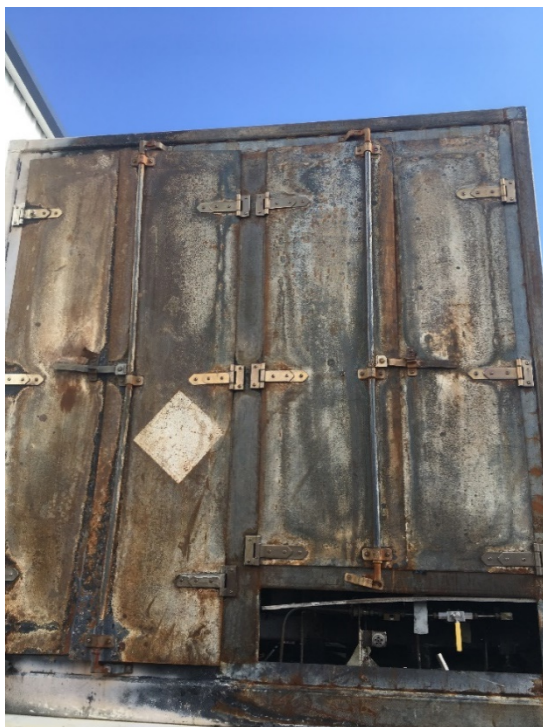
Figure 8. Doors on Rear Module Incident Trailer

The access doors on the rear module were heavily damaged but remained closed as seen in Figure 8.¹⁷ The intact doors prevented any significant damage to the cylinders in the rear module, as indicated in Figure 9.¹⁸

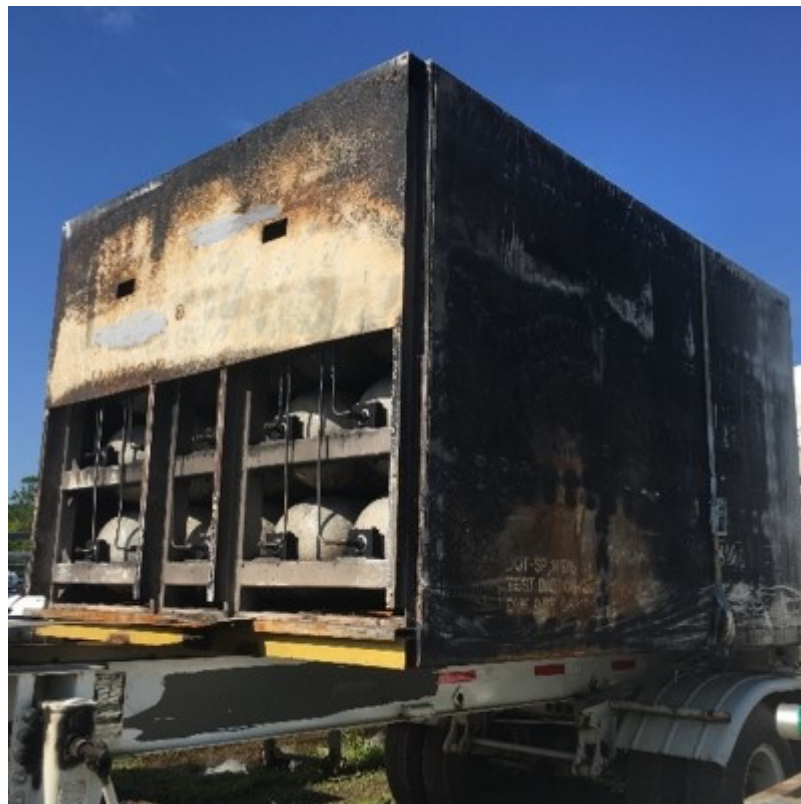
Figure 10. Front and Side Panels on Adjacent Module in Bay #2

The trailer rear module from Bay #2 is shown in Figure 10¹⁹ with an end panel removed. The side panels were significantly scorched but protected the vessels within the enclosure.

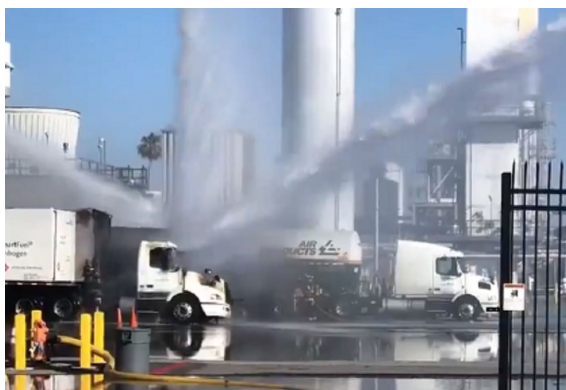
Figure 11. Elevated Aerial Water Streams

Water spray cooling of fire-exposed hydrogen gas and liquid storage equipment was an important factor in this incident to prevent the rupture of any cylinders and tanks. The water spray was provided by the Santa Clara Fire Department in the form of aerial master streams generated by fire department trucks located outside the facility fence. One of the trucks produced a measured water flow rate of 500 gpm (1,893 lpm).⁴⁵ Figure 17⁴⁶ shows the water stream application, which also helped to extinguish the secondary fires on the middle trailer.

Although the Fire Department aerial stream application was effective, there was an understandable delay due to the time required for briefing fire department officers and making the hose connections and pump startup. If there had been provision for automatic water spray application triggered by heat detectors on and around the LH2 tank and tanker truck unloading station, the tank and cylinder module cooling could have been initiated sooner. NFPA 15 provides guidance on the design and installation of such systems.⁴⁷
