DOT/FAA/TC-16/24

Abusive Testing of Proton Exchange Membrane Hydrogen Fuel Cells

October 2016

Final Report

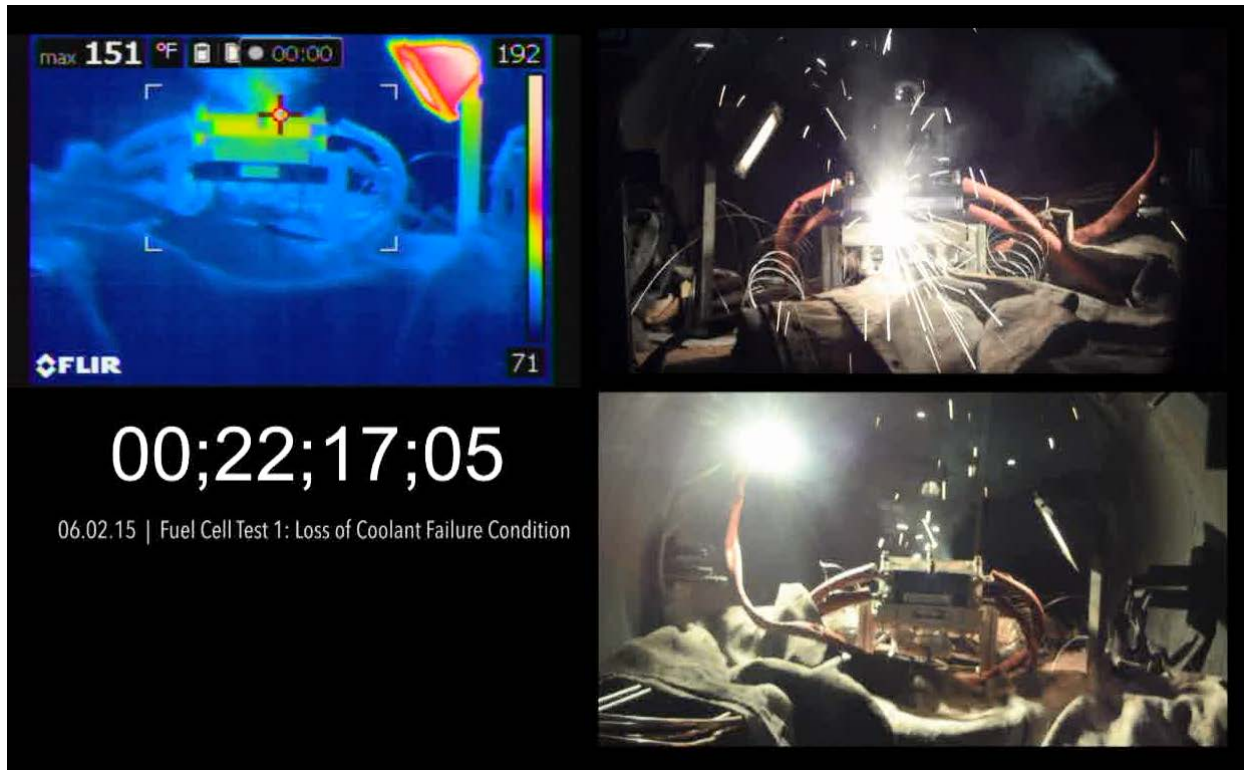
Approximately 111 seconds after completely losing current flow, a thermal event occurred, with sparks emanating from the forward-facing side of the fuel cell stack. This event is shown in figure 12 with a still frame from the recorded video of the test. The event is also shown in figures 9 and 11 as the forward stack surface temperature rises to over 220°F and all of the temperature probes within the pressure vessel also increase. The failure event was allowed to continue for approximately 1 minute after the sparking and flaming was observed. After this point, flow of the reactant gases was shut off and the primary fire was observed to self-extinguish within seconds. Burning of the fuel cell stack materials continued for approximately 40 seconds, after which time it self-extinguished.

Figure 12. Loss of coolant test—still-frame photograph from test video during thermal event

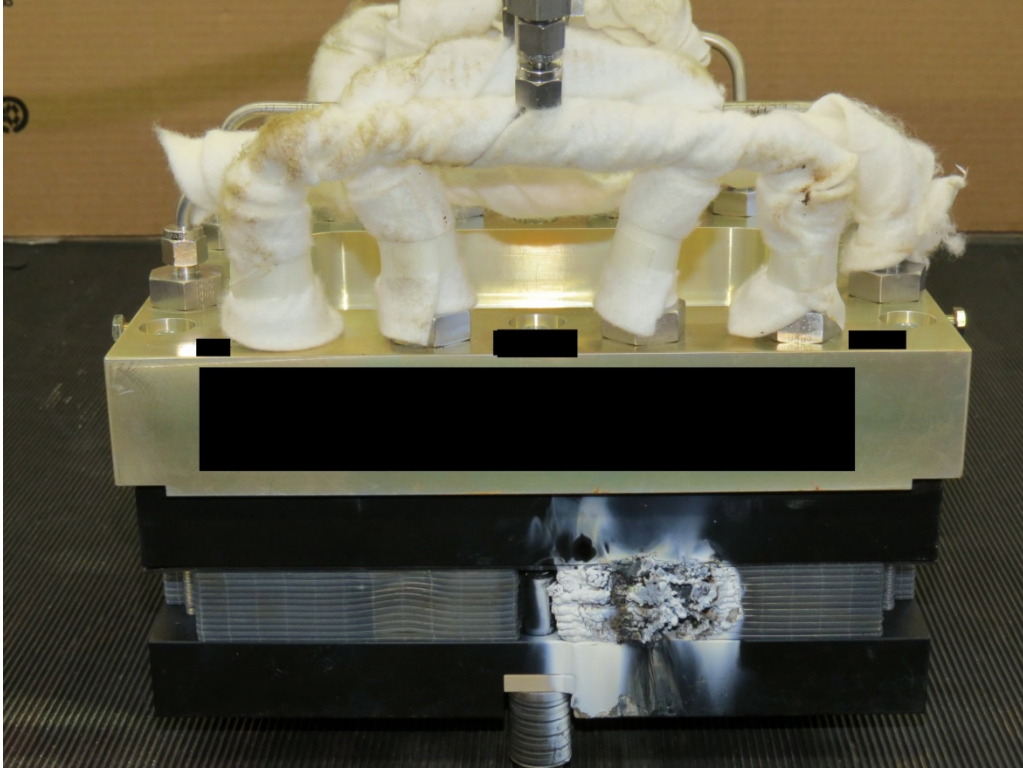
Figures 13 and 14 are photographs of the unit after removal from the test fixture. Figure 13 is an external view of the forward side of the unit; it shows signs of severe damage to the O₂ inlet section of the stack. Figure 14 is a photograph, looking downward into the O₂ inlet port, with the gas manifold removed.

Figure 13. Loss of coolant test—post-test photograph of damaged area

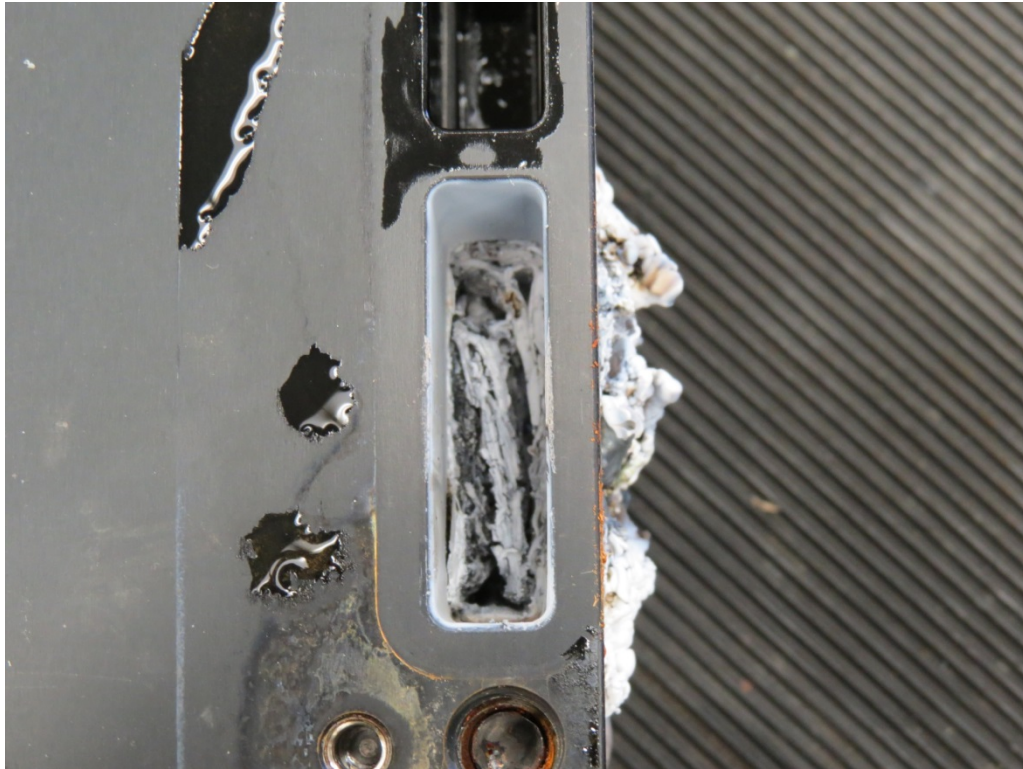
Figure 14. Loss of coolant test—post-test photograph of cathode inlet port with gas manifold removed

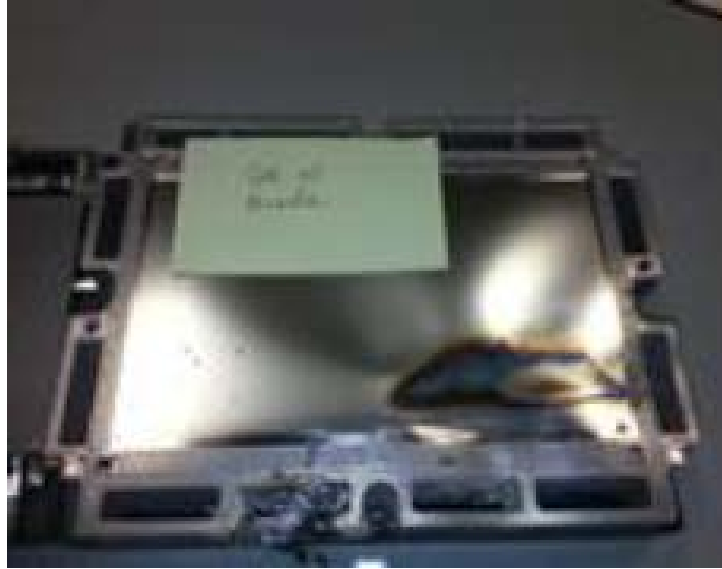
A post-test teardown of the fuel cell stack, conducted by the manufacturer, revealed two distinct areas of damage. One, shown in figure 15, was situated between the active cell area at the oxidant and coolant inlet. This effectively was a hot spot where burning occurred on the active area of the bipolar metal plate. Damage was noted through the discoloration of the plate and fusing of the gasket material to the active area. The damage caused by this was most severe (i.e., largest damage area) toward the center of the stack and smaller toward the end cells. The burning caused by the failure in this area appeared to be caused by shorting of the plates and was isolated to the active area of the plates.

Figure 15. Loss of coolant test—photograph taken during post-test teardown of MEA active area damage (photograph intentionally blurred to protect proprietary information)

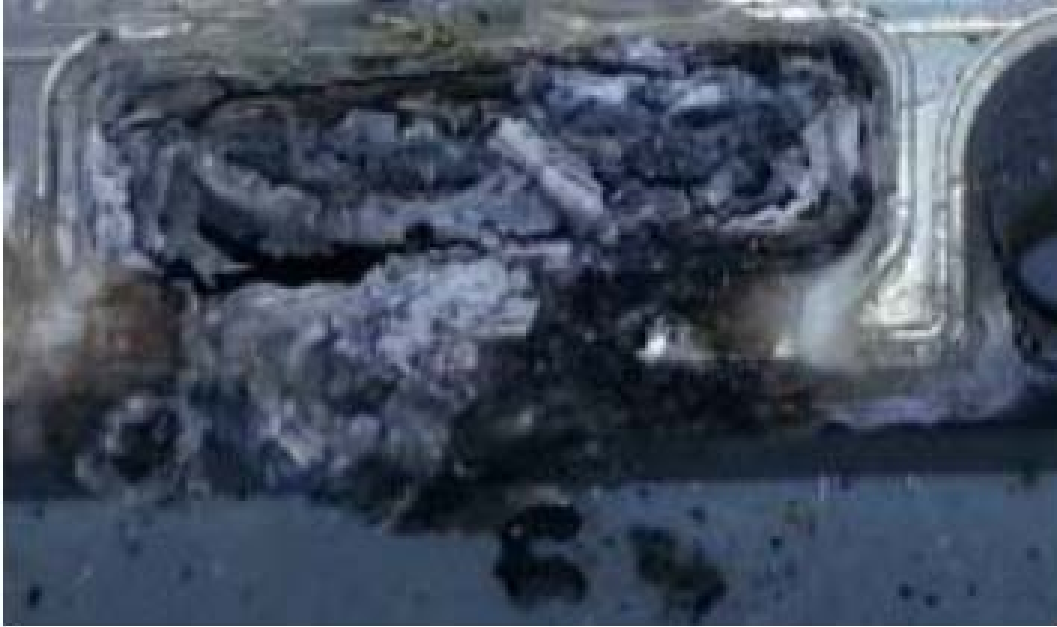
The second area of damage occurred outside of the active cell area between the anode outlet and the cathode inlet manifolds. This is the damage that was noted on the external photographs (see figures 13 and 14) immediately following the test. The post-test analysis showed that there was a fire at the cathode inlet that consumed the gasket material and a portion of the stainless steel plates in this area. This fire breached the anode outlet, allowing H₂ to continue to feed the fire. Figure 16 shows a close-up photograph of this area during the post-test disassembly of the fuel cell stack.

Figure 16. Loss of coolant test—photograph taken during post-test teardown of cathode inlet port damage (photograph intentionally blurred to protect proprietary information)

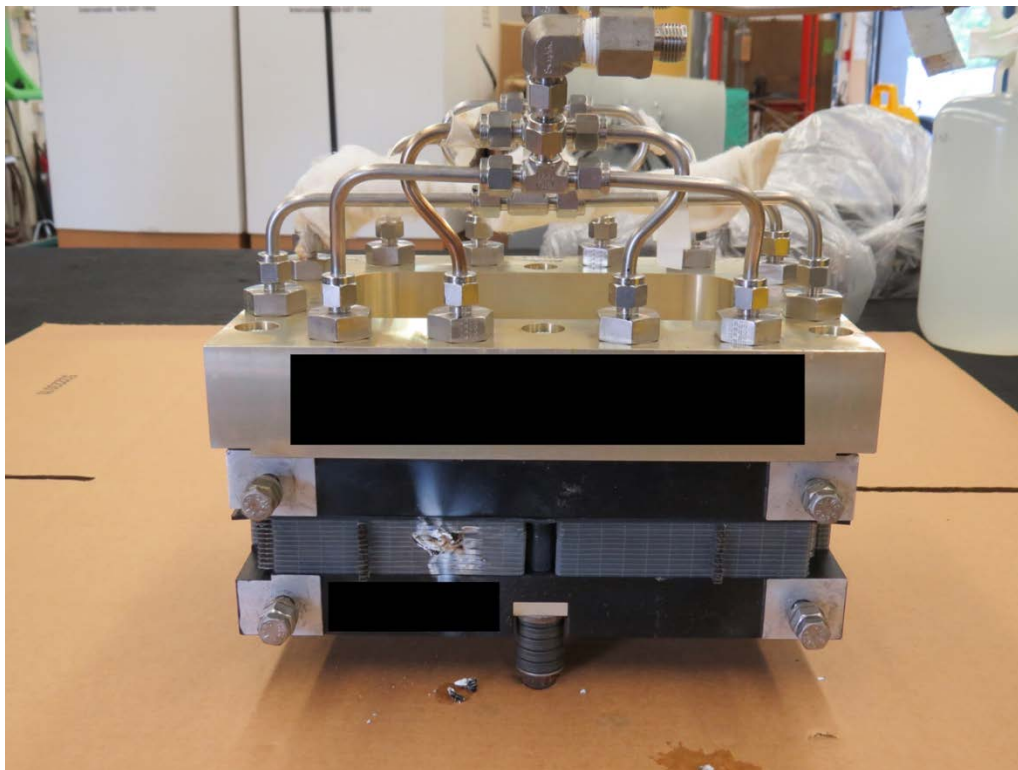
A post-test evaluation of the fuel cell stack showed significant external damage. There was evidence of two distinct damage areas external to the fuel cell stack. The first, shown in figure 25, was at one of the O₂ outlet ports; the other was located at both of the O₂ inlet ports, as shown in figure 26.

Figure 25. Crossflow condition test—external damage at O₂ outlet port

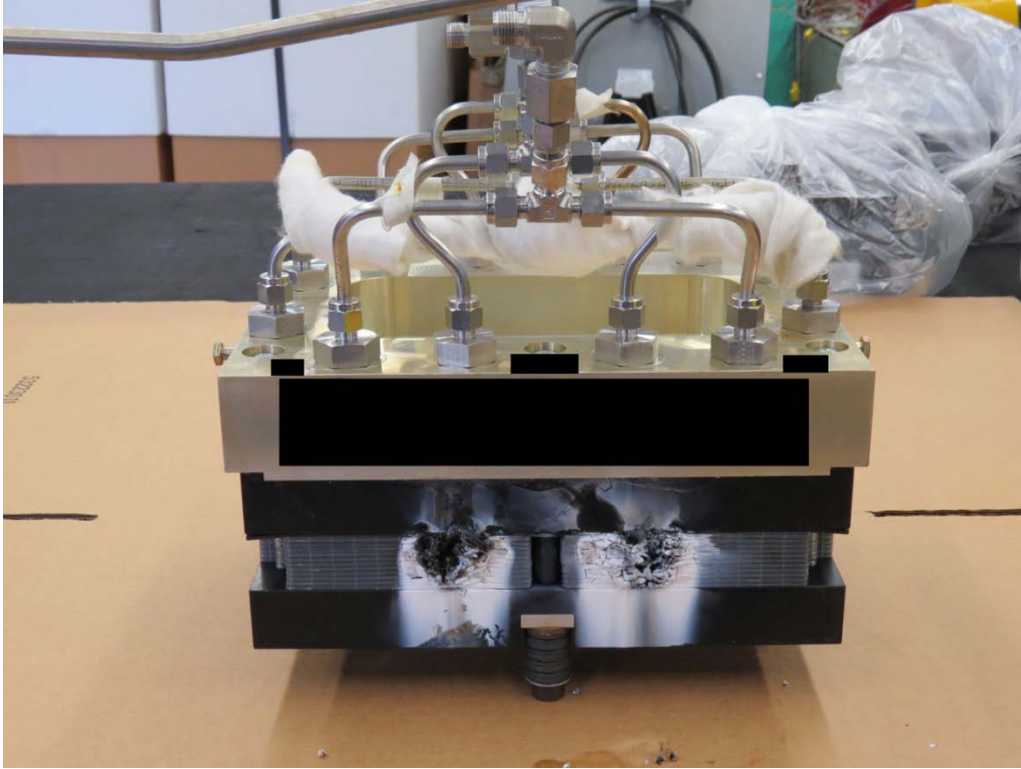
Figure 26. Crossflow condition test–external damage at O₂ inlet ports

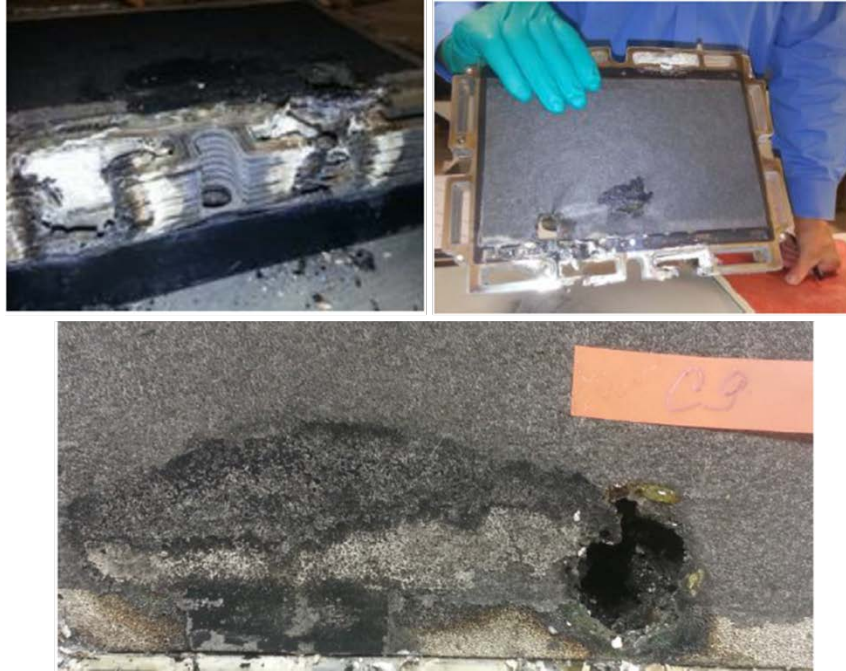
During a complete teardown analysis of the stack, significant internal damage was observed. Nine of the ten cells were fused together, and a large hole was burned straight through the MEAS. Again, heavier signs of damage were observed toward the center of the stack. The gasket material and metal bipolar plate material between the O₂ manifold and ambient environment were destroyed by burning. Though the damage was severe, it still remained localized and did not appear to propagate throughout the active area of the cells. Photographs of the internal damage noted during the teardown analysis are shown in figure 27.

Figure 27. Crossflow condition test—internal damage to fuel cell stack
