**Environment, Safety, Health & Quality (ESH&Q) Event Investigation Report****INSTRUCTIONS**

| <b>Event Number (from EtQ)</b> | E-00503 |
| <b>Event Subject (from EtQ)</b> | Pressure transducer fails on hydrogen compressor |

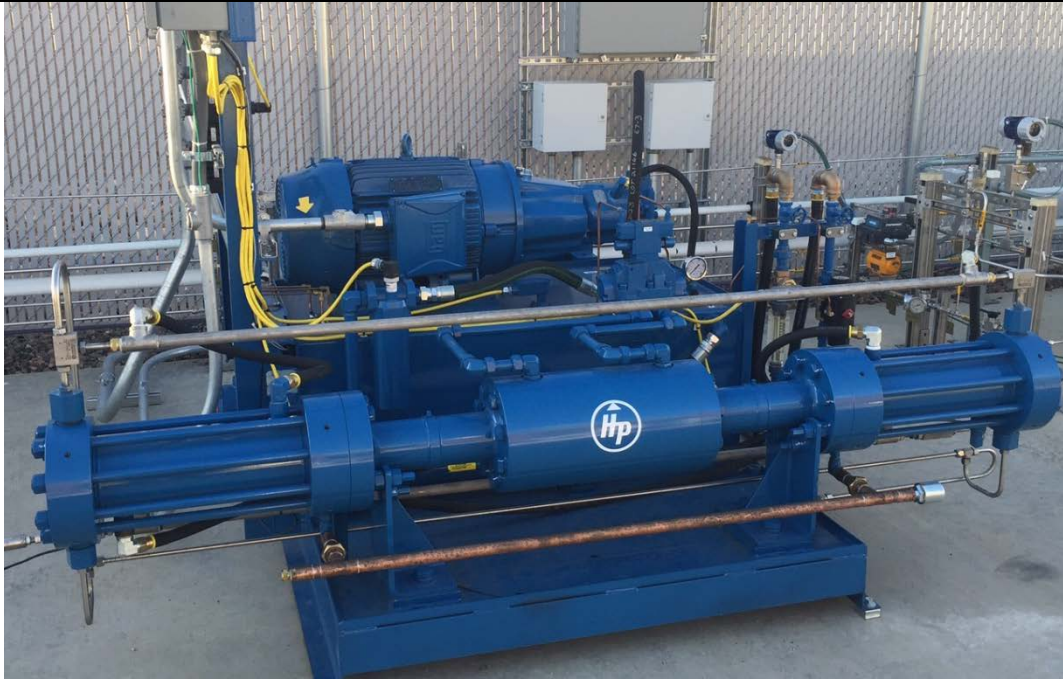
At 1:42 PM on January 15, 2019, the discharge pressure transducer (PT) on a hydrogen compressor unexpectedly failed, releasing approximately 0.1 kilograms hydrogen to atmosphere from the line. The compressor (Photo 1) is located in the Energy Storage Outdoor Test Area (ESOTA) Hydrogen Pad north of the Energy Systems Integration Facility (ESIF).

Photo 1. CNH-371 hydrogen compressor.

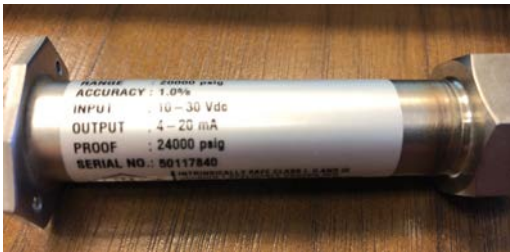
The discharge PT that failed was manufactured with a 17-4PH stainless steel diaphragm (Ashcroft Model K1, pressure rated up to 20,000). 17-4PH is a precipitation-hardened martensitic stainless steel manufactured for its strength and corrosion and temperature resistance. This type of stainless steel, while an industry standard for high pressure resistance with other materials, is known in industry to be incompatible with hydrogen. In 2008, Sandia National Laboratory published a technical reference on the compatibility of hydrogen with stainless steels. The document concludes that "precipitation-strengthened martensitic stainless steels are very sensitive to hydrogen-assisted fracture," and that, "this family of alloys is not recommended for service in hydrogen environments." Ashcroft does not currently offer a transducer pressure rated higher than 7,500 psi that can be used with hydrogen.

Eventually, CNH-371 started automatically one last time. When it did, the diaphragm on the PT ruptured and ejected the electrical potting. The loss of signal from the PT caused a system fault. Upon the fault, both CNH-371 and HP 2 immediately shut down. There was no significant mass lost (~0.1 kg), so tank mass alarms were not activated. The amount of hydrogen released was limited to line volume.

| 1 | Direct | - | Contact with hydrogen resulted in embrittlement of stainless steel diaphragm on pressure transducer |

Photo 2. Failed discharge pressure transducer.

| Action Item # | Addresses Cause # (See Section 8 above) | Description of Corrective Action | Anticipated Deliverable (i.e., expected outcome) | Due Date | Assigned Person and Center # | Comments (If completed, enter completion date here). |
|---|---|--|---|---|---|--|
| 1 | 1, 2 | Replace pressure transducers on Hydropac hydrogen compressor (CNH-371) with appropriately rated components. | Confirmation from Hydrogen System Owner that new PTs have been installed | April 15, 2019 | | |

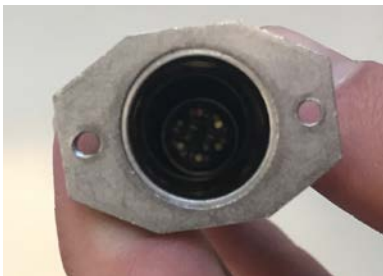
One of the contract workers walked to the Energy Systems Integration Laboratory (ESIL) Control Room to report the noise to NREL Hydrogen System research staff. Simultaneous to the device rupture, researchers were alerted by an alarm on the ESIL supervisory control and data acquisition (SCADA) control system of a PT "wire break." Researcher #1 walked outside to the ESOTA with the contractor and found the damaged PT and hydrogen leaking out. Researcher #1 isolated the leak by closing the upstream and downstream hand valves. The Environment, Safety and Health Point of Contact (ESH POC) was notified and responded, as did other research and engineering staff. Access to the ESOTA was restricted until the line was locked and tagged out and no hydrogen hissing could be heard. The failed component, the high-pressure PT originally supplied and installed by the manufacturer (Photo 2), was removed and inspected. Inspection revealed that the stainless steel diaphragm and electrical potting were damaged and off-center (Photo 3).

Photo 3. Failed discharge pressure transducer.
