Resid Hydrotreater Unit Heat Exchanger Failure

Summary

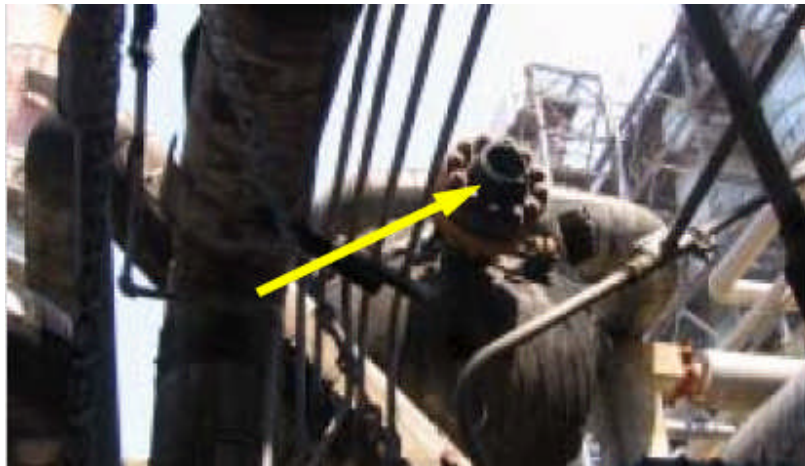
The RHU incident investigation determined that an 8-inch diameter carbon steel elbow inadvertently installed in a high-pressure, high-temperature hydrogen line ruptured after operating for only 3 months. The escaping hydrogen gas from the ruptured elbow quickly ignited.

Figure 1. Carbon steel RHU heat exchanger outlet pipe (arrow) ruptured after operating only 3 months in high temperature hydrogen service.

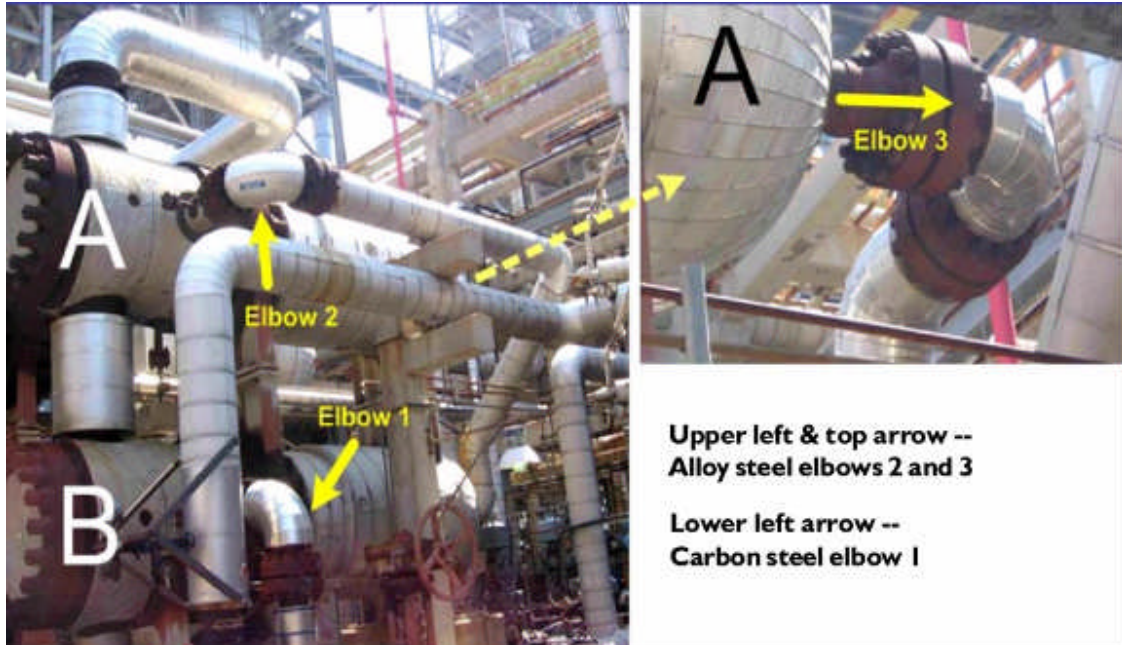
Figure 2. Dimensionally identical piping elbows on RHU heat exchangers A and B.

Construction costs may have been saved by making elbows 1, 2, and 3 on each heat exchanger assembly dimensionally identical, as doing so requires fewer pipe assembly fabrication drawings and weld joints in each assembly. Because the elbows are dimensionally identical, the piping contractor had to ensure that the low alloy steel

elbows 2 and 3 were installed in the correct locations where the RHU was built. Had the elbow 1 design dimensions been different, elbow 1 would not have been interchangeable with elbow 2 or 3 (Fig 2).

- The maintenance contractor inadvertently switched carbon steel elbow 1 (Figures 2 and 5) with the alloy steel elbow 3 during the RHU heat exchanger overhaul.

- Piping systems can be designed such that incompatible components cannot be interchanged. All three elbows could have been made from the same low alloy steel material, even though this would have meant additional material expense. Alternatively, elbow 1 could have been dimensionally different from elbow 2 and 3, although this would have meant additional construction costs.

Designers should consider the entire process system life cycle, including planned maintenance, to avoid piping configurations that allow critical alloy piping components to be interchanged with non-compatible piping components.

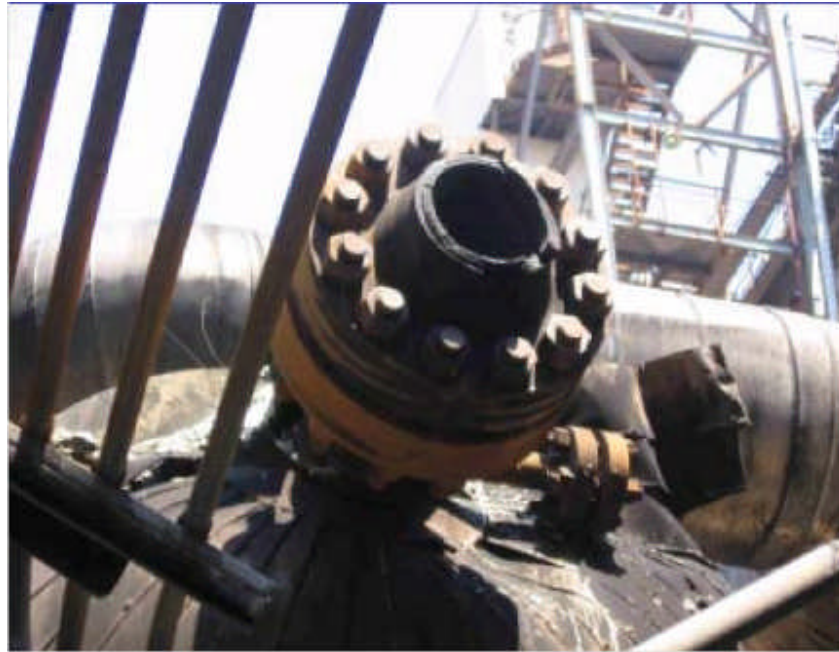
Onsite personnel examined the extensively damaged unit and determined that an 8 inch diameter pipe elbow on an RHU heat exchanger hydrogen gas outlet pipe ruptured (Fig. 3). The investigation team recovered the elbow segments that remained attached to the pipe and three pieces found in the debris.

Figure 3. Ruptured 8-inch pipe elbow on heat exchanger A outlet

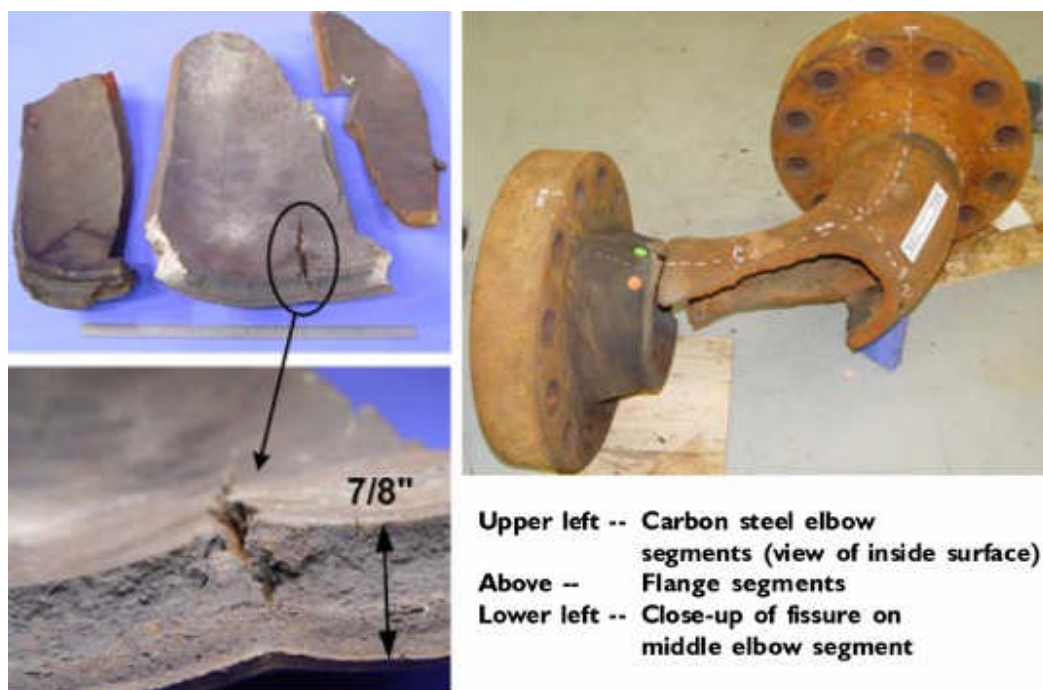
The elbow segments recovered from the damaged unit were examined to identify the steel and the failure mechanisms. Chemical analysis and microscopic examination determined that the elbow was made from carbon steel. Microscopic examination also showed that the segments were severely decarburized and had deep fissures on the inside surface (Fig. 4). The decarburized steel and severe fissuring confirmed that HTHA caused the catastrophic elbow failure.

Figure 4. Ruptured 8-inch carbon steel pipe elbow pieces recovered after the fire

Detailed metallurgical examinations and micro-hardness testing quantified the extent of hydrogen damage to estimate the total time the elbow could have been in the high-temperature, high pressure hydrogen service before if failed. The results, compared to existing experimental data and empirical service life predictions, concluded that the elbow failed after being in service for fewer than 3,000 hours.

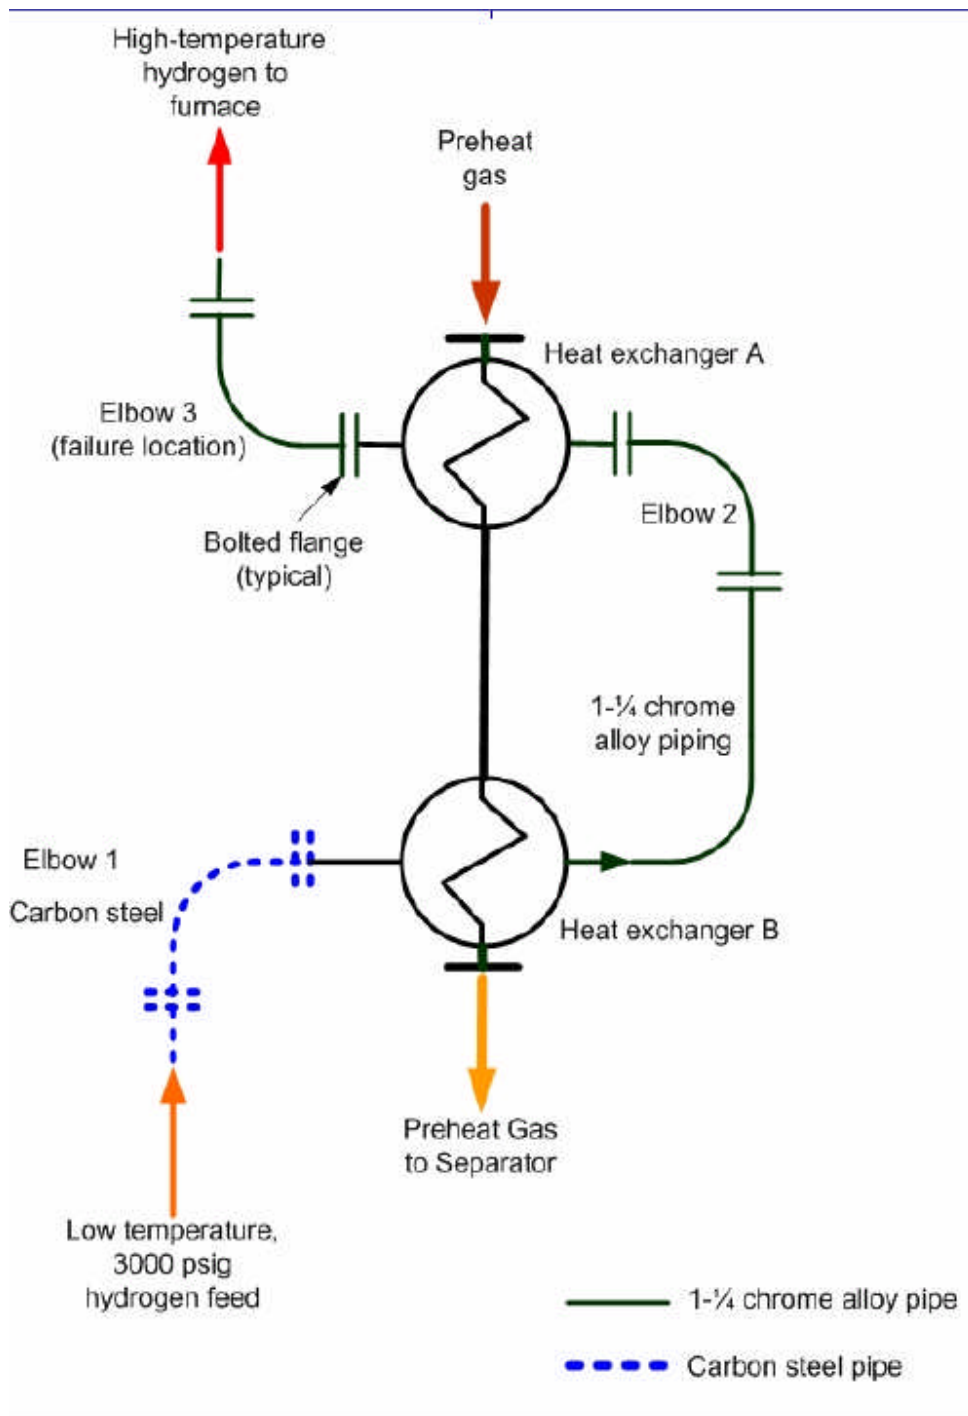
Because heat exchanger B inlet piping and components operate at temperatures below 450 °F, they are carbon steel; heat exchanger B outlet and all downstream piping and components (Fig 5) are required to be low alloy steel because they operate at temperatures above 500 °F.

Figure 5. RHU hydrogen heat exchanger piping material requirements

Metallurgical analysis after the incident concluded that the carbon steel elbow could withstand the high-temperature, high-pressure service for only a few thousand hours. X-ray fluorescence testing confirmed that an alloy steel elbow was installed in the carbon steel elbow position on the heat exchanger B inlet. Therefore, the investigating organization concluded that carbon steel elbow 1 was inadvertently switched with alloy steel elbow 3 when the maintenance contractor reassembled the piping during the winter 2005 heat exchanger overhaul.

In-situ alloy steel material verification using x-ray fluorescence, or non-destructive material testing, is an accurate, inexpensive, and fast PMI test method. Facility owners, operators, and maintenance contractors should ensure that the verification program requires PMI testing, such as specified in API Recommended Practice 578, or other suitable verification process, for all critical service alloy steel piping components that are removed and reinstalled during maintenance.

At a minimum, piping components and their respective locations should be tagged or marked before removal, and the correct installed location is verified after reinstallation.
