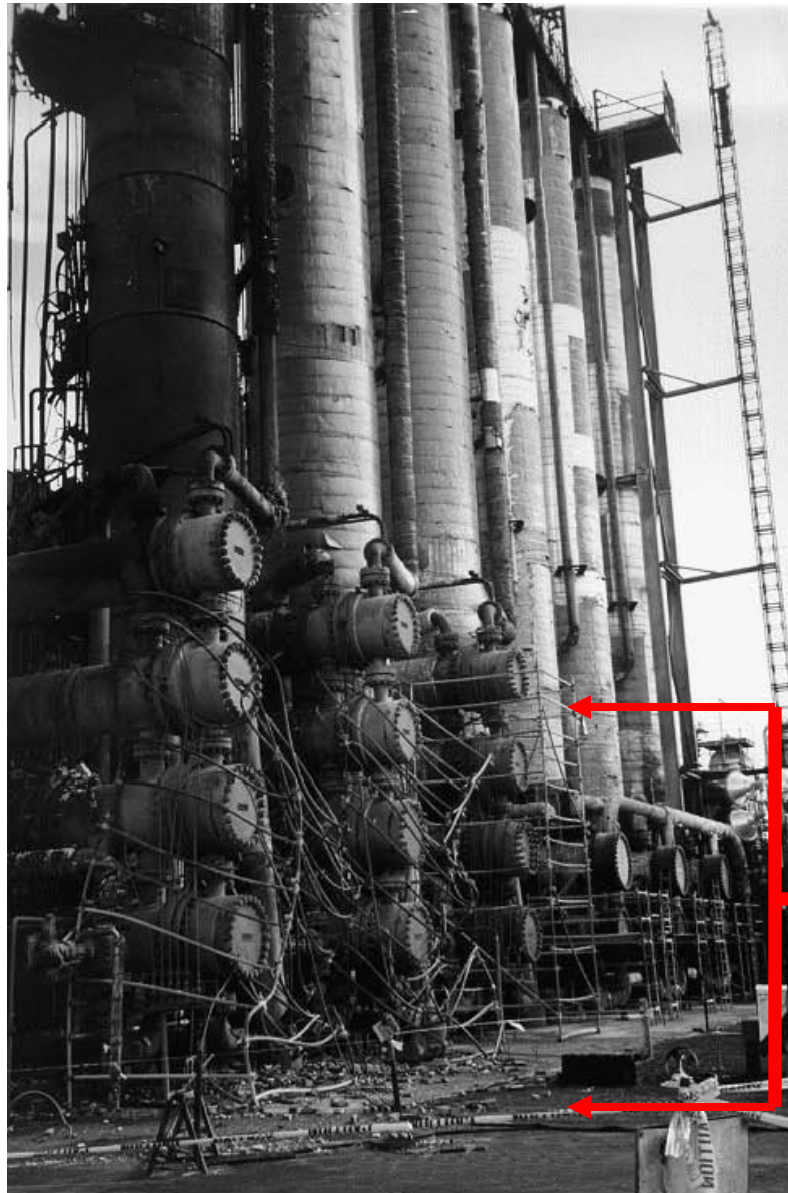
Area of Damaged
Scaffolding

Figure 1 – Reactors with Damaged Scaffolding

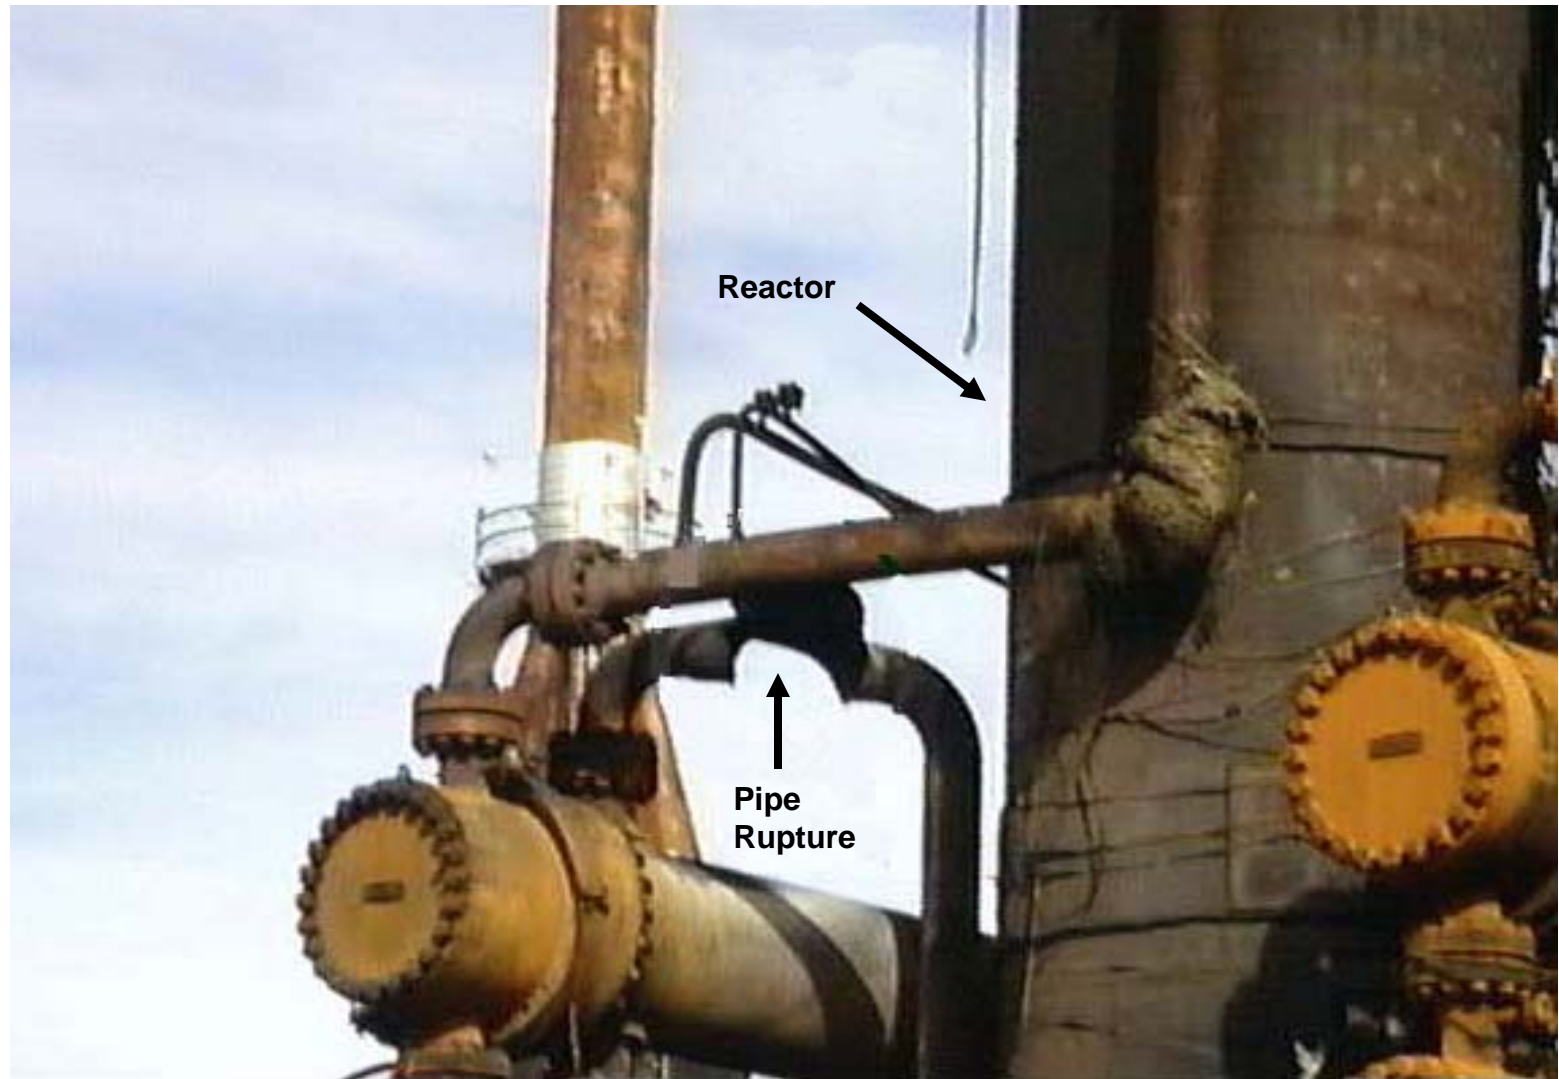
Figure 2 – Reactor Effluent Pipe Rupture

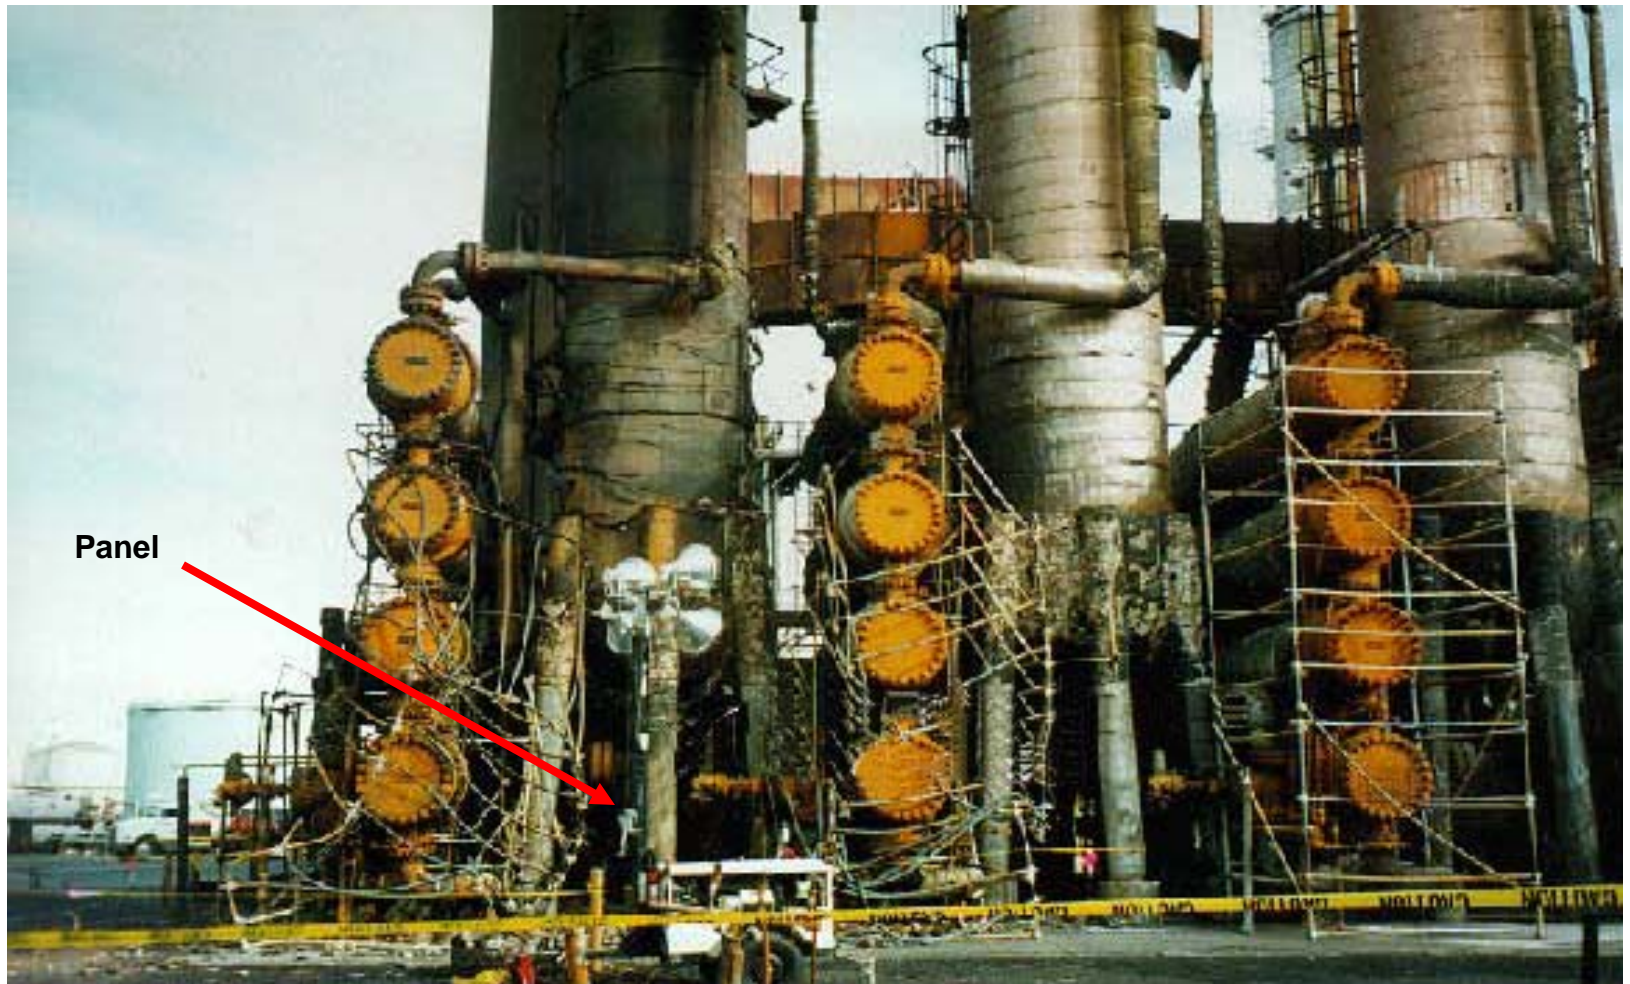
Figure 3 – External Temperature Panel Location

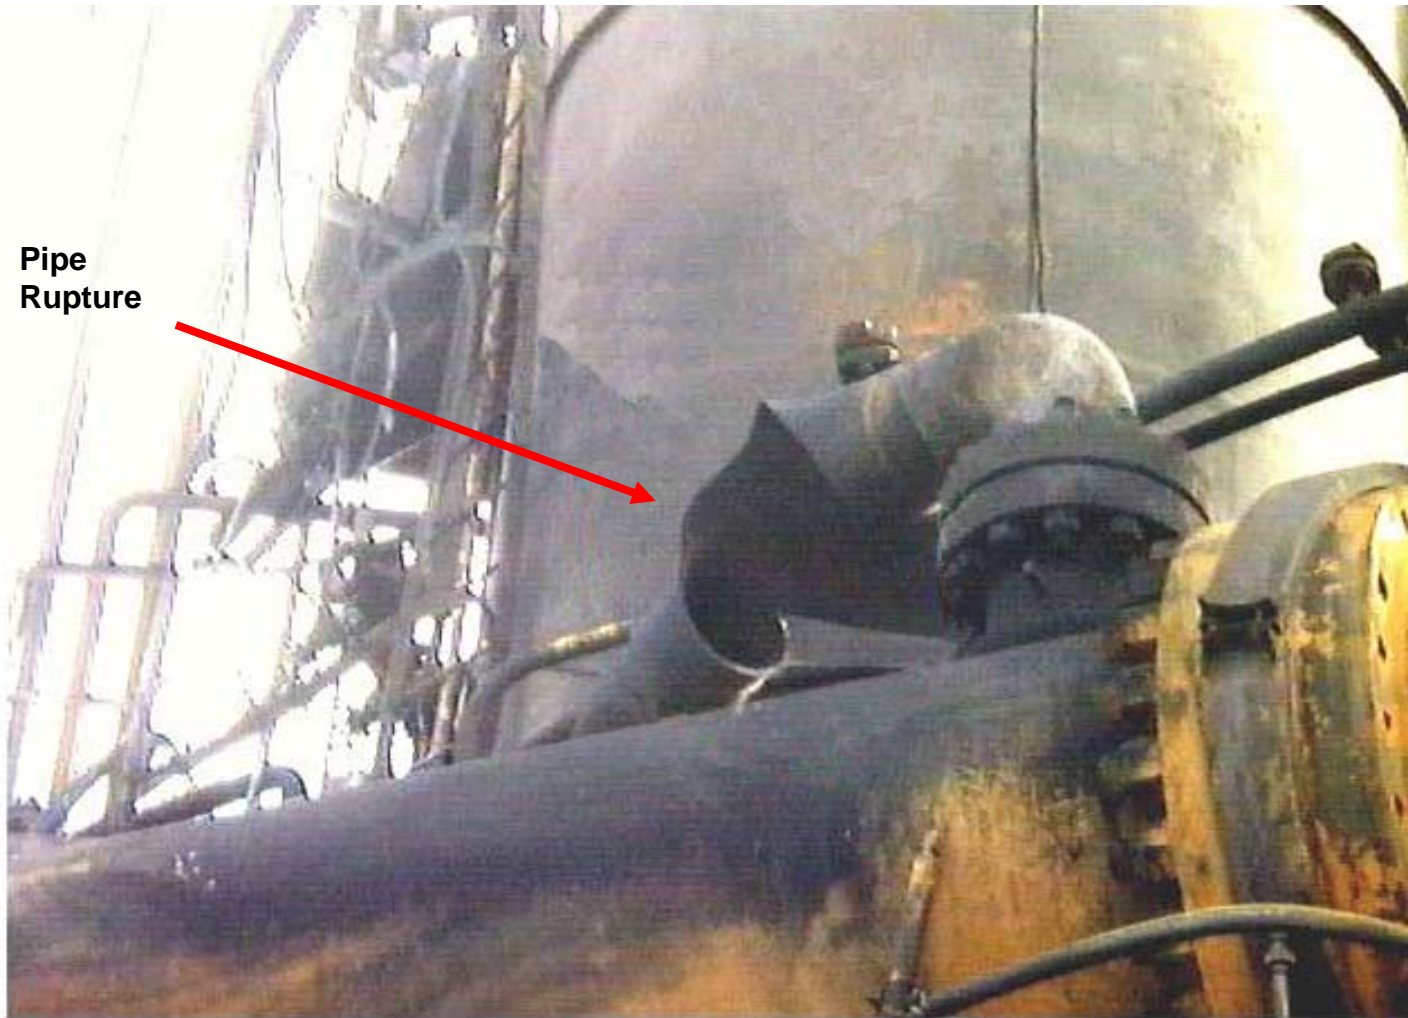
Figure 4 – Effluent Pipe Rupture Seen From Back Side of Reactor

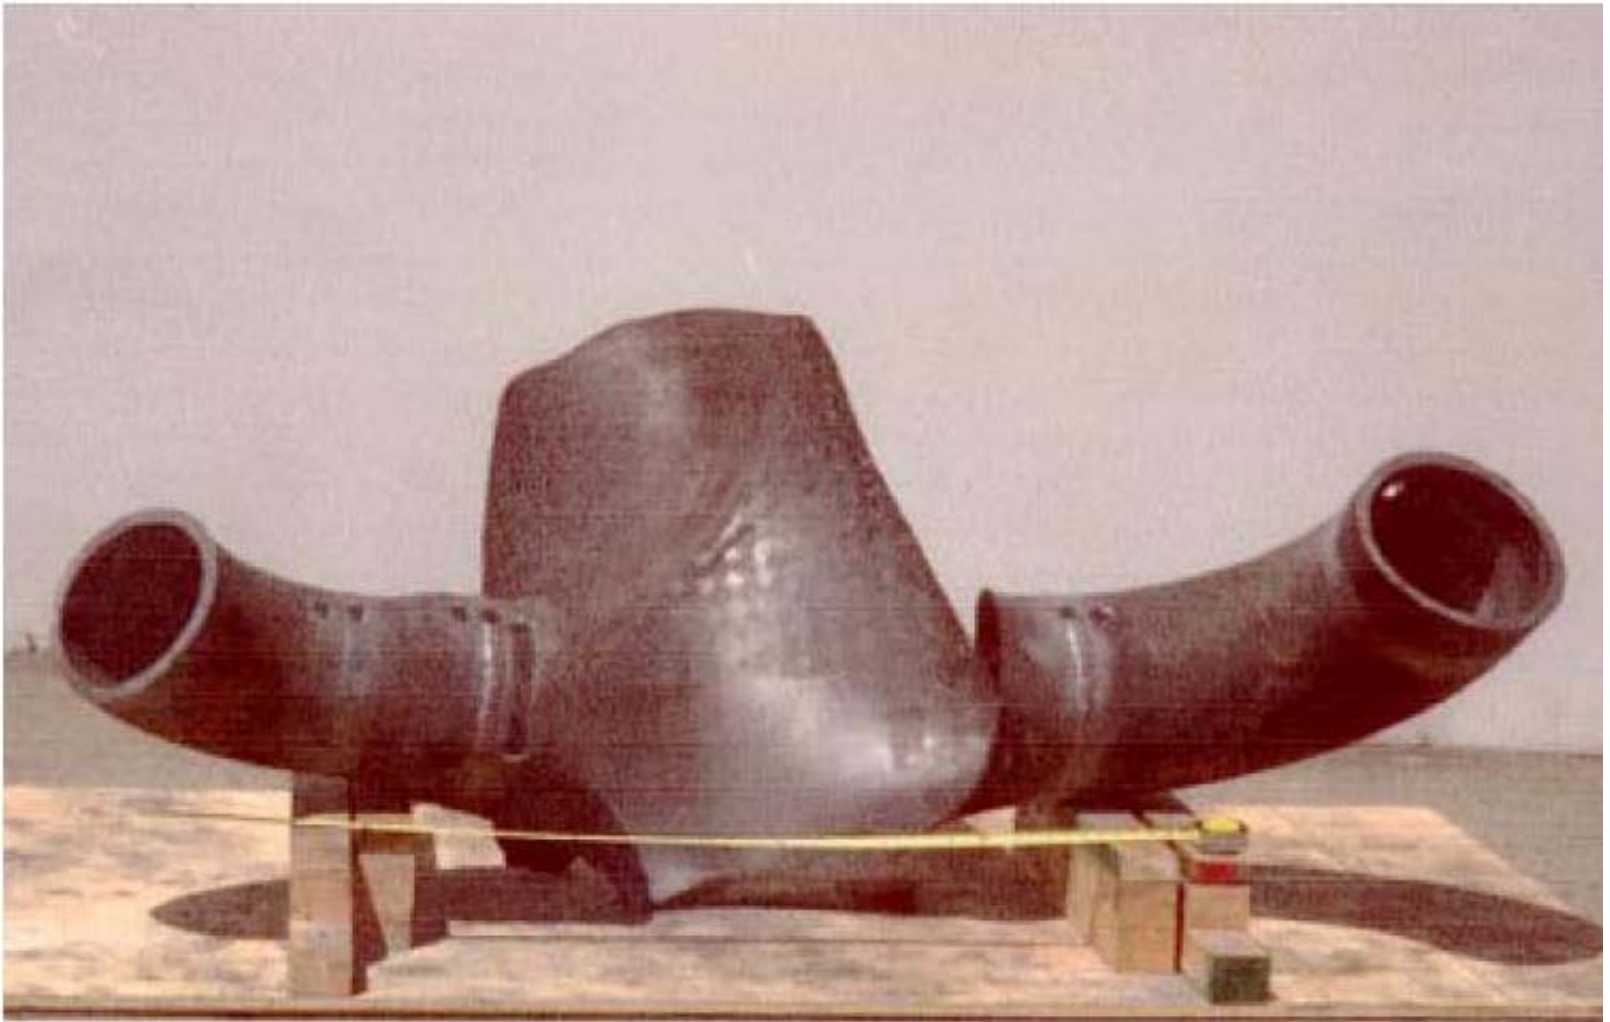
Figure 5 – Ruptured Effluent Pipe After Removal
