Photos 1 – 6, Various Details of Damage to Reformer Furnace

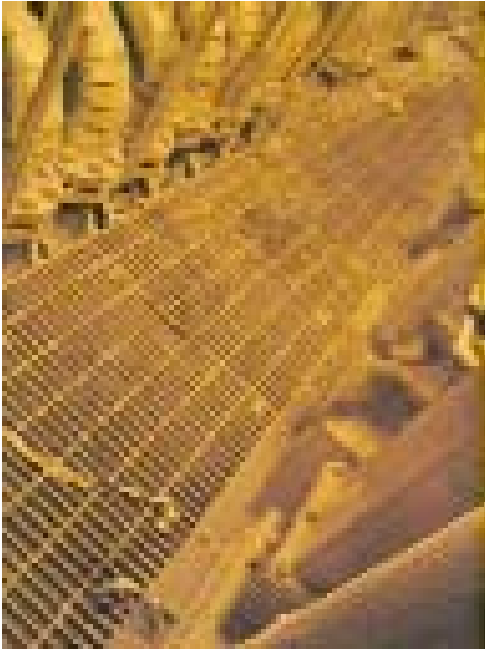
Photo 1 - General arrangement radiant tube inlets

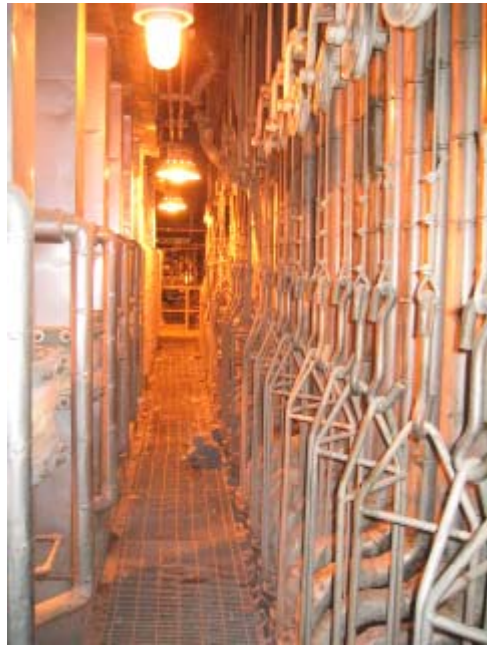
Photo 2 - Pre incident general radiant tube arrangement

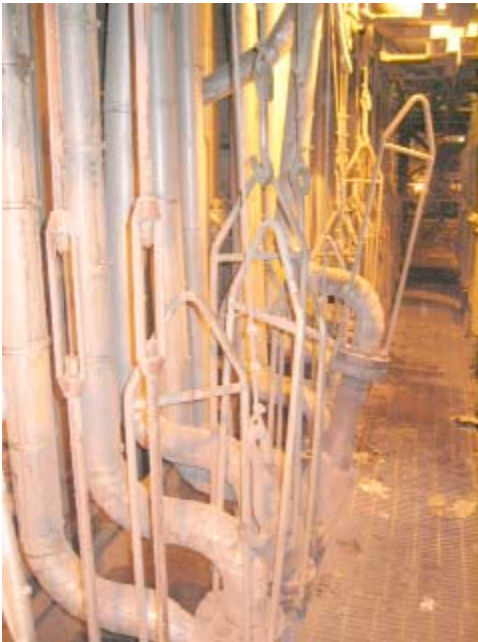
Photo 3 - Post incident damage. Note displaced hangers and counter weights

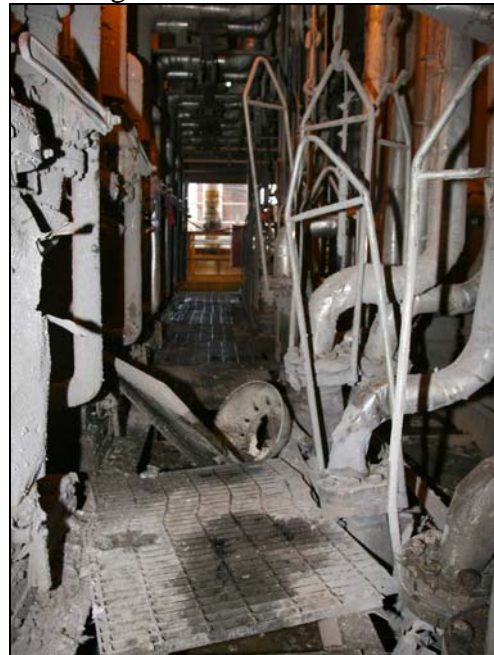
Photo 4 - External damage

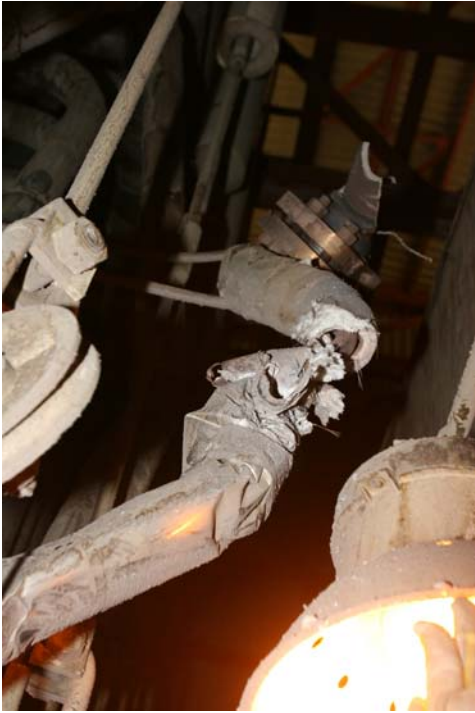
Photo 5 - Tube 161 lifted approximately 16 ft (view looking up)

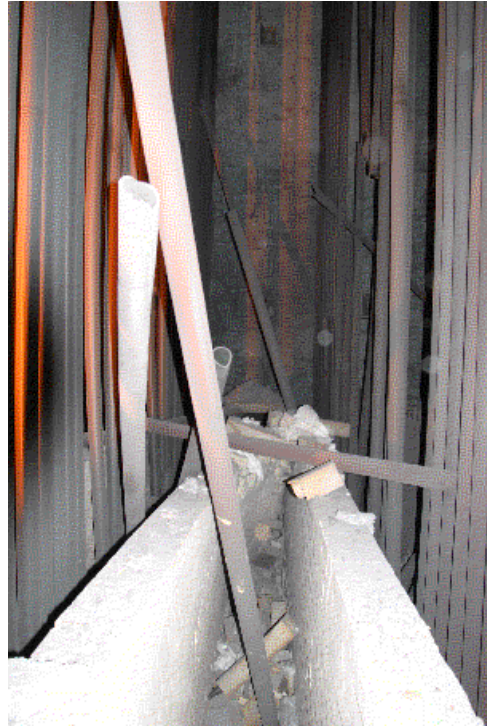
Photo 6 - Internal condition of radiant section
