Experimental Study of Hydrogen Release Accidents in a Vehicle Garage

Erik Merilo
Mark Groethe
James Colton
Seiki Chiba

3rd International Conference on
Hydrogen Safety

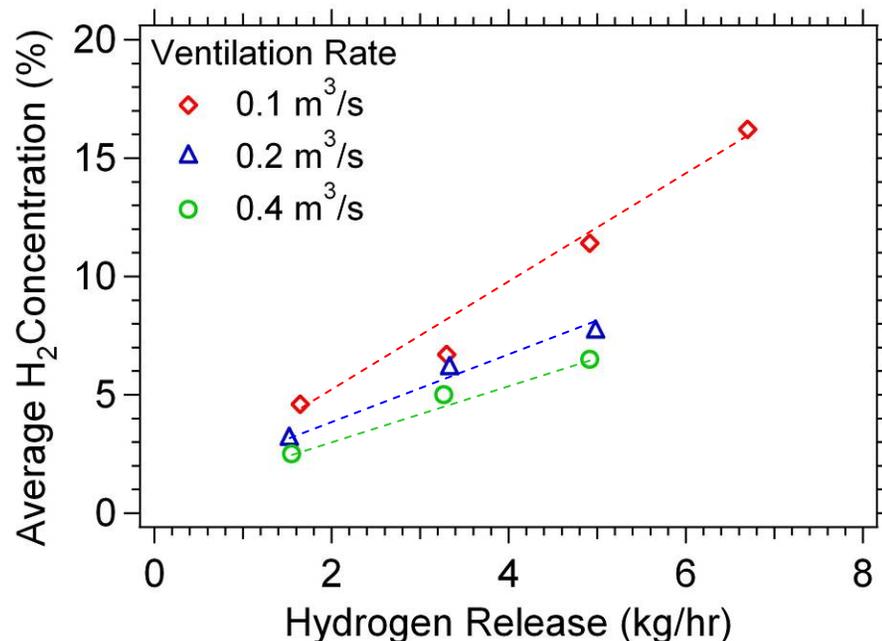
- 6.7 kg/hr release

- *Overpressure generated was well below a level that would cause eardrum rupture.*
- *Overpressure could potentially launch projectiles.*

- ≤ 4.9 kg/hr release

- *Overpressures that resulted were very low and did not represent a risk to people or property.*
- *Primary hazard was the deflagration of the hydrogen and air mixture and the burning of the hydrogen jet fire inside the garage.*

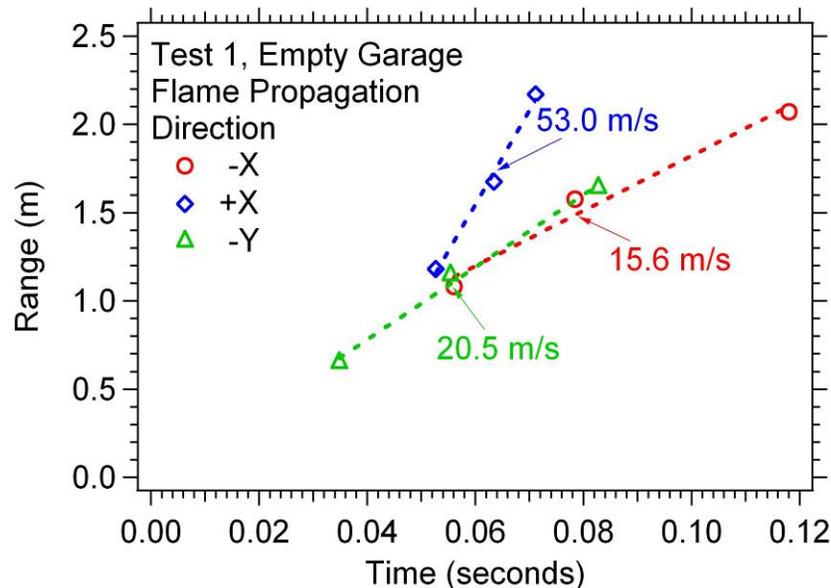
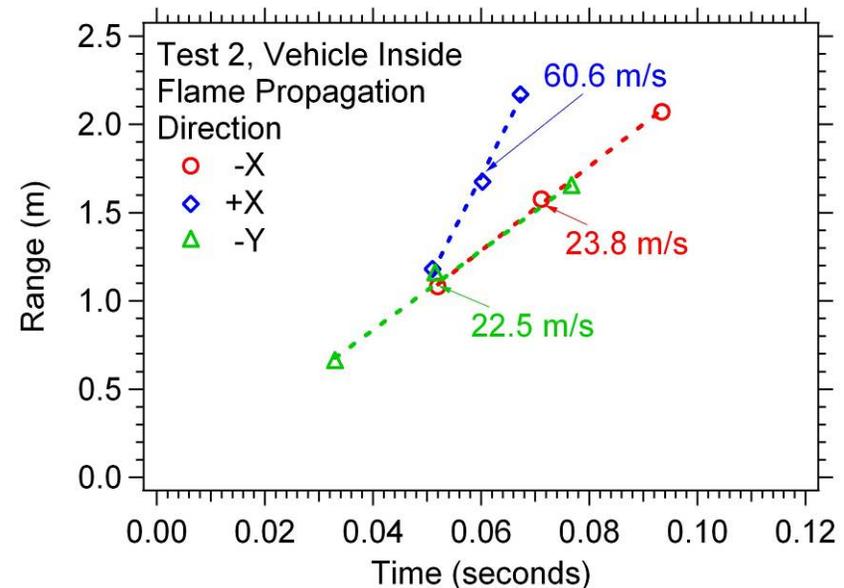
Flame Front Propagation and Flame Speed

- There was a small increase in flame speed when the vehicle was present.
 - *Probably caused by the vehicle-created blockage inside the garage*
- The enhancement of the deflagration caused by the external surface of the vehicle appears to be small.

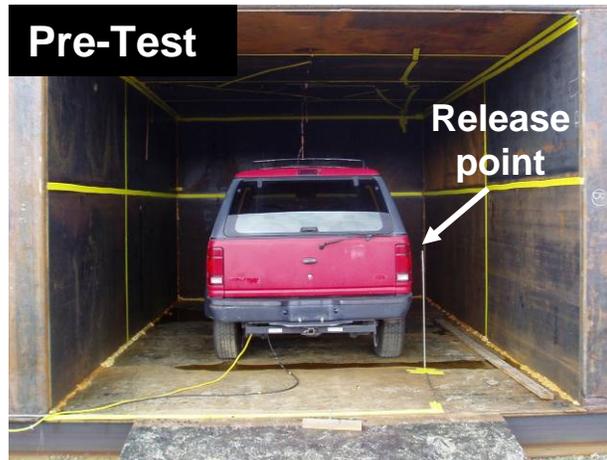
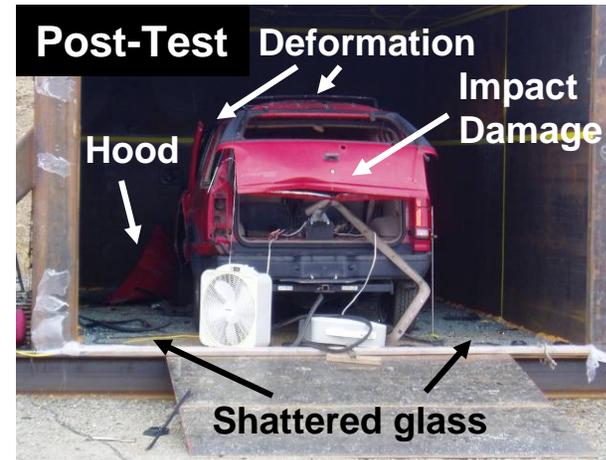
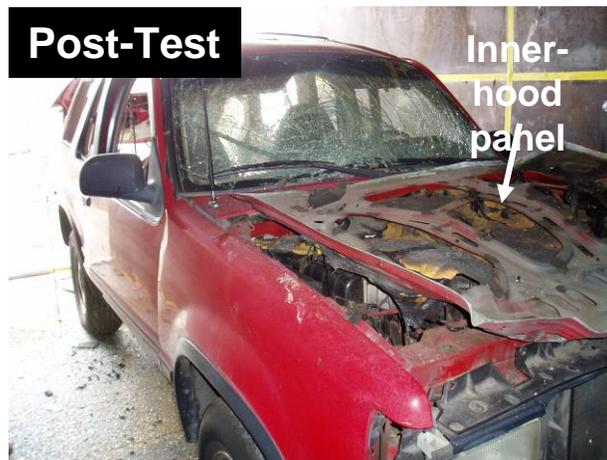
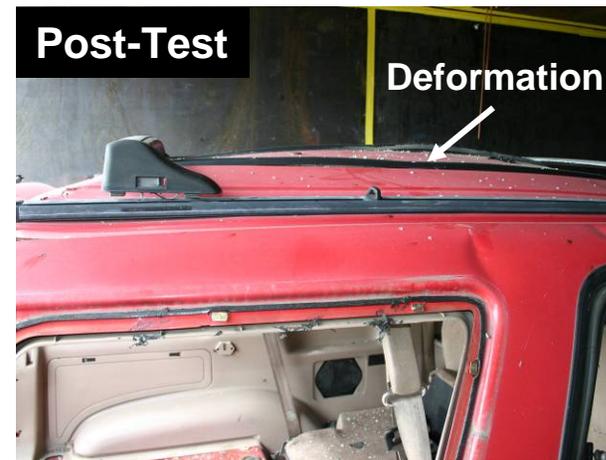
Vehicle Damage

- Internal explosion occurred within the engine compartment and inside the cabin.
- The deflagration did not set the vehicle or any of its components on fire.

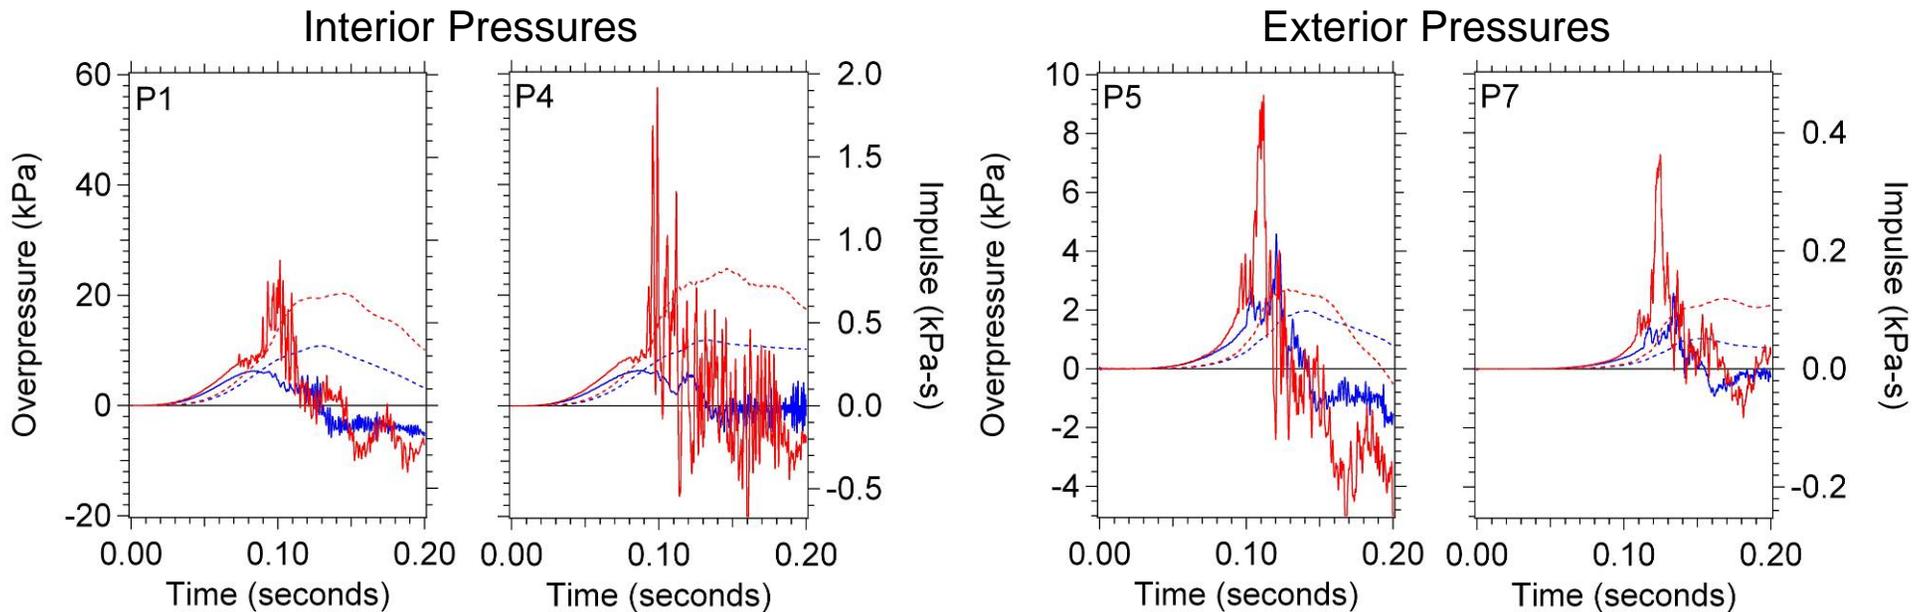
Overpressure and Impulse

- A sudden increase in overpressure occurred about 0.085 s after ignition when the vehicle was inside the garage.
 - *Can be attributed to the enhancement of the deflagration as it propagates through the congested region inside the engine compartment and inside the cabin of the vehicle*
