STUDY ON BEHAVIOR OF AMBIENT HYDRAULIC CYCLING TEST FOR 70 MPA TYPE-3 HYDROGEN COMPOSITE CYLINDER

CHO, SUNG MIN¹, KIM, CHANGJONG², KIM, EUNJUNG³ and KIM, INCHAN⁴

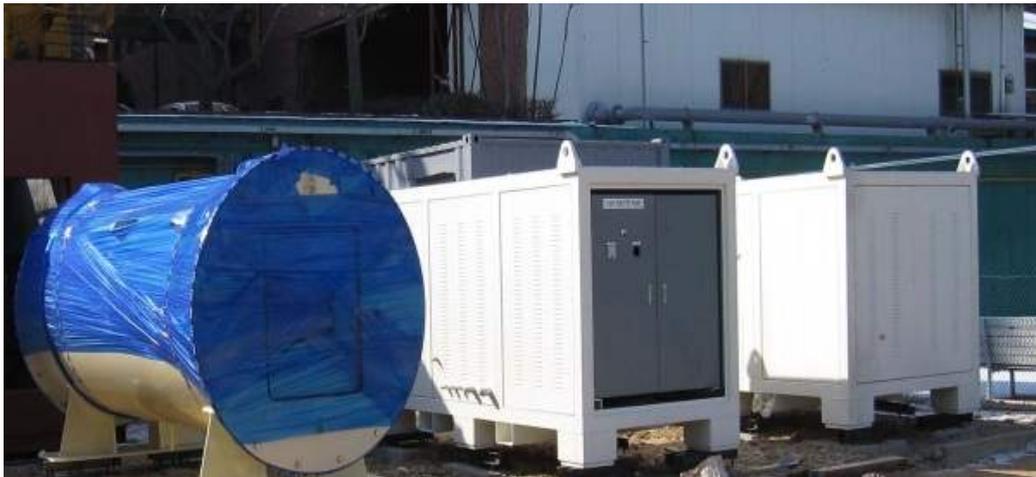
Today, since hydrogen cylinder is charged to 35 MPa and 70 MPa for use, the equipment dedicated to each kind of cylinders which have different performance and capacity is furnished at Korea Gas Safety Corporation for hydraulic cycling test. There is the equipment which can adjust the velocity per minute to the average of 6 cycles so that the time spent on tests can be reduced and there are other apparatuses each of which has its own pressure to match each demanded velocity per minute.

Figure 1. High Pressure Pump and Chamber

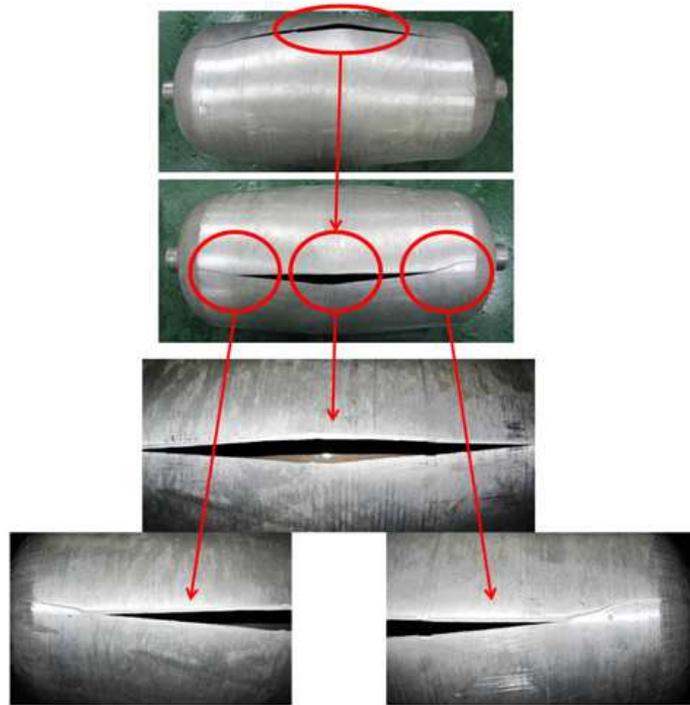
In general, at the test of cylinder burst, the manufacturers design and make the cylinders whose bodies are supposed to burst. The reason is to minimize the impact on other external parts by burst of the body which can absorb some of the impact. The frame for winding carbon fiber and the liner preventing any gas from being released should be checked if the body has stable burst and there is any defects inside the liner. Figure 2 shows the test of burst at the liner made in Korea, which was found to have the burst beginning at the body.

Figure 2. Burst Test of AL Liner

- 1) The burst at cylinder (body) begins first at the test of liner burst, which causes the stress concentrated more at the cylinder (body) than at the dome area.

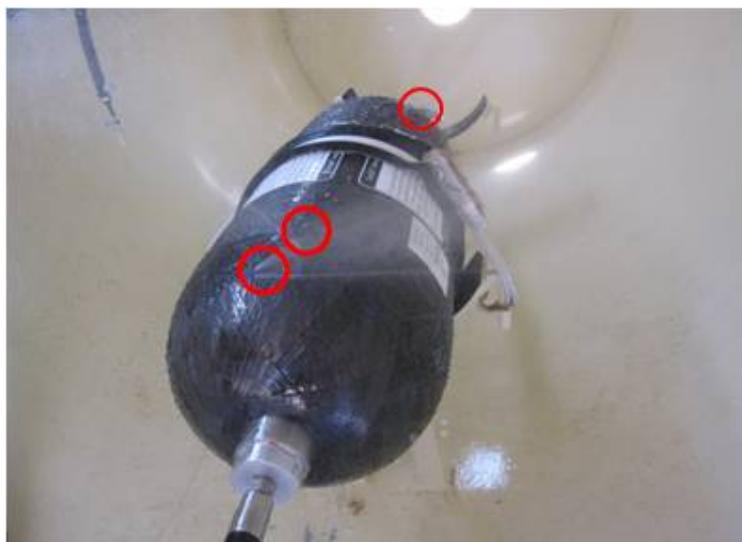
The picture below is about the hydraulic cycling test of foreign-made 40-liter 70 MPa. In general, the composite made of a bundle of fiber is solidified into resin, and if it has no sealing, the fluid inside, on being pressurized, is leaked to outside through small holes. The leakage to outside at the final stage when the liner comes to have internal cracks due to fatigue after it has had more cycles than those guaranteed by the manufacturers. It is necessary to find out what part of the inside of the liner has the leakage which can be visible with that.

Figure 3. Leakage of Type -3 Cylinder

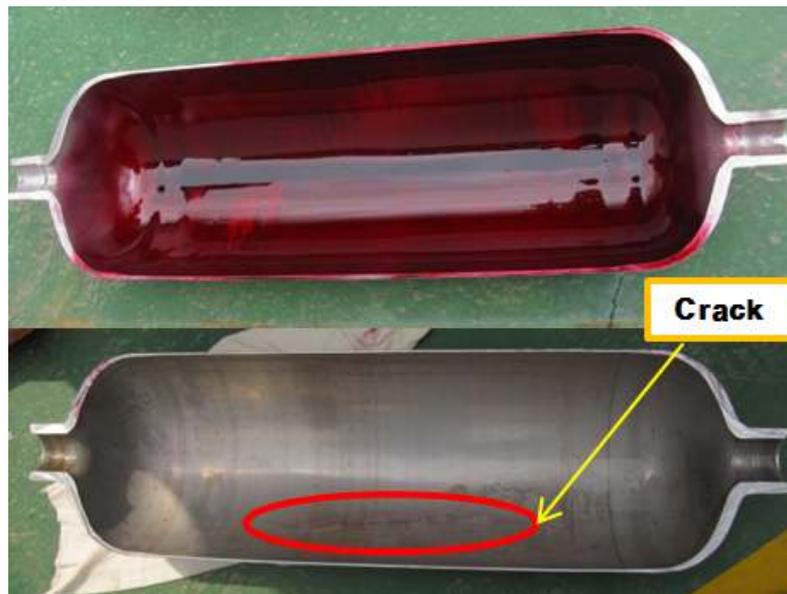
A Penetration Test was carried out inside the liner with cut liner and composite material in order to find the exact position of the defected part in the cylinder which was found to have leakage by hydraulic cycling test, which showed long damage on the cylinder (body) as suggested at Fig. 4. What has to be noted at this point is that the leaking part on the liner was the center of cylinder while that of composite cylinder was dome knuckle and dome area, which can be thought as the following: the fluid did not leak directly into the top of composite material but to the part which is vulnerable to leakage (the parts of composite with the thinnest thickness or the area of insufficient impregnation).

Figure 4. Penetration Test for Inner Liner of Type-3 Cylinder

- 2) In the case of leakage at the liner due to fatigue at Hydraulic Cycling Test of Composite Cylinder, the surface of the composite comes to have several areas of leaking. However, the Penetration Test revealed that the defect inside the liner occurs at the cylinder (body).

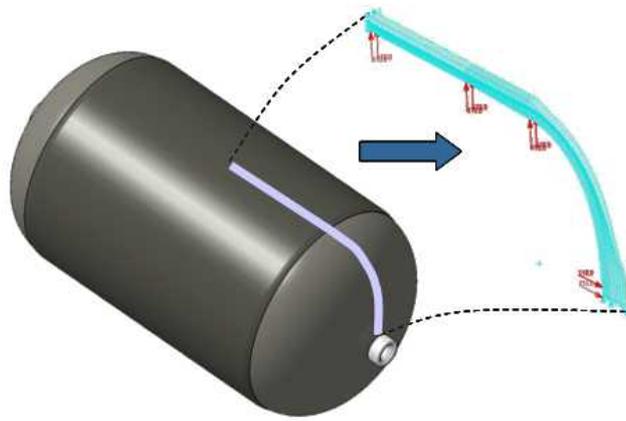
At the modeling of finite elements, the three-dimensional laminated solid elements were used for precise prediction of anisotropy of filament-winding structure and the distribution of local stress at cylinder and dome areas. In addition, multi-point constraint and boundary condition using periodic symmetry condition were applied. The techniques of Geometric Non-linear and Material Non-linear Analysis were adopted for analysis to predict non-linear behavior at the interface of cylinder/dome and liner's plastic behavior[4].

In particular, since the helical angle at the dome area is very likely to continuously change and wind, the technique of designing only with the existing fixed angle causes the accuracy of modeling to drop[5].

Figure 5. FE Analysis Model

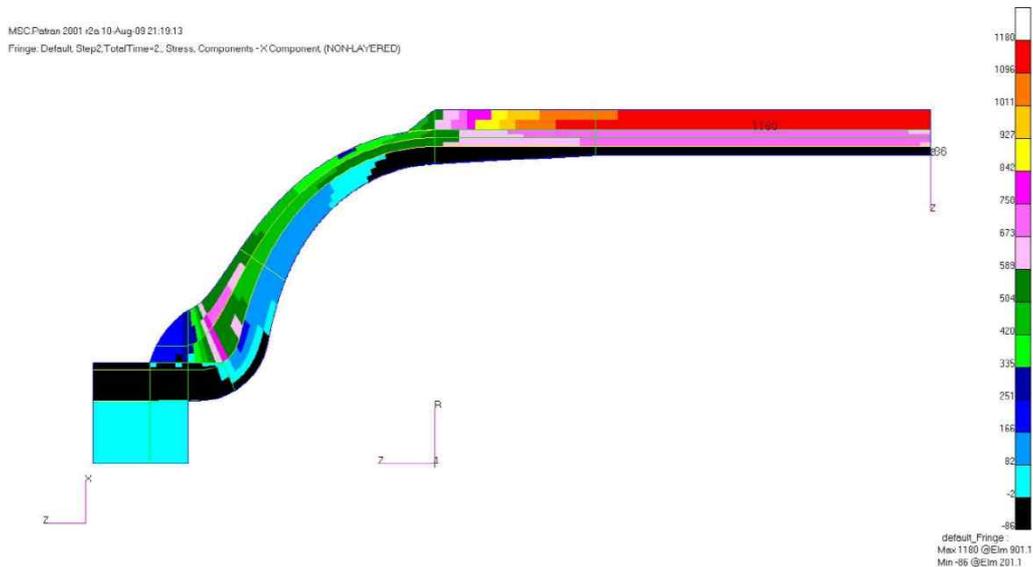
A variety of detailed structural analyses were carried out for the evaluation of the effect of such design variables as carbon fiber and liner shape on the structural behavior of cylinder along with the application of the above various analysis and design elements, which produced the below results as seen at Fig 6 through the examination of cylinder's structural behavior depending on the change of design variables.

For the structural analysis of composite pressure cylinder, the commercial software of MSC/PATRAN was used for 3-D modeling of liner, hoof layer and helical layer and then the stress and the deformation were analyzed by FEA commercial software of ABAQUS to show the stress and the deformation under the representative maximum charging pressure.

This shows that the composite cylinder has vertical motion around dome knuckle and that the parts of dome and boss horizontal motion. Accordingly, it was found that when pressurized, the cylinder (body) gets bigger stress than the dome area and gets swollen as being pressurized, which makes dome knuckle and cylinder (body) vulnerable to fatigue.

Figure 6. Stresses and Strains at Max. Fill Pressure

- 3) The Structural Analysis showed that the stress of cylinder is concentrated on the body. Accordingly, the deformation of cylinder shown by structural analysis revealed that the cylinder has vertical motion while the boss area horizontal motion. Consequently, it was found that when pressurized, the cylinder (body) gets bigger stress than the dome area does and gets swollen as being pressurized, which makes dome knuckle and cylinder (body) vulnerable to fatigue.

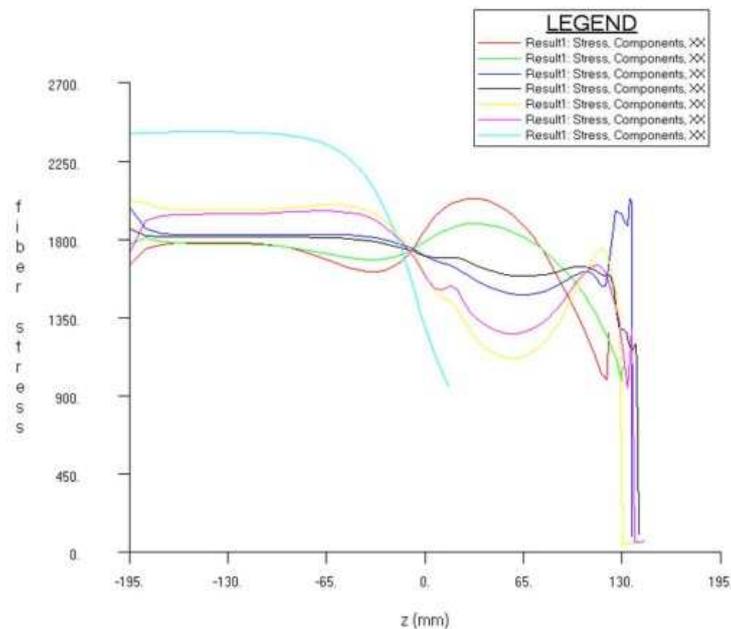
Figure 7. Distribution of Stress for Each Layer
