ADAPTED TUBE CLEANING PRACTICES TO REDUCE PARTICULATE CONTAMINATION AT HYDROGEN FUELING STATIONS

D. Terlip¹, K. Hartmann¹, J. Martin¹, C. Rivkin¹

¹National Renewable Energy Laboratory

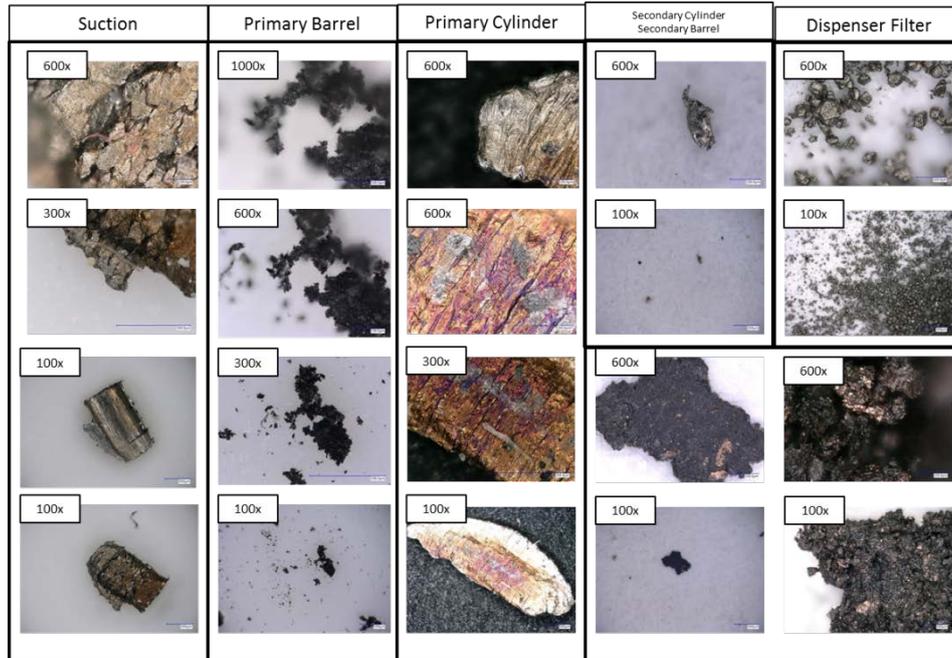
Figure 1. Images of particulates collected from a compressor and dispenser after a compressor failure magnified 100x to 1000x

Metal particulates were found throughout the system along with destroyed elastomers and a failed sintered filter. The metal particulate found in the inlet, or suction, side of the compressor, shown in the first column is about 1 mm by 1.5 mm and resembles half a cylinder. The metal particulate found in the primary cylinder, shown in the third column measures 3.6 mm by 1.3 mm and has discoloration consistent with high heat. Multiple particles were found in the secondary barrel. The particle shown in the fourth column and first row measures 0.25 mm by 0.1 mm and has no discoloration.

Magnified images of particulates collected after a compressor failure are shown in Figure 1.

NREL analyzed the metallic debris collected from the suction, primary cylinder of the compressor and dispenser filter for chemical composition using SEM. The results showed compositions high in iron, nickel, chromium and molybdenum in the same ratio as 316 stainless steel [12]. The origin of these particles is not known.

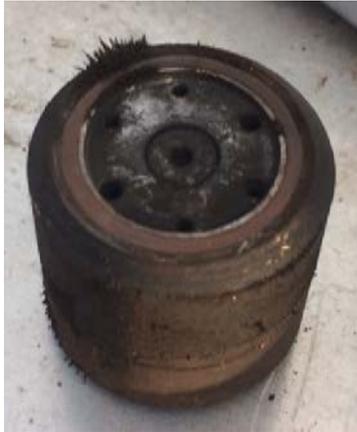
Figure 2. Failed check valve from a leaking compressor. Metallic debris is shown in the top left.

In other samples, more metallic particulate was found in a failed check valve (Figure 2), compressor rider band (Figure 3) and valve seat material (Figure 4). The metal debris in Figure 2 appears to be magnetized, yet austenitic stainless steels are typically nonmagnetic. Heat treating and physical deformation, as may take place in a compressor environment, have been shown to magnetize austenitic steels and may be responsible for magnetizing the metal particulates here. Unfortunately, the amount of other material on the sample did not allow for SEM analysis.

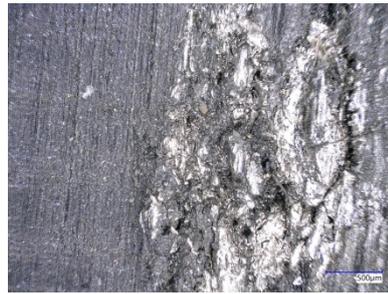
Figure 3. Microscopic image of metal impregnated rider band collected from a compressor after a failure.

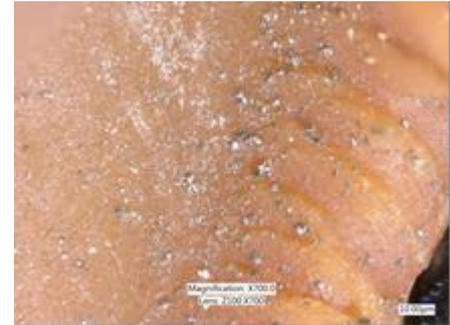
Figure 4. Microscopic image of a failed valve seat showing metal debris

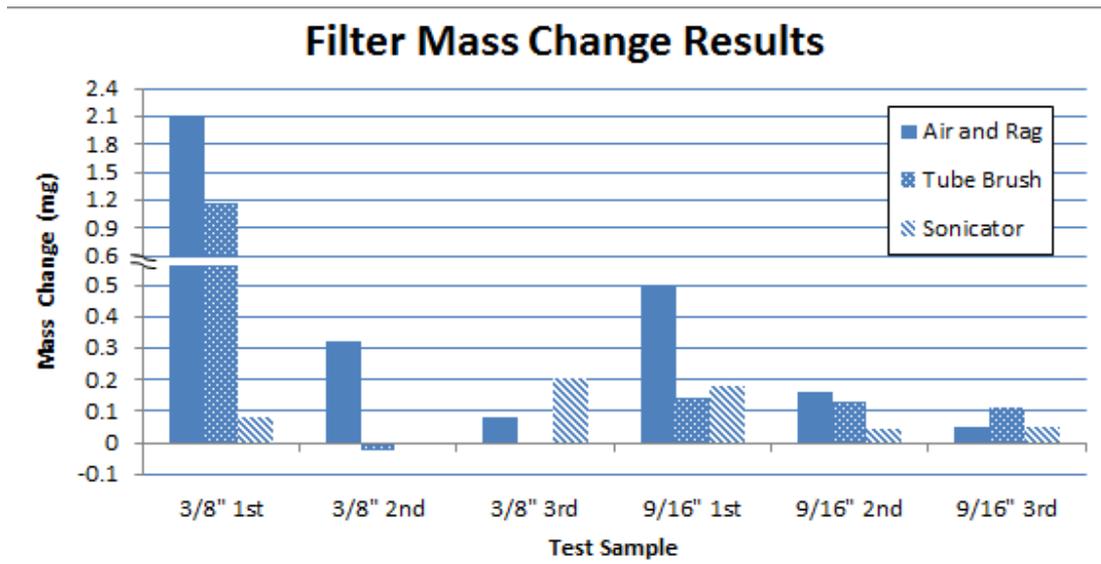
Figure 5 shows the mass difference results for each filter used in the tube tests. The first filters for the 3/8" and 9/16" tubing are outliers. Microscopic analysis showed that the outliers are a result of cutting oil deposition. The standard error in average mass difference across tube cleaning methods was 0.13 mg. Therefore, the air and rag (average = 0.53 mg, median = 0.24 mg) method is definitely worse than the sonication (average = 0.30 mg, median = 0.13 mg) method for mass difference, but within the standard error of the tube brush method (average = 0.11 mg, median = 0.08 mg). The tube brush method is within the standard error of the sonication method for mass difference and therefore not definitively better or worse.

On average the filters from 3/8" OD tubing showed a mass change of 0.56 mg (median = 0.20 mg) and filters from the 9/16" OD tubing showed a mass change of 0.15 mg (median = 0.13 mg), and thus on average the 3/8" OD tubing resulted in more particles than the 9/16" tubing. One explanation for this result could be that because the gas travels at higher velocity through smaller OD tubing for the same flow rate, it picks up larger particles. This effect was discussed in [6].

Figure 5. Results of laboratory tube cleaning tests, separated by cleaning procedure. The 2nd Sonicator sample for 3/8" OD and the 3rd Tube Brush for 3/8" OD samples were thrown out due to an operator error during collection.

NREL compared the mass change of filters, the number of particles and the size of particles across cleaning methods and tubing size. The filters from tubing cleaned with the air and rag method had the highest mass change and highest number of particles, indicating the most contamination. Filters from tubing cleaned with the sonication method had the lowest mass change, indicating the least amount of particles by mass. Filters from the samples cleaned by tube brush had the lowest number of particles. The largest particles were found in the filters from tubing cleaned by the air and rag method. Filters from the 3/8" OD tubing had a higher mass change than filters from the 9/16" OD tubing did. The results were inconclusive for the number of particles collected on filters between 3/8" OD tubing and 9/16" OD tubing. Results for two samples (6 and 8) were thrown out due to an operator error in the testing procedure.

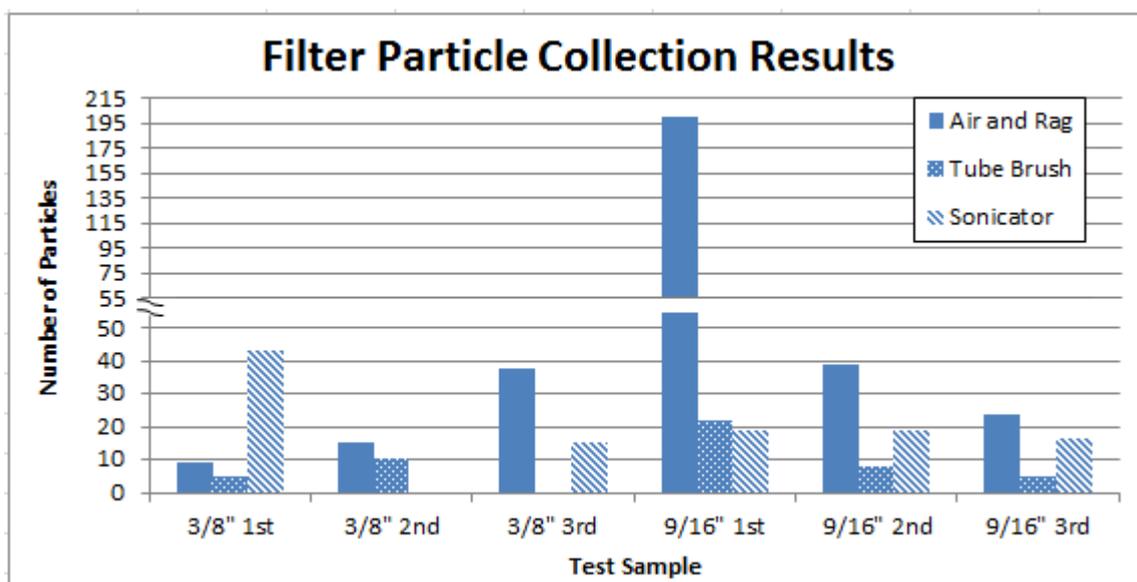
Microscopic analysis gave the number and size of particles on each filter (Figure 6). With a standard error for the number of particles per filter of 11, the air and rag method (average = 54, median = 31) yielded definitively more particles than either the tube brush (average = 10, median = 8) or sonication methods (average = 22, median = 19) did. The results for the average number of particles between the tube brush and sonication methods were inconclusive. The number of particles collected on filters for the 3/8" OD (average = 19, median = 15) and the 9/16" OD (average = 39, median = 19) show more particles on the 9/16" tubing, but not outside of the standard error.

Figure 6. The number of particles collected on each filter, sorted by cleaning method. The 2nd Sonicator sample for 3/8" OD and the 3rd Tube Brush for 3/8" OD samples were thrown out due to an operator error during collection.

The average particle size was 72 μm . The largest three particles found during the study were 1,030 μm , 630 μm and 407 μm , and all three were found in tubing cleaned by the air and rag method. Over

200 particles were found in sample 10, which had the highest filter mass difference of all samples without visible oil deposits.
