# ACCIDENTAL HYDROGEN RELEASE IN GC-LABORATORY; A CASE STUDY

## ABSTRACT

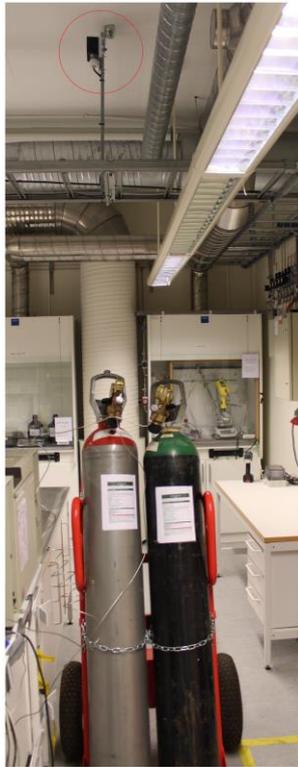
Figure 1 - Temporarily GC instalment with hydrogen detector (red ring)

The red circle in the upper part of Figure 1 shows that the hydrogen gas detector was installed right above the hydrogen cylinder. The detector is connected to a Dräger QuadGuard controller located in the neighbouring laboratory. The Dräger QuadGuard controller unit has three detectors connected. One hydrogen and one carbon monoxide detector is located in the same room as the QuadGuard unit (the neighbouring laboratory) and the hydrogen detector shown in Figure 1 (The laboratory containing the FID-GC).

Figure 1 shows a photo of the temporarily instalment before the event. Figure 2 shows an illustration of temporarily instalment.

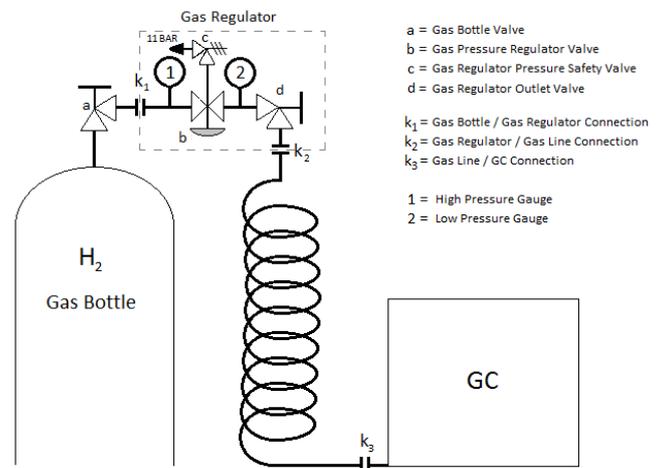
Figure 2 - Illustration of temporarily Instalment

On the 16<sup>th</sup> of January 2015, the first 50 litre hydrogen gas cylinder was depleted and was changed to continue operation. Due to a miscommunication between the risk assessment team and the instrument operator, a new 50-litre hydrogen gas cylinder was ordered and installed. The new installed 50-litre hydrogen cylinder showed 210 barg in the high-pressure gauge. A small irregularity in the behaviour of the hydrogen pressure regulator was noticed when adjusting to the set pressure. The pressure seemed to increase slowly relative to the adjustment done on the gas-pressure regulator valve (valve b in Figure 2). After reaching the desired pressure of 4 barg, a leak check was performed with Digitron

DGS-10. During the leak test, the gas-regulator outlet valve (valve d in Figure 2) was closed. No leaks were found. Before leaving for the weekend, the gas cylinder valve (valve a in Figure 2) was closed.

On the 20<sup>th</sup> of January, the instrument operator return to turn on the gas chromatograph saw that the pressure in the system had drop to 0 barg. Since the regulator outlet valve was closed (valve d in Figure 2), a leak was suspected. The regulator was detached and then reattached. After opening the gas cylinder valve (valve a in Figure 2), a leak check was performed. The high-pressure gauge showed 210 bars and no leaks where found. Before operating the gas chromatograph, the instrument operator noticed that the low-pressure gauge showed just over 10 barg. The instrument operator then decided to bleed down the pressure slowly (10 ml/min) from the low-pressure to and through the gas chromatograph. This was done by closing the gas pressure regulator valve (valve b in in Figure 2 and opening the regulator outlet valve. At this point, the gas cylinder valve and the gas regulator outlet valve was open, and the gas pressure regulator valve was closed. While the pressure was bleeding down, the instrument operator decided to go back to the office and retrieve some items before returning to the laboratory. Before leaving the laboratory, the instrument operator met and talked to the laboratory safety officer explaining the situation. While away, the hydrogen gas leak occurred.

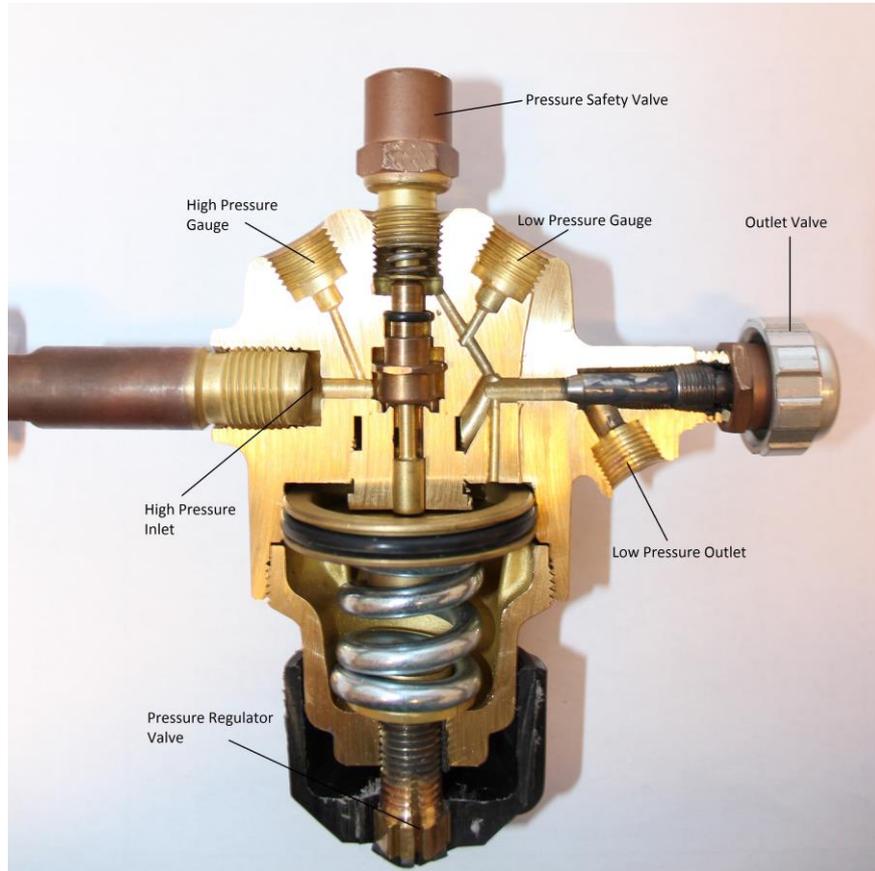
A pressure regulator suited for hydrogen was used to regulate the flow from the hydrogen cylinder to the gas chromatograph. The regulator has maximum operation pressure of 230 barg on the high-pressure side and maximum operation pressure of 10 barg on the low-pressure side. The regulator is equipped with a pressure safety relief valve on the low-pressure side, which will open when the low pressure exceeds 11 barg. There is no pressure safety valve to reduce the pressure on the high-pressure side. Figure 3 shows a cross section of the gas regulator.

Figure 3 - Hydrogen gas regulator

The age of the hydrogen gas regulator was unknown until after the event, but was confirmed by a supplier to be almost 40 years. The hydrogen pressure regulator was produced 1975, week number 25. Along with the model number, the year and week the model was manufactured is located on the back of the regulator, in that order.

The pressure safety valve on the gas regulator does not work as a safety feature when the safety valve releases the gas into an environment that contains several ignition sources. To work as a safety feature the gas needs to be routed to a safe ventilation point. A similar event happened at a commercial facility in 05/03/2013, where a failure of the pressure safety valve occurred. One of the conclusions from the investigation was that if the safety valve shall function as a safety feature the gas needs to be released in a safe location. [7]

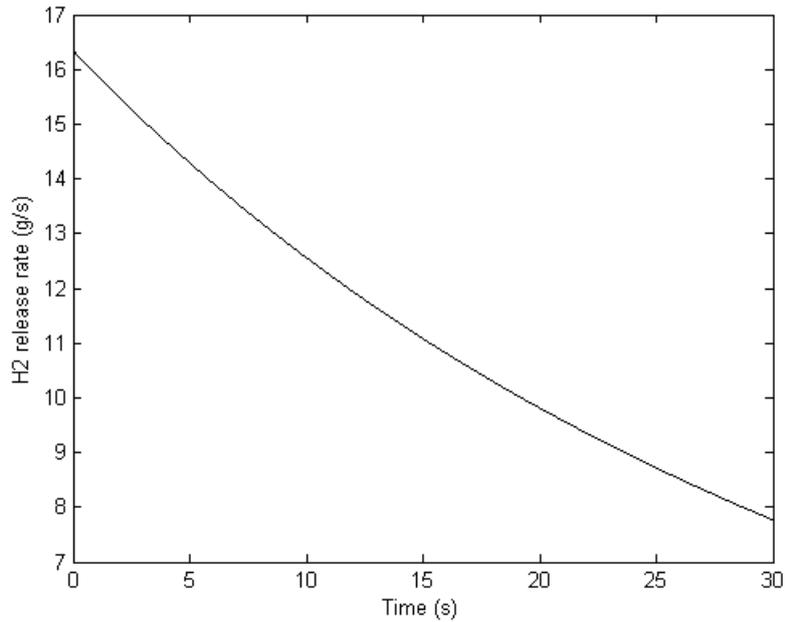
Using Abel-Noble equation of state and assuming adiabatic choked flow, the mass flow rate and total release hydrogen mass can be calculated. Figure 4 shows the change in the mass flow rate and Figure 5 shows the hydrogen released during the leakage. [3]

Figure 4 - Mass flow rate, initial 21 MPa, nozzle diameter 1.3 mm, Vol 50 dm<sup>3</sup>

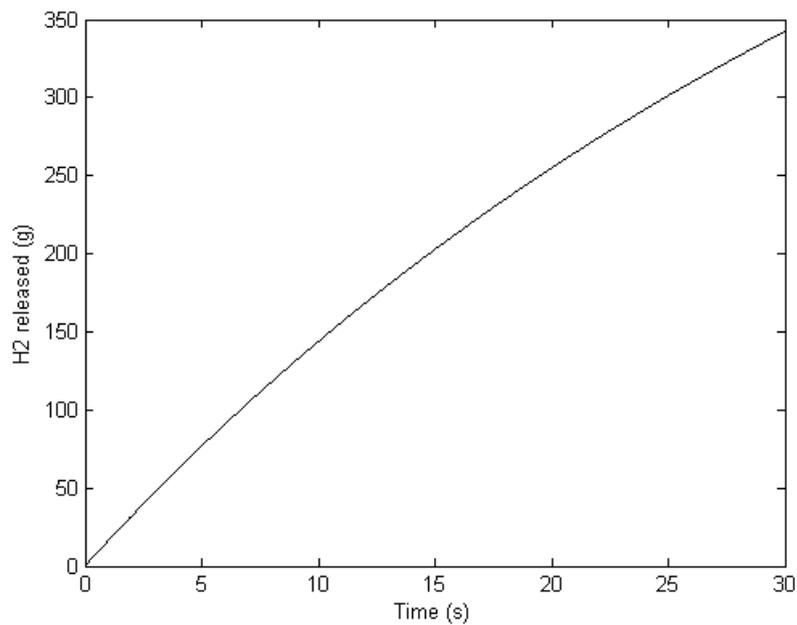
The total hydrogen release calculated by Abel-Nobel equation of state corresponds very well with steady state isothermal (using NIST database) calculation.

Figure 5 - Hydrogen released, initial 21 MPa, nozzle diameter 1.3 mm, Vol 50 dm<sup>3</sup>

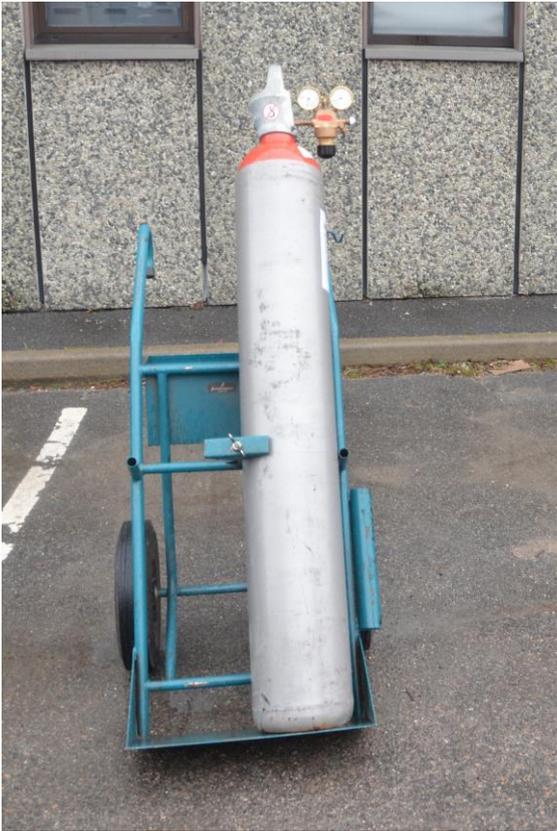
To recreate the incident a controlled test was performed with the same cylinder and the same leaking regulator. In this test the gas cylinder had about 100 bar pressure. The test setup is shown in Figure 6. Both the pressure regulator valve and the outlet regulator valve were closed while the cylinder valve was opened. The gas flowed out of the safety valve showing that the regulator was faulty. To visualize the jet height the released hydrogen was ignited. Figure 7 shows a Background Oriented Schlieren (BOS) image of the ignited jet. By averaging 200 frames from a high speed film the height of the flame was measured to approximately 1.5 m. This height is in accordance to the calculation method by

Figure 6 - Test setup

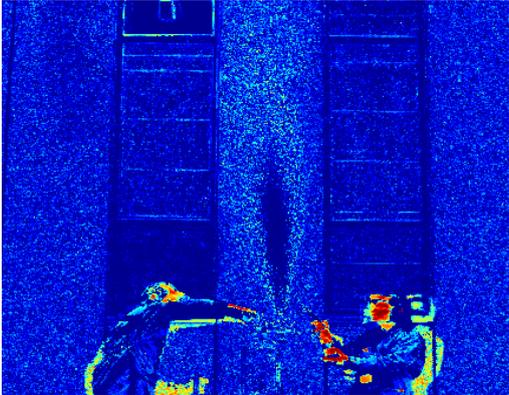
Saffers and Molkov [6] when using 1.3 mm nozzle diameter and 100 bar cylinder pressure. Using the same calculation method with cylinder pressure of 210 barg, as was the case in the incident, the jet height would be about 2 m. [5]

The test and calculation shows that a possible ignited jet would reach the ceiling in the laboratory and shows that the concentration in the core of the unreacted jet was initially close to stoichiometric at the ceiling height.

Figure 7 - Turbulent flame height

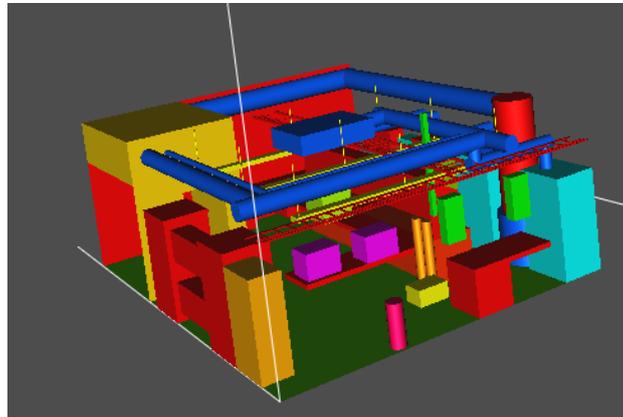
We have performed a CFD-simulation of the event to estimate the explosion pressure in case of a homogeneous gas cloud and an open door in to the laboratory. Figure 8 shows the geometry of the laboratory generated in CASD-FLACS.

Figure 8 - Laboratory Geometry

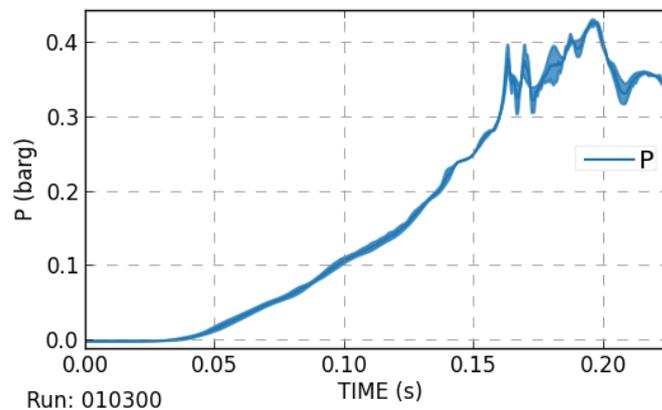
Figure 9 shows the pressure in the room reached 0.4 barg in the FLACS simulation, which is in the same order as the simple calculation shown in the previous section.

Figure 9 - Explosion pressure versus time
