# Effectiveness of a Blower in Reducing the Hazard of Hydrogen Leaking from a Hydrogen-fueled Vehicle

Yohsuke Tamura, Masayuki Takeuchi  
Japan Automobile Research Institute

Sato Kenji  
Toho University

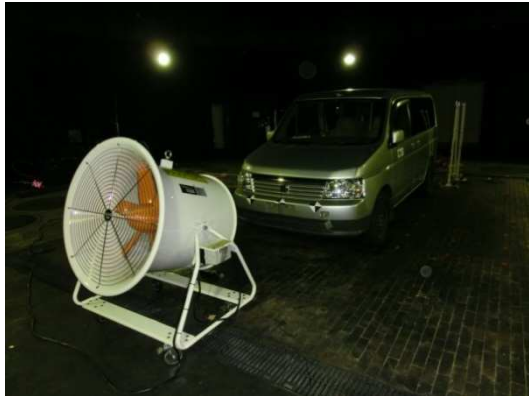
Blower 2 m forward to vehicle; wind velocity distribution on vehicle front

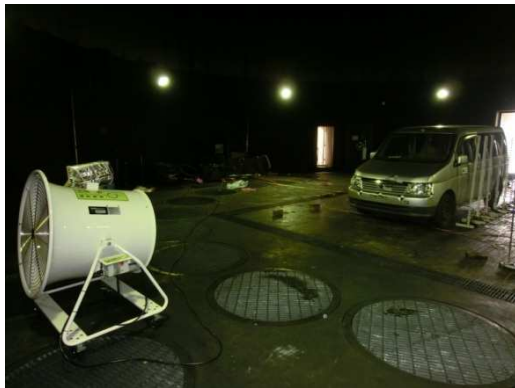
Blower 5 m forward to vehicle; wind velocity distribution on vehicle front

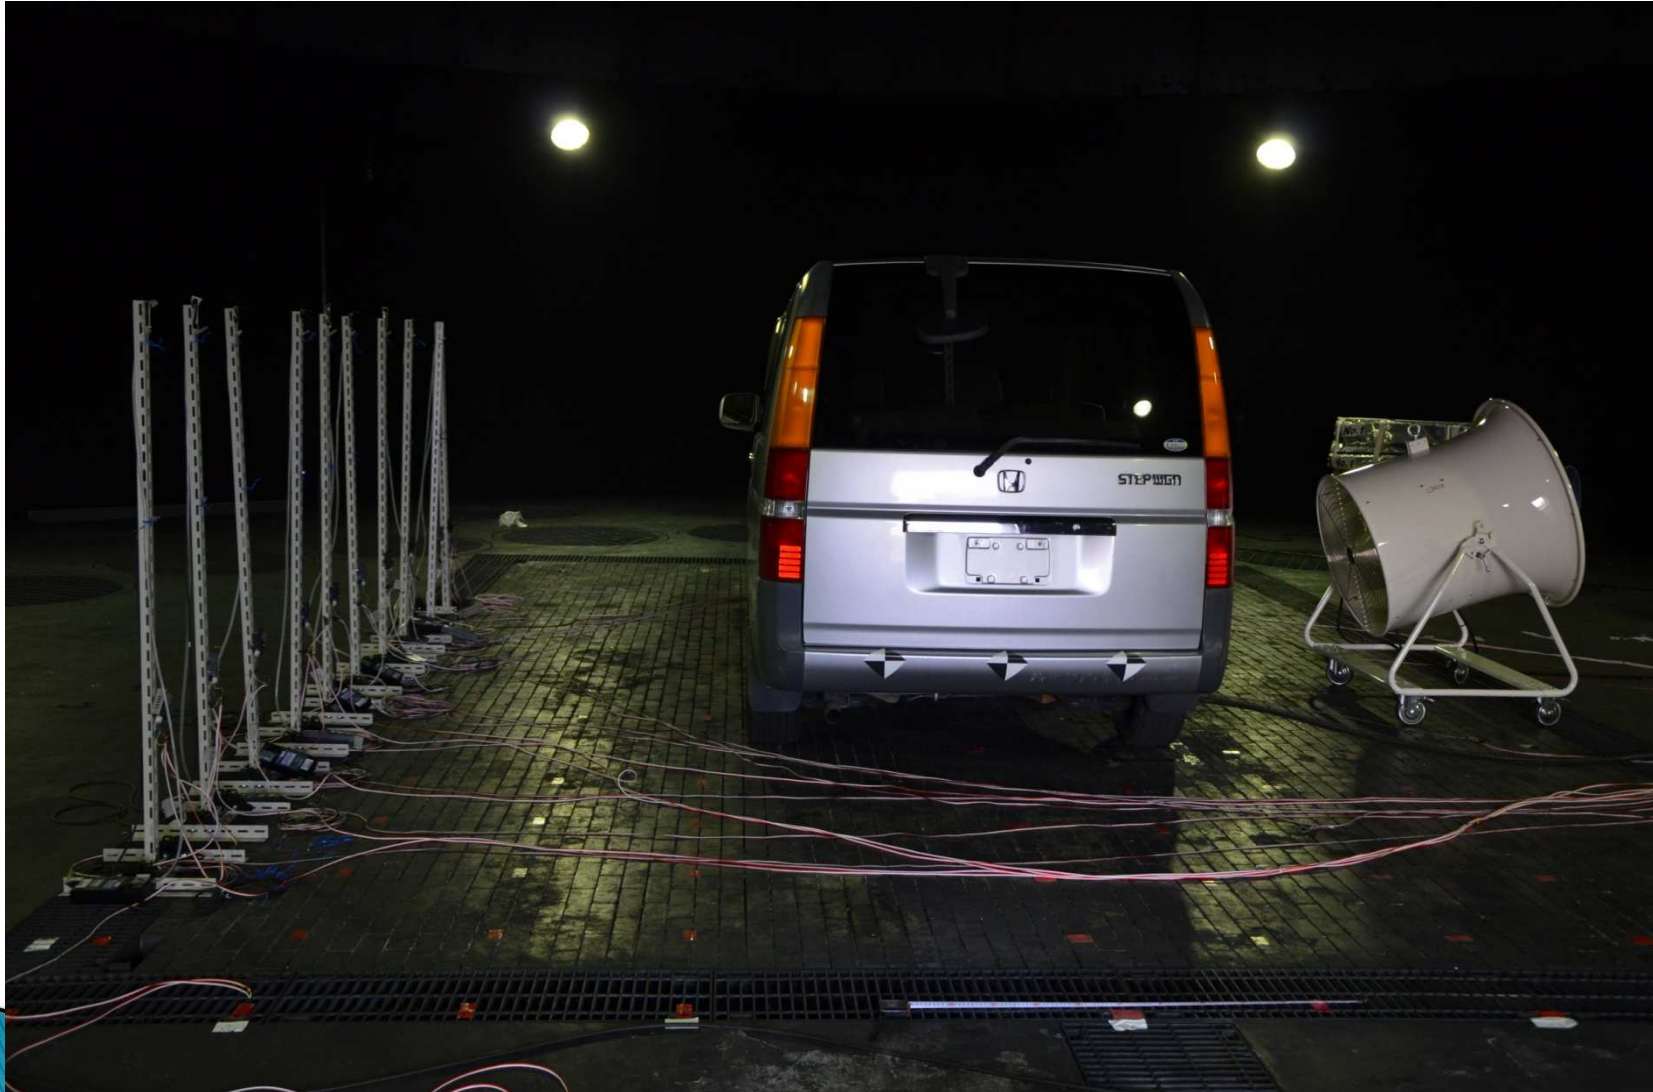
# H<sub>2</sub> concentration measurement

*H<sub>2</sub> 2,000 NL/min, leakage point A, blower 2 m from vehicle side*

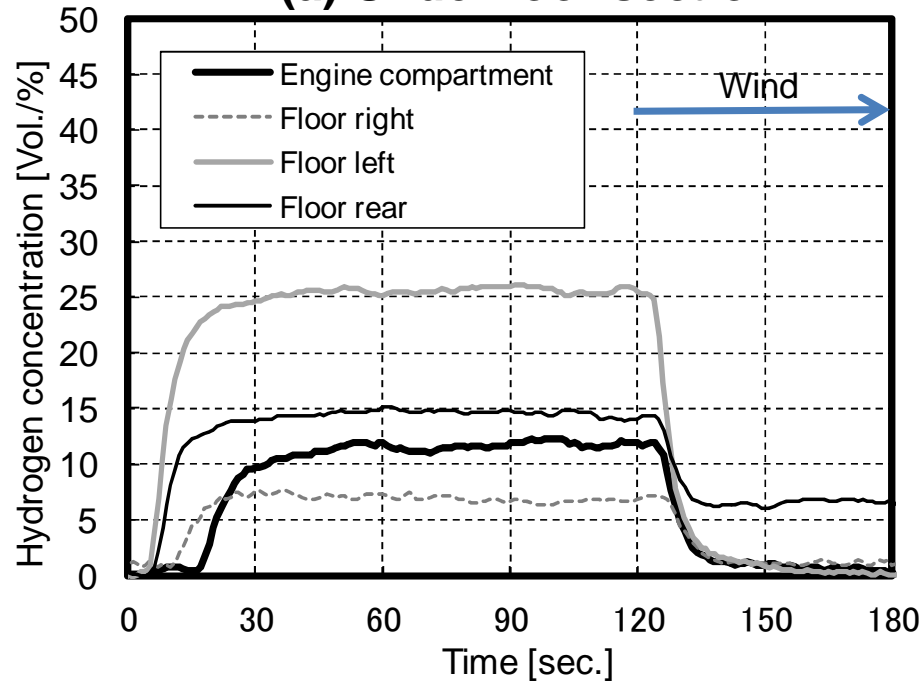
(a) Underfloor section

Hydrogen 2,000 NL/min, Leakage point A, Blower 2m from vehicle front

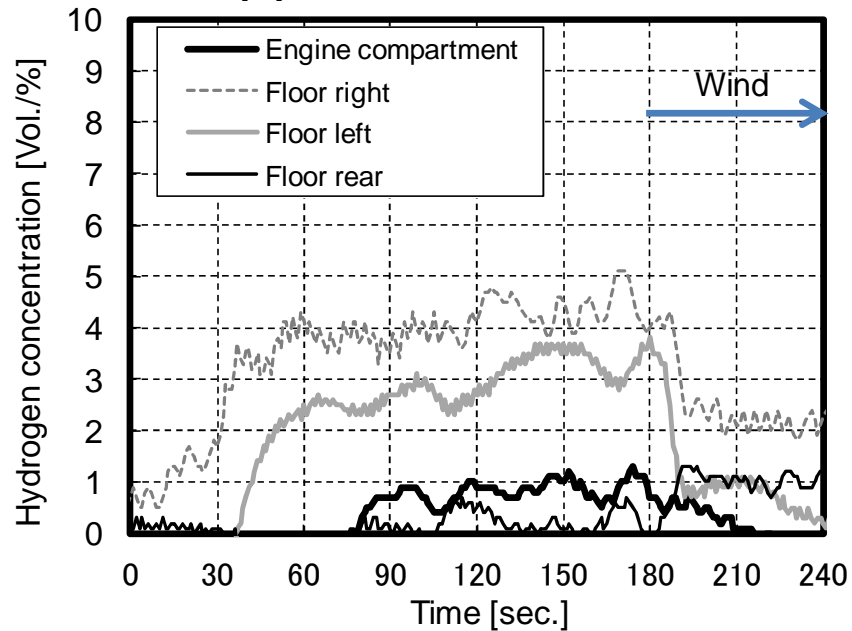
(a) Underfloor section

Hydrogen 2,000 NL/min, leakage point B, Blower 5m from vehicle front

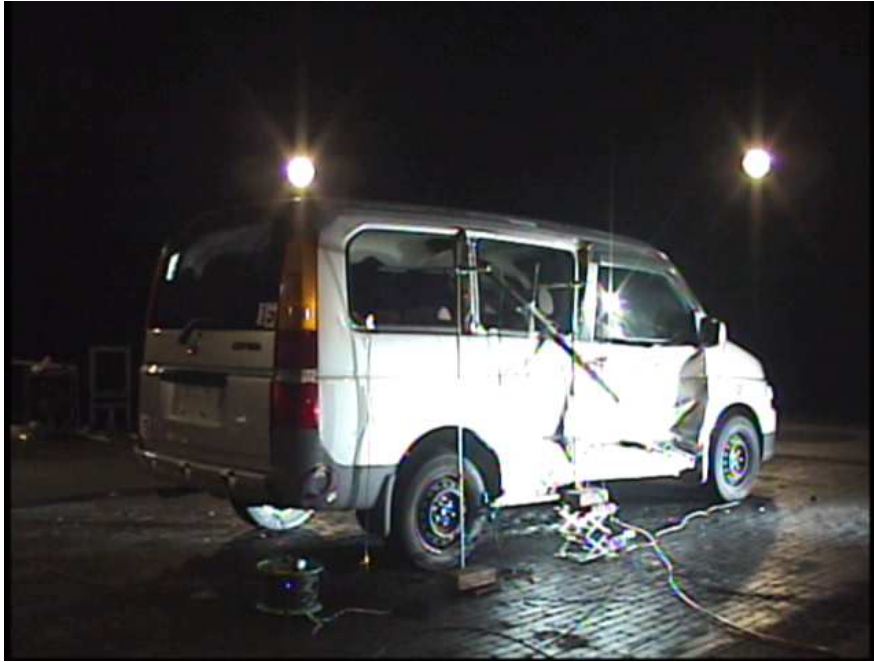
Windlessness

# The situation of ignition (Case #3)

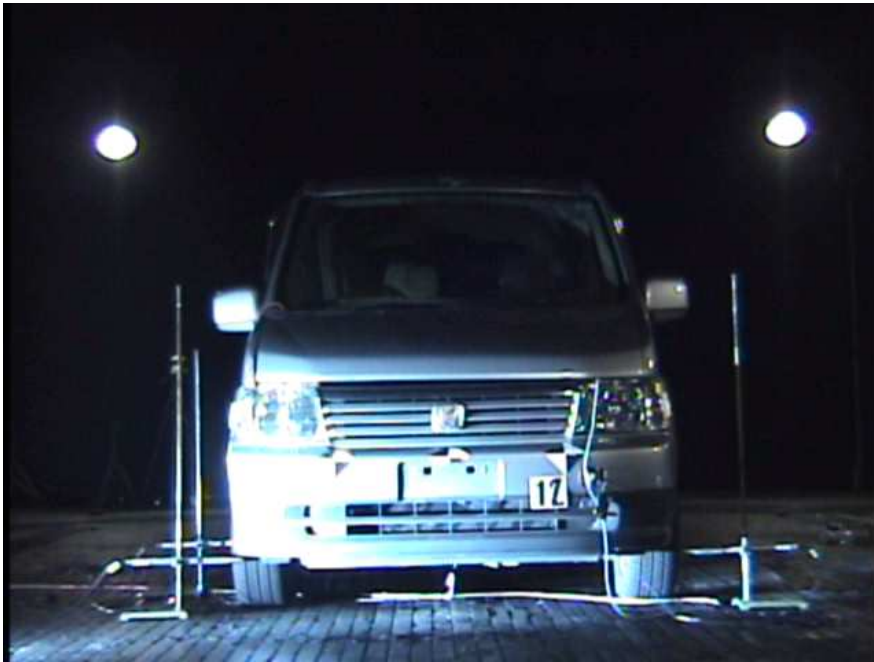
Windlessness

# The situation of ignition (Case #4)

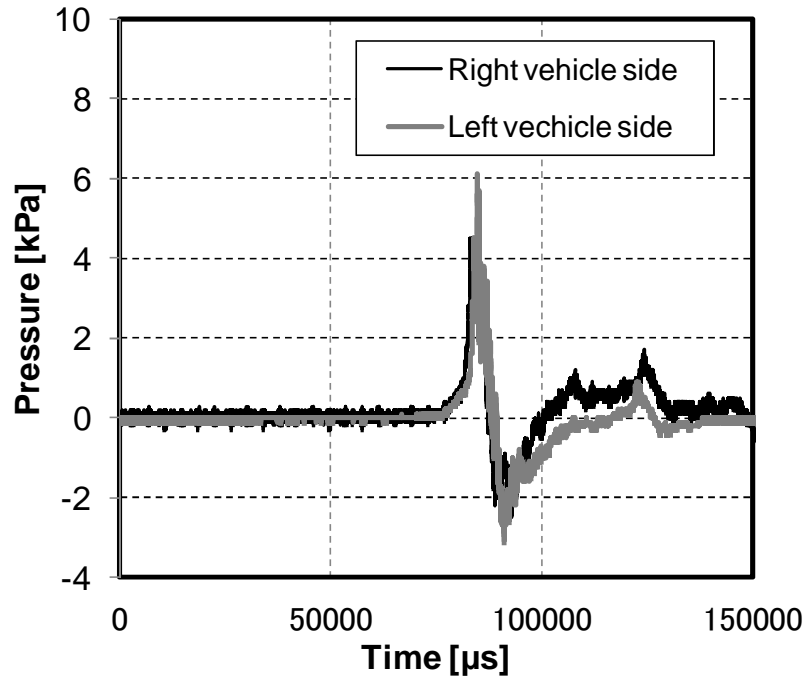
Windlessness

# Blast-wave pressure(Case #4)

at vehicle's both sides, 0.2m above ground

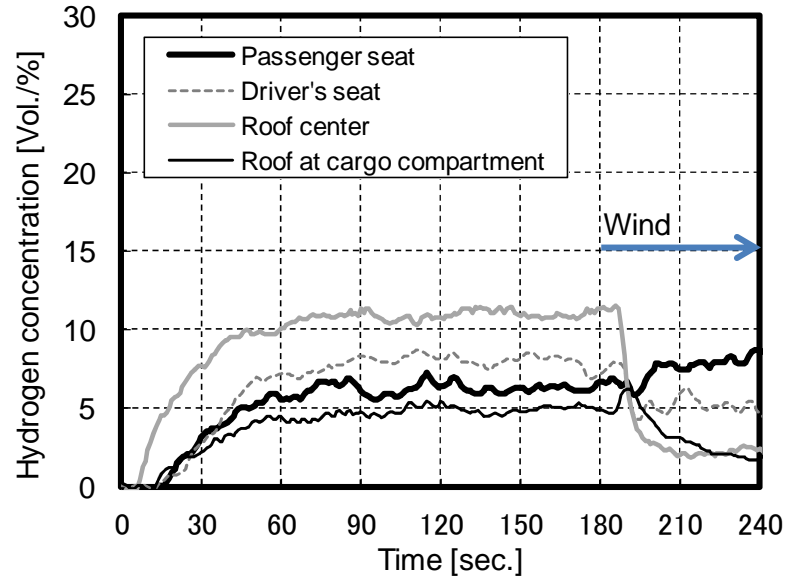
(a) Blower 5m from vehicle side

Hydrogen 2,000 NL/min, Leakage point C
