HYPACTOR

Residual performance of composite pressure vessels submitted to mechanical impact

7th International Conference on Hydrogen Safety
Hamburg, Germany – Sept. 11-13, 2017

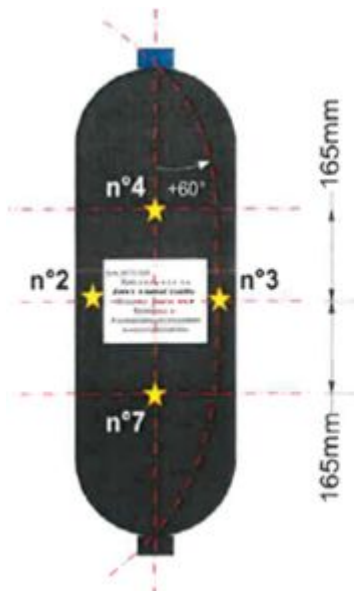
Hypactor in a few figures

Tank tested # **100**

CPV Working Pressures from **250 to 950 bar**

CPV Water Volumes from **36 to 513 L**

Impact Energies (**0,3 to 10 kJ**), Weights (**1-100kg**), Speeds (**3-120m/s**), Multi-impacts, Pressure state (**0 to 875 bar**), composite thicknesses (**16 to 63mm**)

Test to Failure or further NDT testing

Short-term (Burst) and Long-term (hydraulic cycling, hold) evaluations

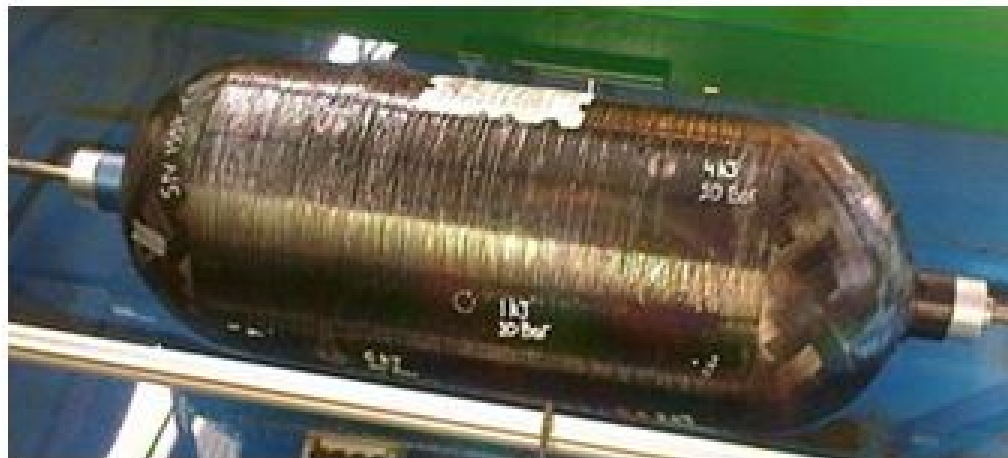
Cylinders used

Hexagon ID	Volume (Liter)	Working pressure (MPa)	Nominal length (mm)	Nominal Diameter (mm)	Composite wall thickness (mm)	Weight (kg)
A	36	70	906	319	23	32
B	255	95	2783	515	63	369
C	513	25	2032	675	16	128

All cylinders presented here are **Type 4 cylinders** of water volume 36L (model #A) produced by Hexagon Composites. They are all made of **HDPE-liner, metallic boss, and carbon fibre reinforcement**.

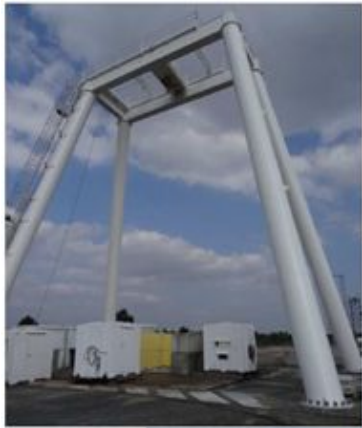
Impact test setup (1)

Fast camera

Impactor

Vessel

DROP TOWER

Sandbags for impactor protection

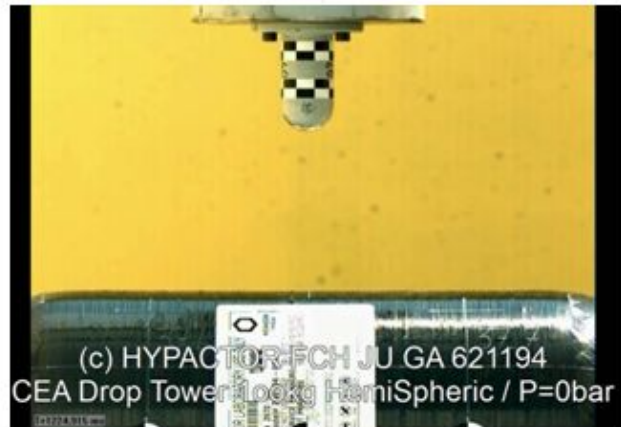
(c) HYPACTOR FCH JU GA 621194
CEA Drop Tower Logg HemiSpheric / P=0bar

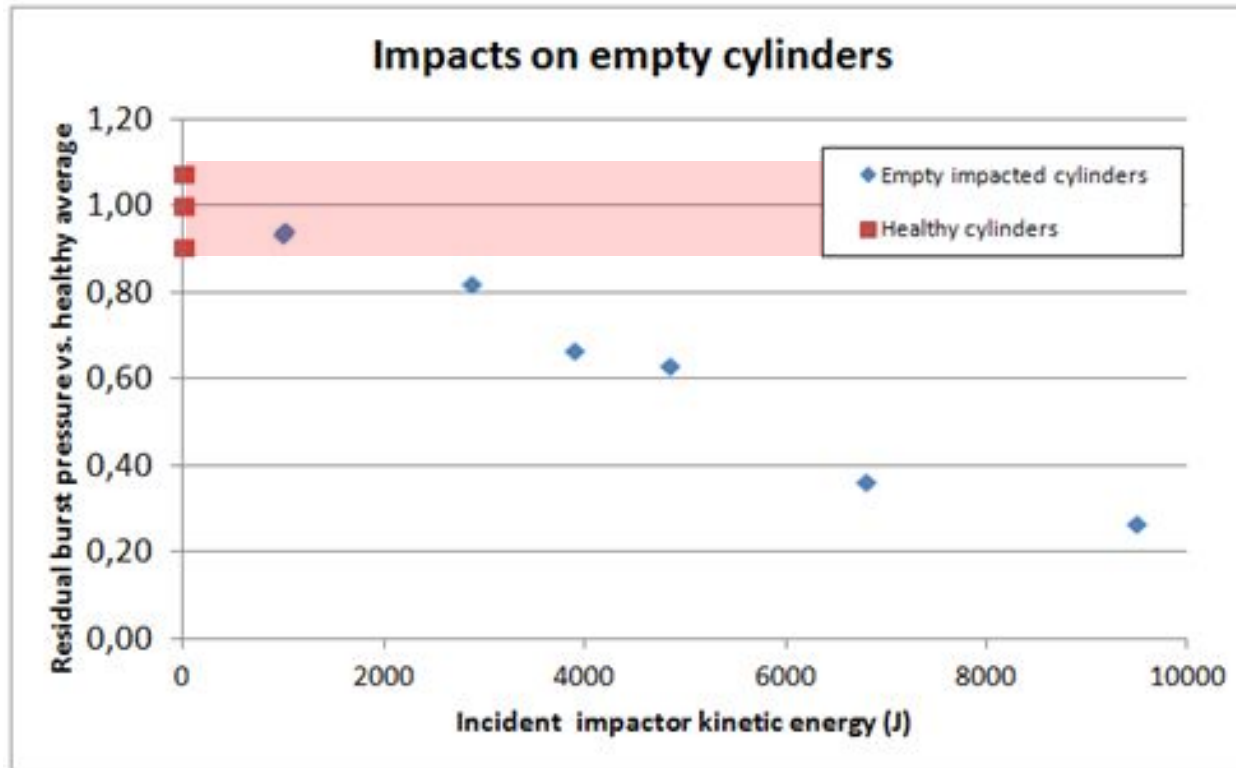
Impacts on empty cylinders

There seems to be an **energy threshold** below which **burst pressure becomes reduced**. Such behaviour has also been **observed on other models** of cylinders from [1].

For these Hexagon 36L cylinders impacted empty, the threshold seems to be between 1kJ and 3kJ

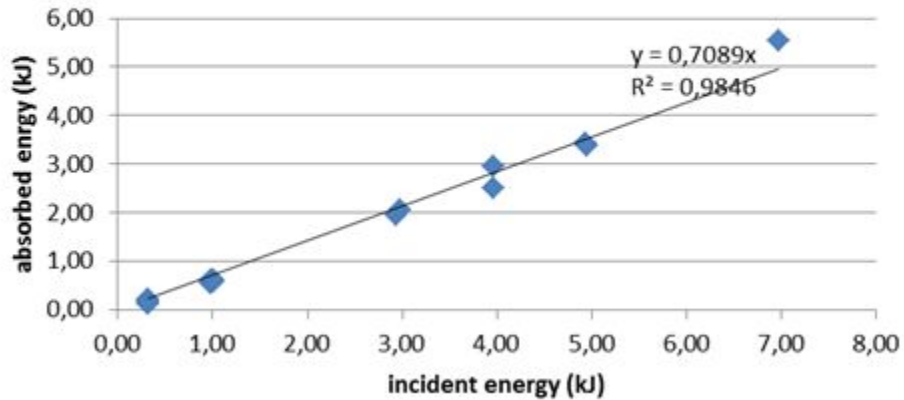
Absorbed energy related to incident energy for all 36L vessels (empty)

- Empty 36L vessel : 71% absorbed (28 vessels)
- 700 bars 36L vessel : 57% absorbed (15 vessels)
- “Mean” value : 66% absorbed (43 vessels)

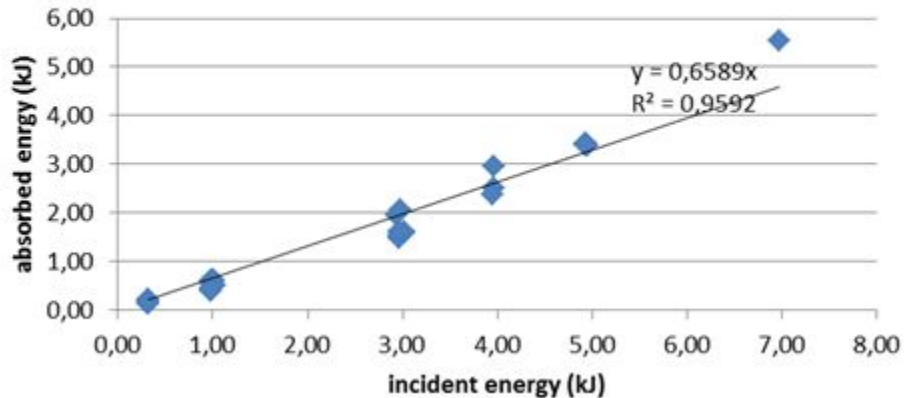
Absorbed energy related to incident energy for all 36L vessels (empty + 700 bars)

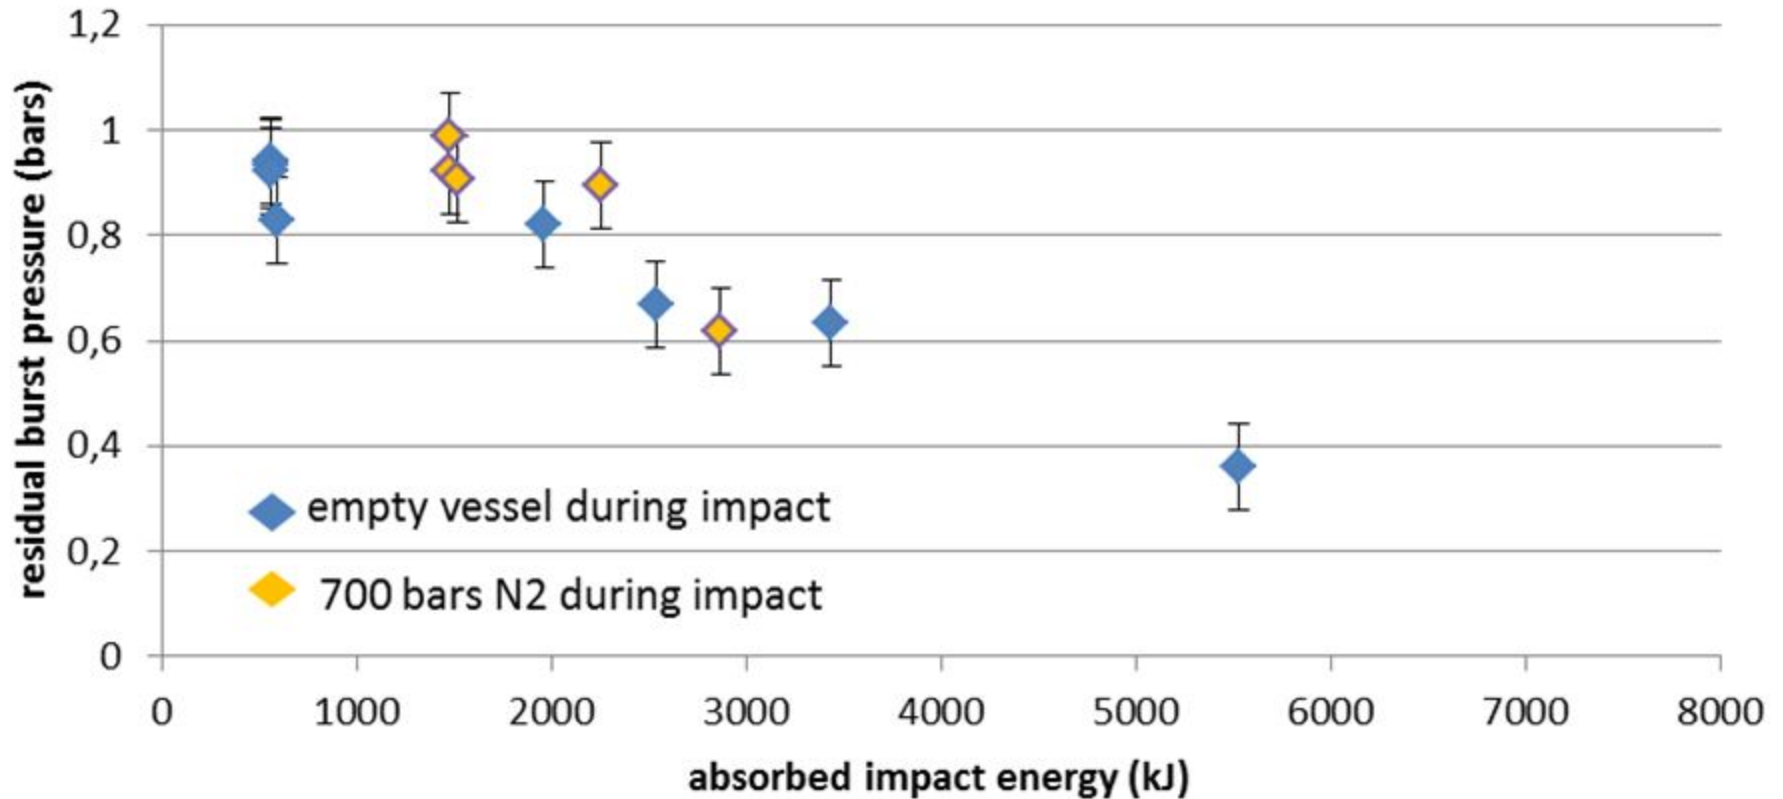
Burst pressure after 1 impact related to absorbed energy

Considering **absorbed energy** leads to a **common trend for empty and pressurised** cylinders.
