HYDROGEN TRASPORT SAFETY: CASE OF COMPRESSED GASEOUS TUBE TRAILER

1.1 Motorway accident of Cessalto (Ve) in the March 2003.

1.2 Traffic accident near SERRAVALLE PO (Mantua) Of February 2004

1.3 ACCIDENTAL TRAFIC INVOLVED PACKAGE CYLINDERS NEAR PISTOIA

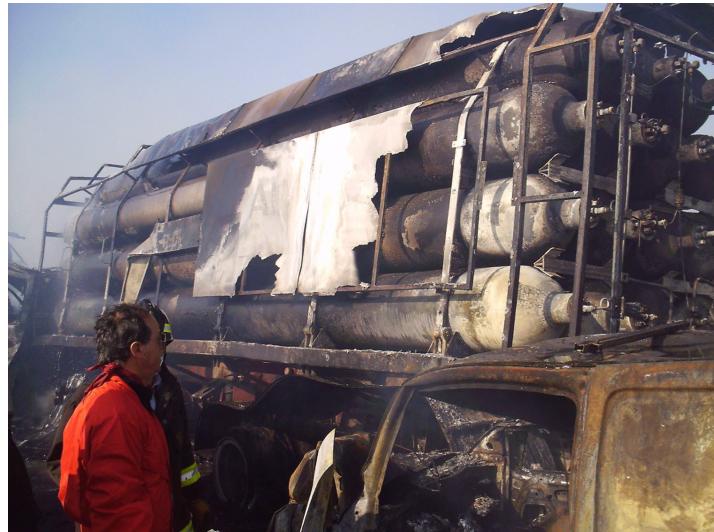
To the arrival on the place of the HAZMAT team the situation was the following: gaseous tube trailer was involved in dense smoke, some motorcars were under the back part of the gaseous tube trailer and there was still fire in action, with notable development of flames.

From this control they found that in proximity of the valves of the lowest containers there was flame, and there was an hydrogen release which was burning. From this control it was noticed in the right side, in correspondence of tractor's wheels, that one of cylinder was deformed.

Through other verifications effected through the employment of the thermo camera it was noticed that a container in the point of the deformation had a long longitudinal crack about 10 centimeters long.

Figure 1° Hydrogen tube trailer after the accident.

1. Lack of equipments to evaluate pressure inside the cylinder gaseous tube trailer.

2. Lack of protection in the back part of the tube trailer.

4. Lack of protection among the trailer wheels in rubber and the cylinders.

In the gaseous tube trailer the part with greater fire load are constituted by the tires. Other important fire load is the tractor with tires and oil in the tanks. During the fire that is developed following road accident, heat warmed anterior parts of the cylinders of tube trailer. Thermal heater and the increase of pressure can generate cylinder collapse.

3. Necessity to foresee a system of protection fire of the cylinders on the gaseous tube trailer.

In the accident happened near Cessalto the problem of the separation you/he/she is found between the combustible material and the impending castle of the cylinders. With the purpose to reduce the thermal impact on the reservoirs it would be necessary to guarantee the disposition of a plan of isolation fireproof. In this way you/he/she could be prevented at least the direct action of the flames on the mantle of the reservoirs and possession therefore heatings located particularly dangerous for the structural resistance.

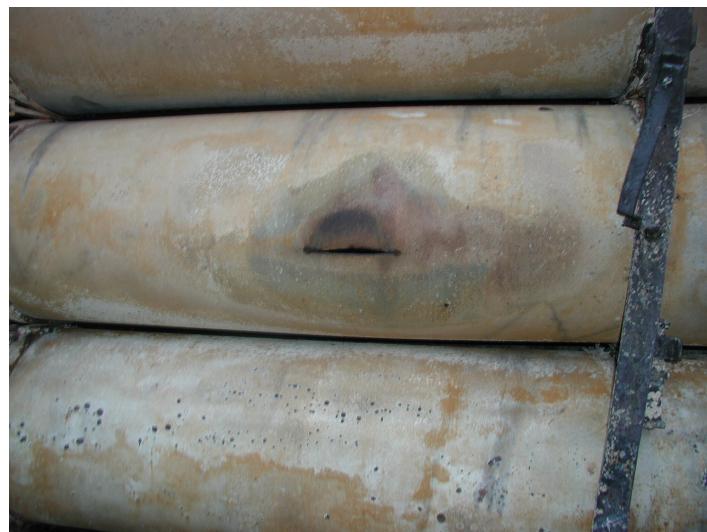
Following the accident it has been verified that one of the cylinder had a complete breakup in correspondence of the anterior section (figure. 2).

Figure 2° Hydrogen Cylinder breakup for combined effect of pressure inside and temperature.

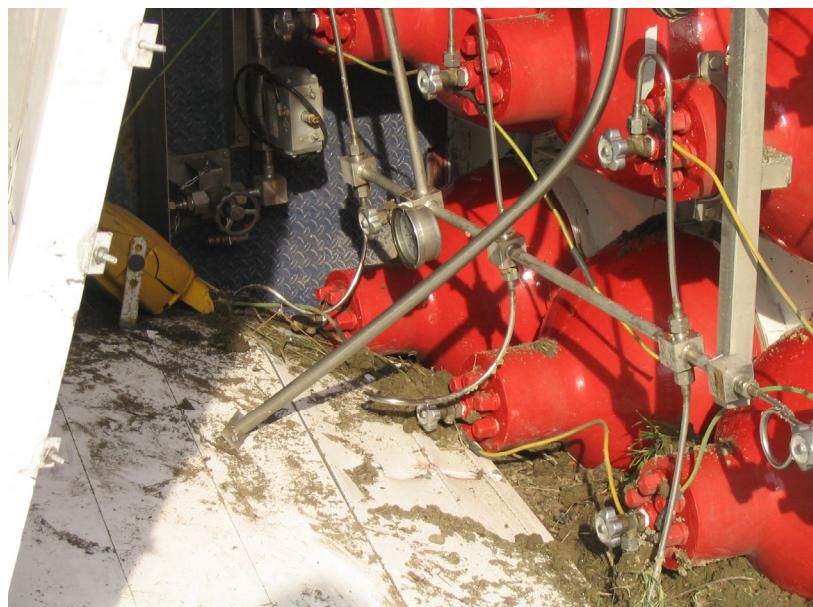
Accident has involved a gaseous tube trailer that has gone out street in a zone of fields and to the arrival rescue teams it resulted abandoned on a side. Following the crash with the ground involved the back part of the tube trailer (high pressure collector) occurred the breakup of the auction of manoeuvre of a valve of close/open of one of the cylinder. The interested cylinder was positioned in the low band in central position. The breakup of the valve causes a consistent loss of hydrogen. All cylinders were loaded to a pressure of 200 bars.

Figure 3° Breakup valves of head of the cylinders of the wagon

1. Lack of the side protection to the bodies valve and pipes of connection among the containers.

The back part of the mean that contains the whole hydraulic system (valves of intercept, manometers and collectors is not really provided of a system of efficient protection in degree to protect from bumps. Such situation is valid is towards back bumps that of side bumps.

5. Necessity to foresee a system of protection of the back part of the tube trailer. Back part of the tube trailer constitutes the most delicate area of the structure of the towing, I am in fact you introduce all the valves group, the collectors and the manometers. This part requires therefore a system of protection more effective than that present currently able to protect the components in case of accident as for instance crash with other vehicles, etc.....

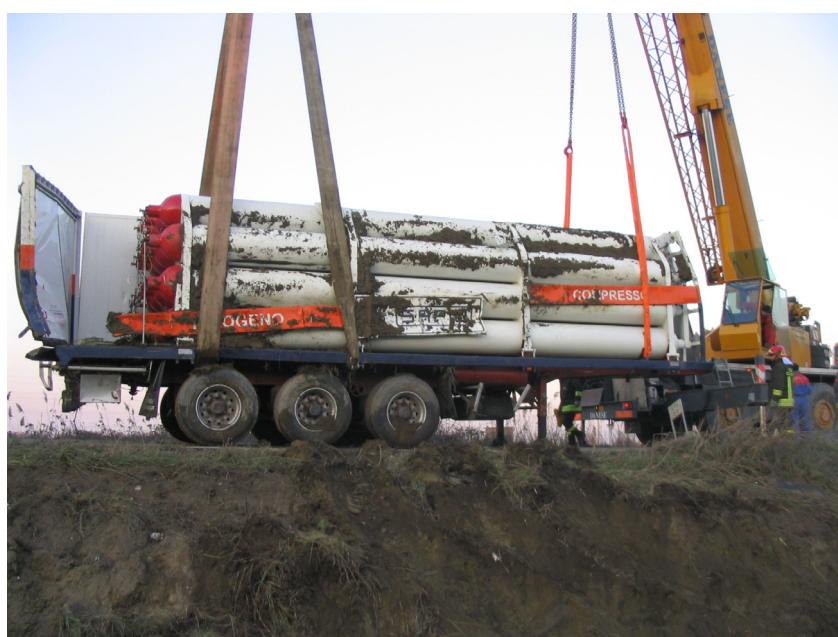
Chemical Firebrigade Team decided to lift the gaseous tube trailer by some belts which are fixed near of anchorage point of cylinder to trailer. There weren't any project point to lift the trailer.

Fig. 4 operations of harness and lifting of the .

2. Lack of the necessary points for the lifting of the wagon during the phases of recovery of the mean.

In case of accident with wagon hydrogen out in the road center besides the phase of mass in safety it is necessary however to perform the recovery of the mean. For this it is necessary in the majority of the cases to handle to lift through the employment of crane.

4. Necessity to foresee a system of lifting of the gaseous tube trailer. Gives the particular structure of the wagon it would be necessary to foresee a suitable system for the lifting of the mean. Particularly such points of anchorage should be situated in the zones the more possible protected from bumps and being projected also for the lifting of the mean container internally still product. Necessity to lift the half anchor loaded is important sights the difficulties of I decant of the product and the risks that can be had in to free hydrogen in air.

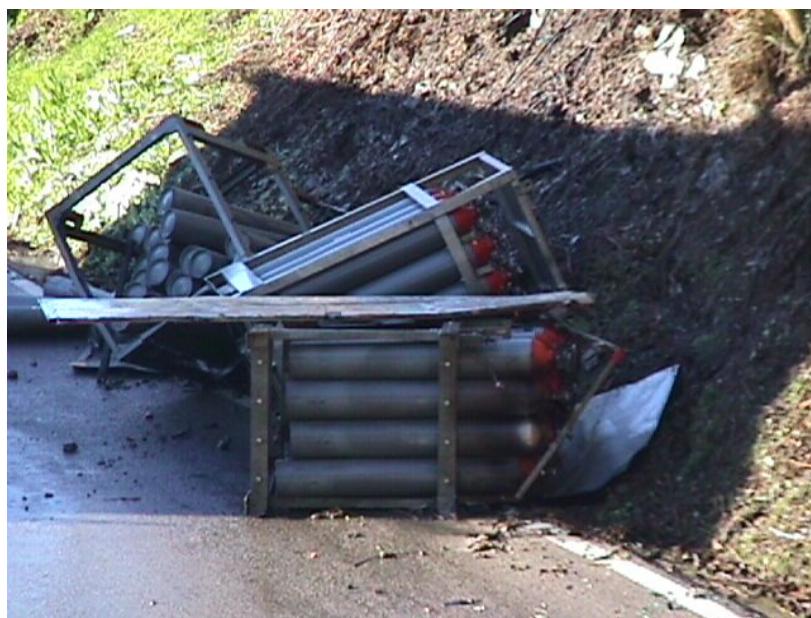
This accident has happened in date 23/12/03 on the SS66 in the place Borghetto and it has involved a trailer that transported some packages cylinders containing hydrogen. Cylinder package fallen on the road center when fixing straps were broken.

The breakup of the collector of the package cylinders and fact that some valves on the cylinders were open or damaged by the fall produced a gas release that has given origin to an accumulation in air.

Some moments later probably for due effect to a primer caused from a spark or from other extremely warm part (component of motor) a deflagration has happened with consequent development of wave of bump that caused consistent damages to the vehicle that followed the truck and to the glass door of house in the proximities.

Figure 5° Packages cylinders fallen on the center road. Metallic structures of containment has collapsed.

3. The structure of containment of the package cylinders it doesn't guarantee any structural resistance under conditions of bump following accidents.

The package cylinders following fallen by the flatcar you/he/she has suffered the complete breakup with spillage of the cylinders.

The breakup of the package can produce a situation of risk in how much the separation of the cylinders involves the collapse of the collector of distribution and possible release of gas if the valves of the cylinders are not in position of closing. Fall of separate cylinders not protected from

the metallic structure of the package can produce lesions in correspondence of the head valve with consequent risk of rupture and hydrogen release.

2. Necessity to realize packages cylinders with suitable characteristics of structural resistance and endowed with structures for the correct anchorage on the flatcar of the means. The possibility of falls of packages cylinders from flatcars of car it is an enough frequent eventuality under accidental conditions, for such motive it is necessary to realize structures able to withstand to possible impacts with the ground with the purpose to succeed in guaranteeing at least the containment of the inside cylinders. And necessary therefore to think about appraising some programs of test and testing and therefore to plan and to certify the metallic structures of the packages according to these parameters. It owes an indication to be anticipated on the package of the happened certification.
