DOT/FAA/TC-16/24

Abusive Testing of Proton Exchange Membrane Hydrogen Fuel Cells

October 2016

Final Report

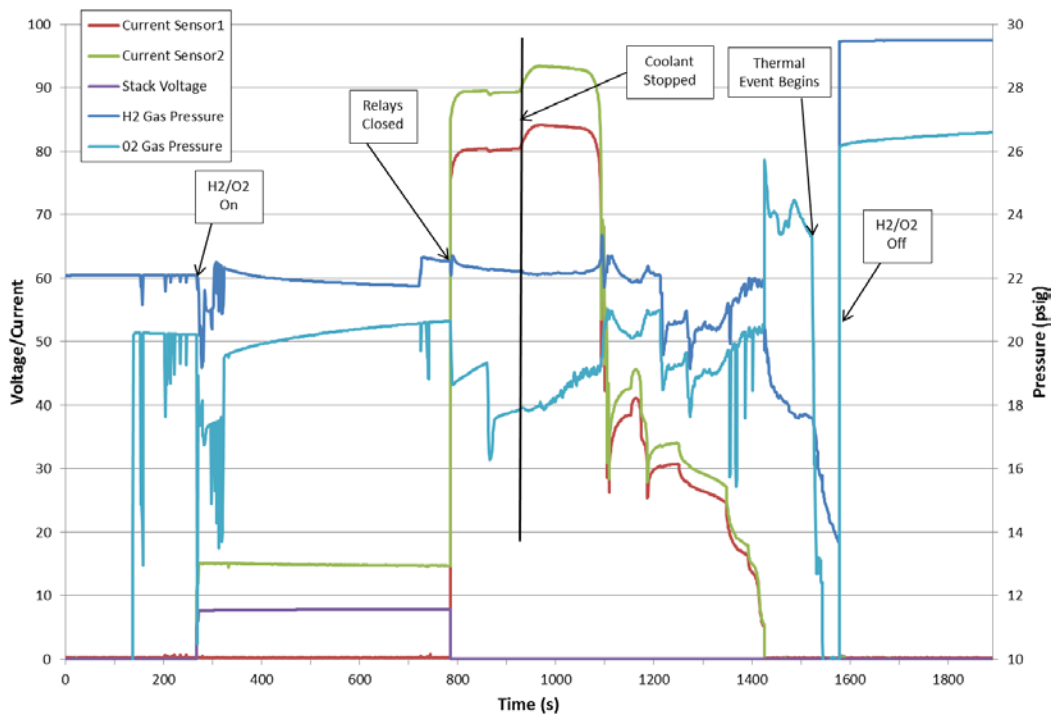
Figure 8. Loss of coolant test—reactant gas pressures and stack voltage/current

Once the electrical load was placed on the system, it was allowed to operate at 170A for approximately 140 seconds with coolant flow. At this point, the voltage reading was lost because of an error in the sensor placement. This sensor placement was corrected for subsequent tests. Following the initial load application, coolant flow to the unit was stopped by closing the coolant isolation valves and disabling the coolant pump. This resulted in a slight increase in the load current to approximately 175A for a period of 165 seconds. The current increase and a change in the coolant exit temperature were noted almost immediately after coolant flow was stopped. Within approximately 1 minute after stopping the coolant flow, an increase in the stack surface temperatures was also noted. In addition, at this point, current began to drop and reactant supply pressures were adjusted in an attempt to recover the unit. The current was unable to be fully recovered, however, and continued to decline until reaching 0A approximately 500 seconds after the coolant flow was stopped.

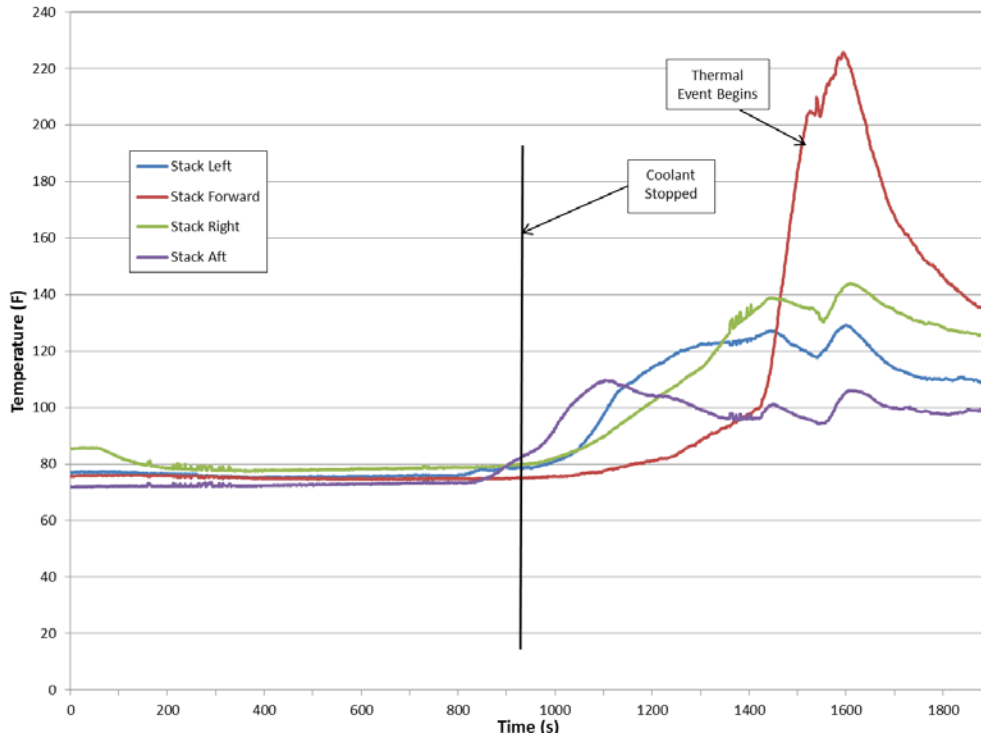
Figure 9. Loss of coolant test–stack surface temperatures

Approximately 111 seconds after completely losing current flow, a thermal event occurred, with sparks emanating from the forward-facing side of the fuel cell stack. This event is shown in figure 12 with a still frame from the recorded video of the test. The event is also shown in figures 9 and 11 as the forward stack surface temperature rises to over 220°F and all of the temperature probes within the pressure vessel also increase. The failure event was allowed to continue for approximately 1 minute after the sparking and flaming was observed. After this point, flow of the reactant gases was shut off and the primary fire was observed to self-extinguish within seconds. Burning of the fuel cell stack materials continued for approximately 40 seconds, after which time it self-extinguished.

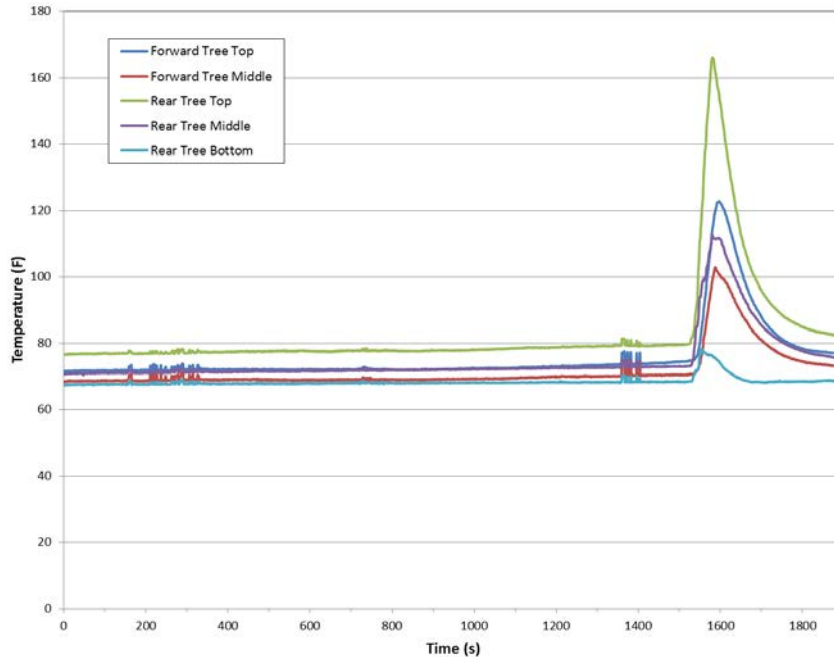
Figure 11. Loss of coolant test–pressure vessel temperatures

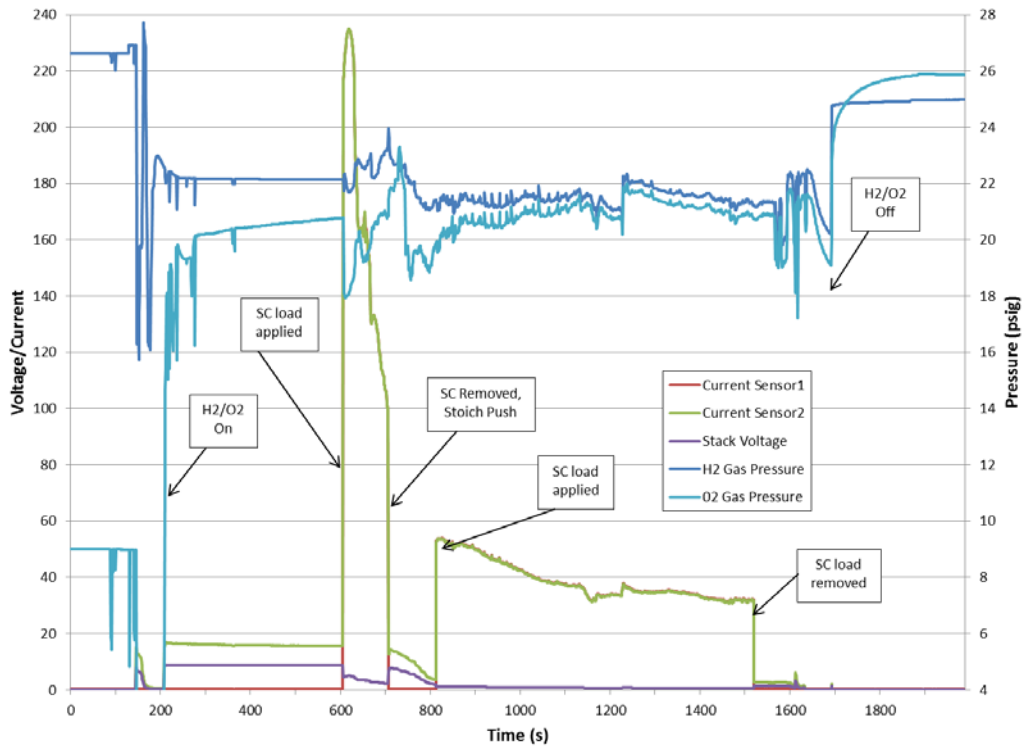
Figure 17. Short-circuit test—reactant gas pressures and stack voltage/current

The stack was run at the idle condition with a 15A load for a period of time before applying the short-circuit condition. Once applied, a peak current of 470A (235A/sensor) was observed for approximately 10 seconds. The voltage and current then began to drop significantly until reaching approximately 200A. At this point, the short-circuit condition was temporarily removed and gas pressures were adjusted in an attempt to recover full operation of the system. The current continued to drop during this duration and, approximately 100 seconds later, the short-circuit load was again applied. The stack was operated for nearly 12 minutes in this condition and, though the electrical capacity of the fuel cell continued to deteriorate, there were no observed conditions indicating a stack fire or hydrogen leakage in the chamber.

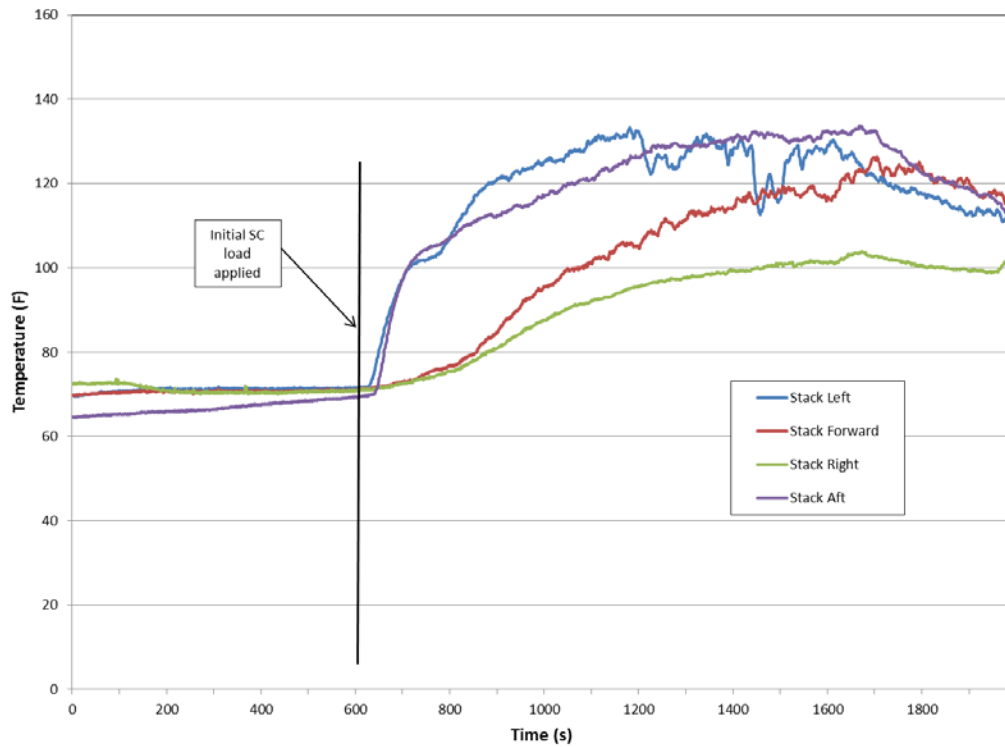
Figure 18. Short-circuit test—stack surface temperatures

Temperature increases of the stack surfaces and coolant exit are shown in figures 18 and 19, respectively. These increases could be observed during the test as steam exiting the stack through the coolant exhaust ports located on top of the stack.

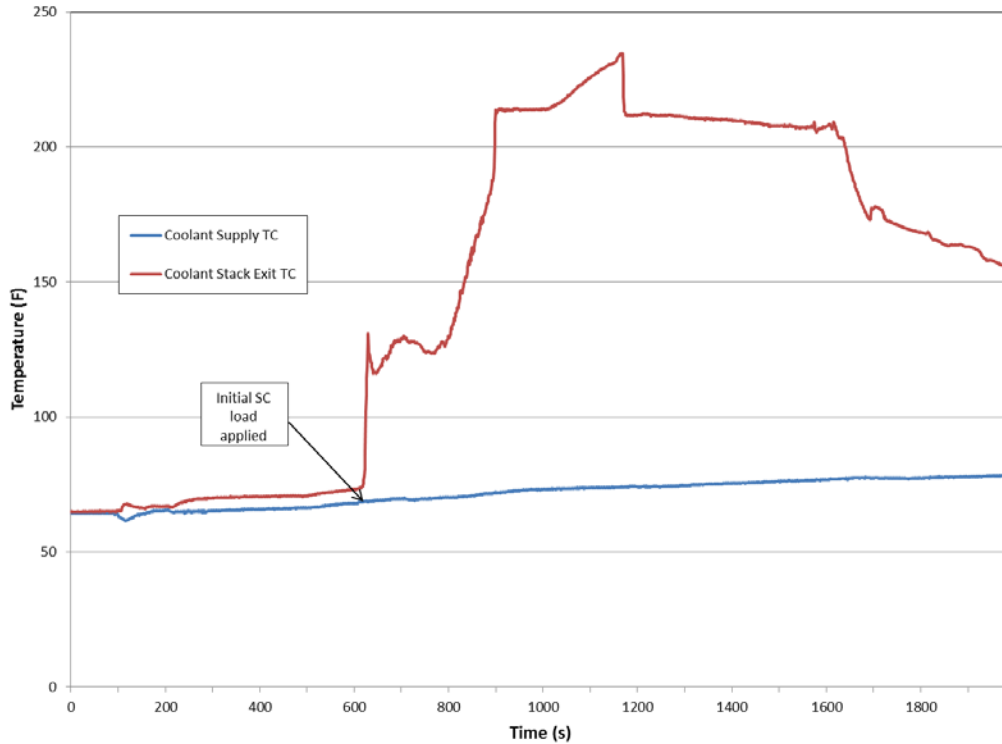
Figure 19. Short-circuit test–coolant supply and exit temperatures

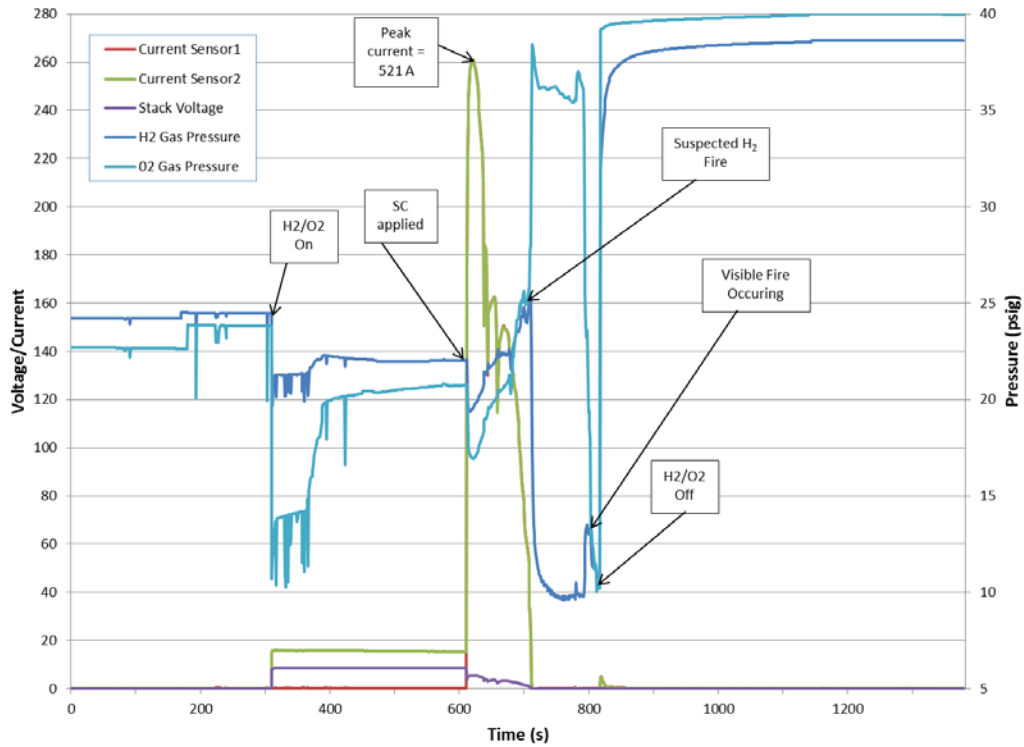
Figure 20. Crossflow condition test—reactant gas pressures and stack voltage/current

After supplying the reactant gases to the fuel cell, it is observed in figure 20 that, because of the crossover condition, there was initial difficulty in obtaining a constant gas pressure supply to the stack. Nevertheless, the stack was able to be operated in its idle condition at a load of 15A for a period of approximately 5 minutes without any apparent impact to the resulting voltage or current output of the stack. After approximately 5 minutes of idle performance, a short-circuit condition was applied to the fuel cell stack. This resulted in a peak current of 521A for approximately 4 seconds. The voltage and current then decayed until complete failure 110 seconds later. At the approximate time of the stack current reaching 0A, it is suspected the H₂ fire initiated. This suspicion regarding the timing of the H₂ fire is because of the pressure readings observed in figure 20 and the slight stack surface temperature (see figure 21) and pressure vessel temperature increases (see figure 23) observed at this time. In addition, figure 22 shows an increase in the coolant exit temperature at this time. Approximately 90 seconds later, a visible fire occurred along with the detection of H₂ leakage into the pressure vessel. At this point, the reactant gases were turned off and the fire rapidly self-extinguished.

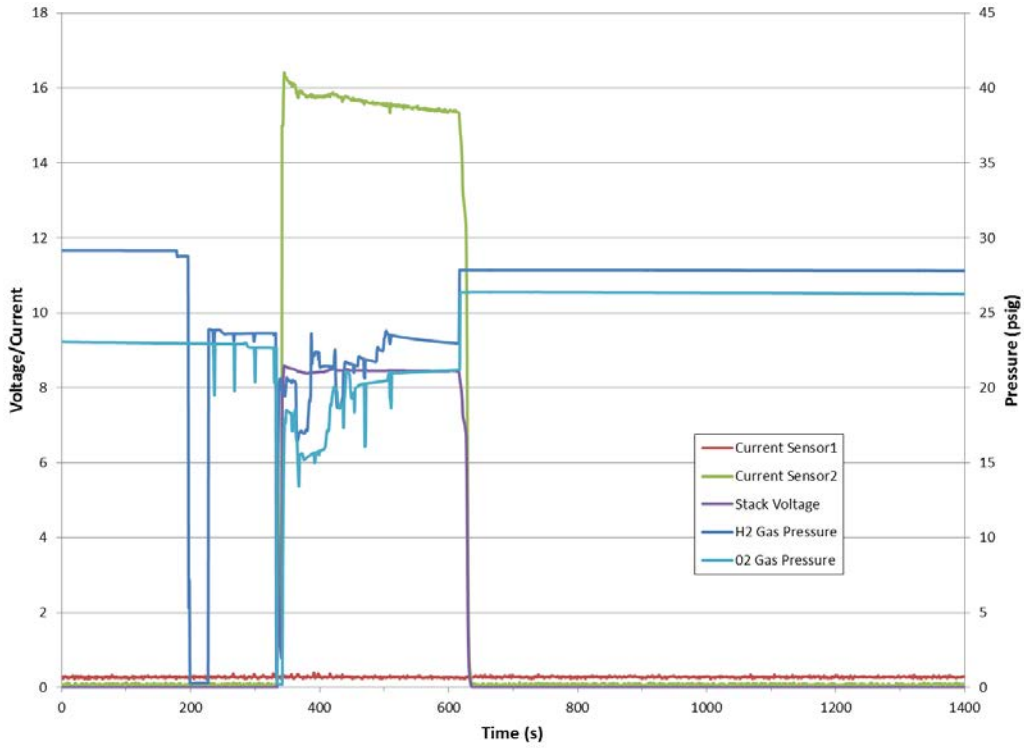
During the first attempt at conducting the short-circuit condition test, there was an accidental failure of one of the anode gas connection points. This failure resulted in a hydrogen leak into the pressure vessel, which came very close to reaching the lower flammability limit. This constitutes another potential failure condition that could lead to hazardous conditions and must be protected against.

Figure 28. Hydrogen leakage–reactant gas pressures and stack voltage/current

Aside from the H₂ concentration reading in figure 30, there were several indicators that there was a failure condition existing within the stack. Figure 28 shows that the test operators were having a difficult time maintaining the reactant gas pressures. In hindsight, it is clear that this was due to the H₂ leak occurring at the time. In addition, stack surface temperatures indicated a failure condition long before the leak was detected by the gas analyzer, with temperatures exceeding 400°F. There were, however, no visual indications of any thermal event on the HD or FLIR video.

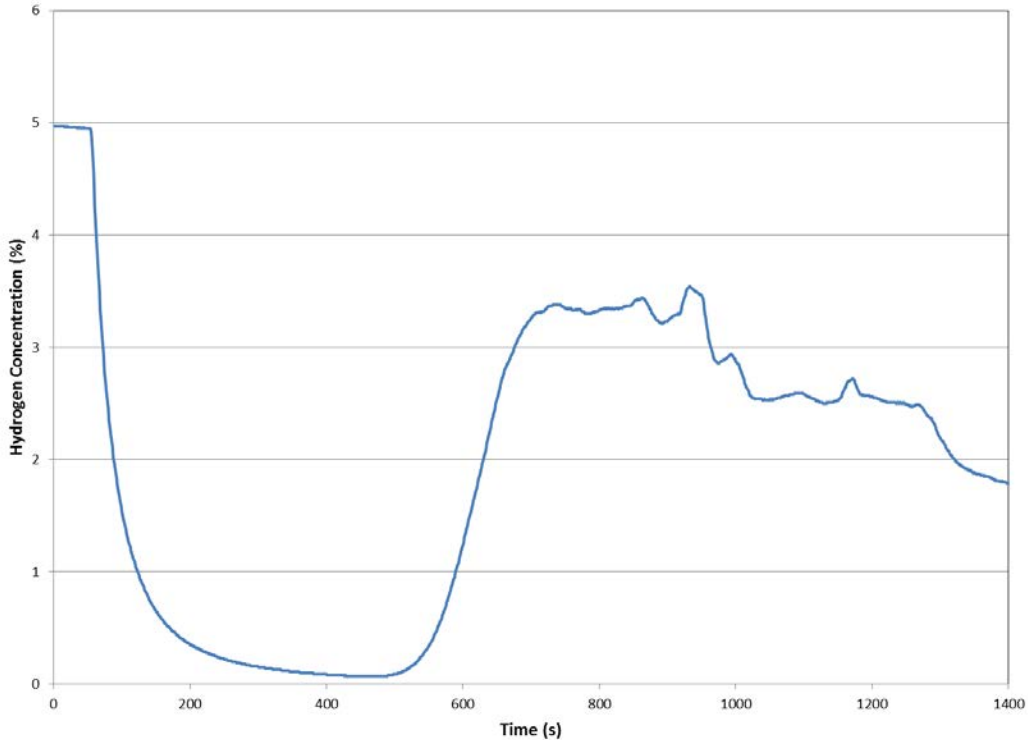
Figure 30. Hydrogen leakage–hydrogen concentration
