EFFECTIVENESS OF A BLOWER IN REDUCING THE HAZARD OF HYDROGEN LEAKING FROM A HYDROGEN-FUELED VEHICLE Tamura,Y.¹, Takeuchi,M.¹ and Sato, K.² ¹ FC-EV Research Division, Japan Automobile Research Institute, 1328-23,Takaheta, Osaka , Shirosato, Ibaraki , 311-4316, Japan, ytamura@jari.or.jp ² Department of Environmental Science, Toho University, 2-2-1, Miyama, Funabashi, Chiba, 274, Japan

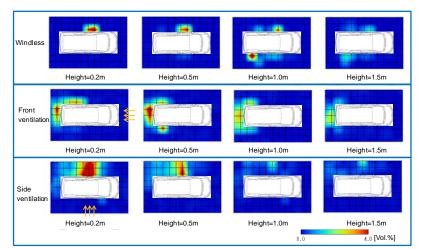
Figure 1. Isosurface of hydrogen concentrations around vehicle (by experiments)¹⁾

Tamura et al. [4] experimentally investigated hydrogen dispersion in the vicinity of a vehicle which was releasing hydrogen horizontally in its underfloor section at a single volumetric flow of 2,000 NL/min while forced winds of a maximum 2 m/s were applied to the vehicle from its lateral or frontal side (Fig. 1). Tamura et al. [4] reported that forced winds of 2 m/s enlarged the region of hydrogen concentrations equal to or exceeding the lower flammable limit, thus failing to disperse leaked hydrogen sufficiently. It was suggested that the velocity of forced wind needs to be increased or the wind blowing method should be improved to disperse hydrogen gas to safe levels.

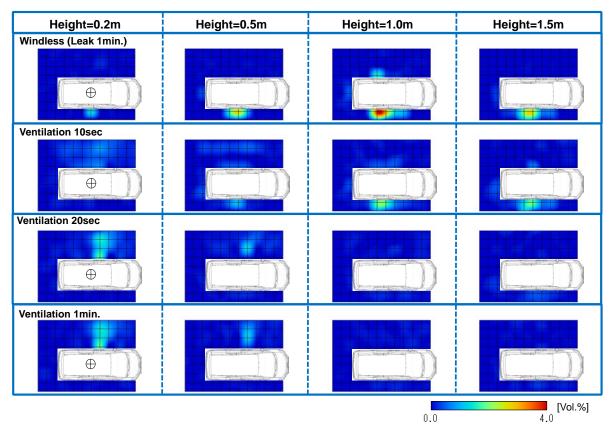
Figure 8. Isosurface of hydrogen concentrations around vehicle (hydrogen flowrate of 2,000 NL/min, leakage point A, blower 2 m from vehicle side)

In a windless condition, hydrogen flowed upward along the side surfaces of the test vehicle and generated some areas where hydrogen concentration exceeded the lower flammable limit of 4 vol%. Then, the blower was turned on; the hydrogen gas was gradually dispersed leeward and the hydrogen concentrations around the vehicle declined below 2 vol%.

Fig. 8 shows the isosurface images of hydrogen concentrations around the test vehicle leaking hydrogen at a flowrate of 2,000 NL/min from point A at its underfloor center. The isosurface images compare a windless state with the situations of winds delivered by a blower 2 m away from a position lateral to the vehicle.

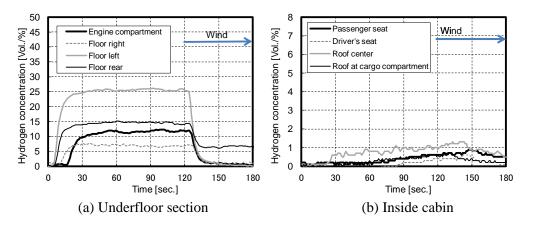
Figure 11. Hydrogen concentrations inside vehicle (hydrogen flowrate of 2,000 NL/min, leakage point A, blower 2m from vehicle front)

In a windless condition, hydrogen concentrations in the underfloor section exceeded 10 vol% while hydrogen also entered into the cabin from the window broken in the side crash test [4]. Once the

blower was turned on, however, the hydrogen concentrations in the underfloor section and cabin gradually declined.

Fig. 11 shows the hydrogen concentrations measured in the underfloor section and cabin of the vehicle when winds were blown from 2m in front of the vehicle. Hydrogen was made to leak from point A at a flowrate of 2,000 NL/min for 180 sec while the blower was turned on from the 120th sec after the start of hydrogen leakage.

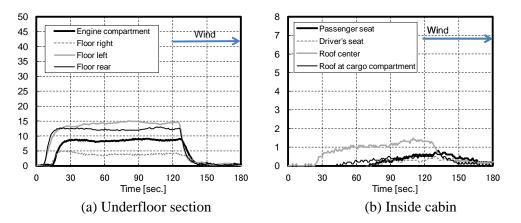
Figure 12. Hydrogen concentrations inside vehicle (hydrogen flowrate of 2,000 NL/min, leakage point A, blower 5m from vehicle side)

Fig. 12 shows the hydrogen concentrations measured in the underfloor section and cabin of the vehicle when winds were blown from 5 m lateral to the vehicle. Similar to the case of forced winds from the front side of the vehicle, forced winds from the lateral side caused hydrogen concentrations to decline in both underfloor section and cabin.

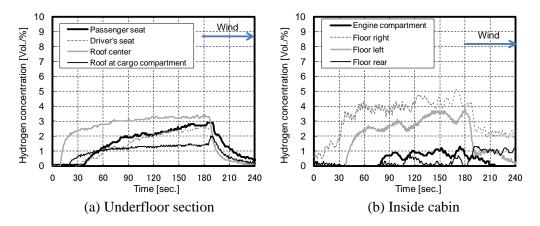
Figure 13. Hydrogen concentrations inside vehicle (hydrogen flowrate of 2,000 NL/min, leakage point B, blower 5m from vehicle front)

Fig. 13 shows the hydrogen concentrations measured in the underfloor section and cabin of the vehicle when winds were blown from 5 m in front of the vehicle. This time, hydrogen was leaked from point B at the same flowrate of 2,000 NL/min for the first 180 sec while the blower was turned on from the 180th sec.

While point B was located on the vehicle's crash impact side, hydrogen continued to accumulate inside the underfloor section and cabin in the absence of forced winds. Once wind delivery was started, the hydrogen concentrations gradually declined.

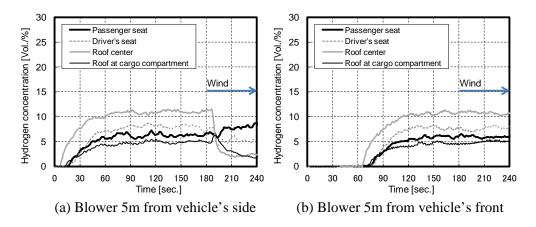
Figure 14. Hydrogen concentrations inside cabin (hydrogen flowrate of 2,000 NL/min, leakage point C)

Fig. 14 shows the hydrogen concentrations measured inside the cabin when hydrogen gas was leaked from point C located also inside the cabin. Fig. 14(a) relates to the test setup where the blower was placed 5m lateral to the vehicle and the wind delivery started from the 180th sec. It was found that the hydrogen concentrations at the roof center, cargo compartment roof and driver's seat all declined as winds entered into the cabin from the broken window.

In contrast, the hydrogen concentration at the passenger seat which was located opposite to the crash side proved higher than when there were no winds. This was presumably because the hydrogen leaking from the cabin floor center was carried towards the passenger seat by the winds that had entered from the broken window.

In the case of Fig.14 (b) relating to the test setup where the blower was placed 5 m forward to the vehicle, the hydrogen concentrations inside the cabin remained constant presumably because practically no winds entered from the broken window to influence the hydrogen accumulating inside the cabin.

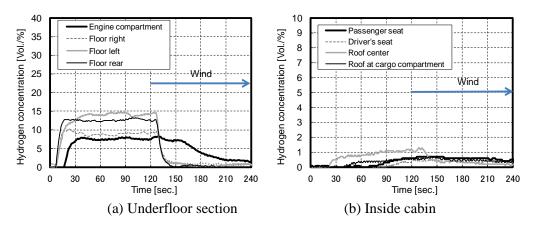
Figure 15. Hydrogen concentrations inside vehicle (hydrogen flowrate of 2,000 NL/min, leakage point A, duct aimed at vehicle side)

Fig.s 15 and 16 show the hydrogen concentrations in the underfloor section and cabin of the vehicle when winds were delivered by a duct from lateral and frontal directions, respectively.

Hydrogen concentrations in both underfloor section and cabin declined after the delivery of winds from a duct. Consequently the use of a duct fitted to a blower is considered effective in diluting leaked hydrogen. One advantage of a duct is that it can increase the wind velocity of a small blower. One disadvantage is that because of its narrow wind width, a duct is usable only when the point of hydrogen leakage has been located.

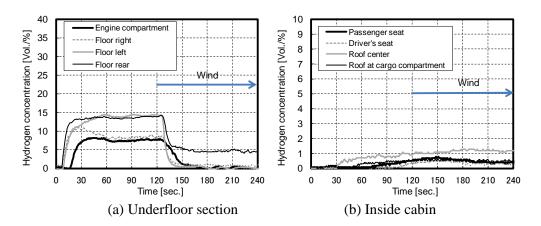
Figure 16. Hydrogen concentrations inside vehicle (hydrogen flowrate of 2,000 NL/min, leakage point A, duct aimed at vehicle front)

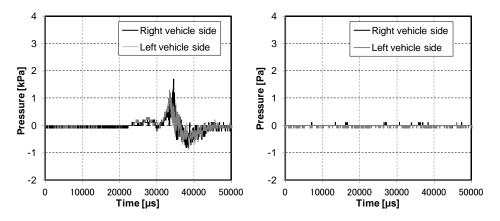
(a) No forced winds (b) Winds from 5m forward to vehicle Figure 18. Blast-wave pressures at vehicle's both sides, 0.2 m above ground (hydrogen flow rate: 2,000 NL/min)

Fig. 18 shows the blast-wave pressures of ignition as measured on the lateral sides of the vehicle and 0.2 m above ground. While the maximum blast-wave pressure reached 1.7 KPa without forced winds, practically no blast-wave pressure was recorded in the presence of forced winds.

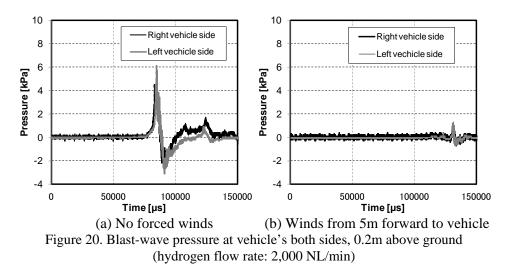
While the maximum blast-wave pressure reached as high as 6 KPa without forced winds, it fell to less than 1 KPa in the presence of forced winds.

Fig. 19 shows the ignition test case where the hydrogen leak point was at the center of the engine compartment base and the ignition point at the center of the firewall top. Fig. 20 shows the blast-wave pressures of ignition as measured on the lateral sides of the vehicle and 0.2m above ground.

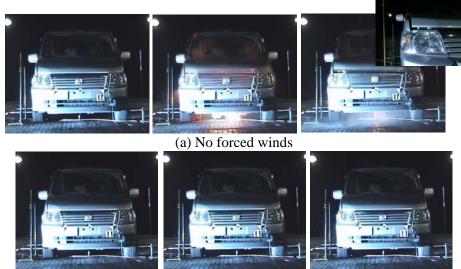
(b) Winds from 5m forward to vehicle Figure 21. Sequence photographs of ignition

Fig. 21 shows the sequence photographs of ignition. In the absence of forced winds, ignition took place and resulted in a blast that deformed the hood. In the presence of forced winds, although ignition took place the resultant blast was so moderate that none of the vehicle's adjacent parts were deformed or damaged.
