4<sup>th</sup> ICHS 2011

# Assessment of Safety for HFCV

**Korea Transportation Safety Authority**  
**Korea Automobile Testing and Research Institute (KATRI)**

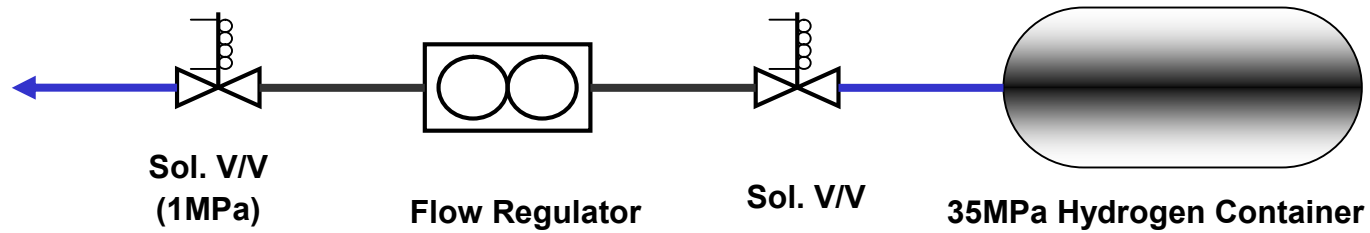
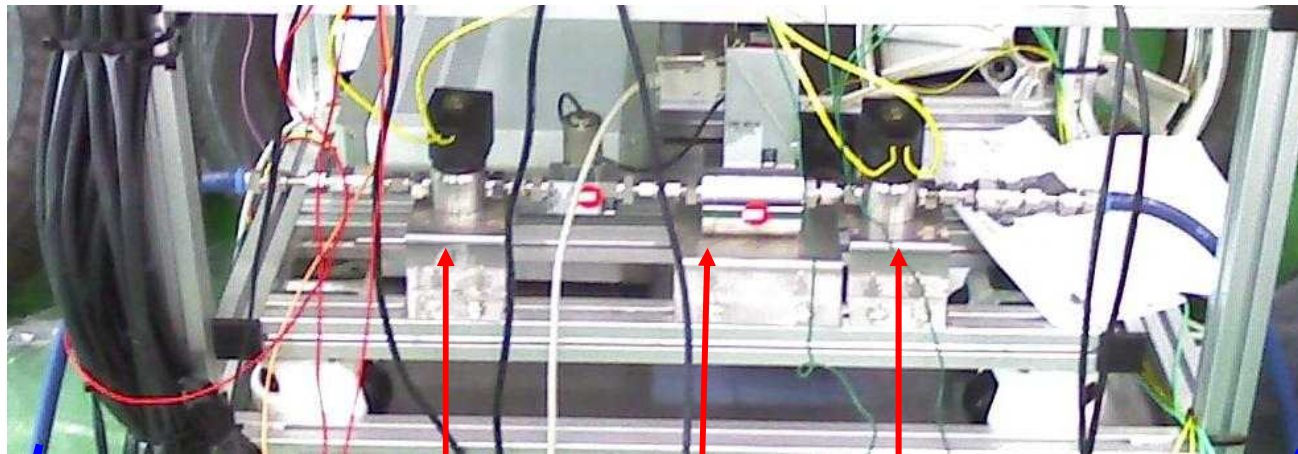
## Hydrogen leakage Simulation System

H2 Leakage

Sol. V/V

Flow Regulator

High Pressure Regulator

35MPa Hydrogen Container

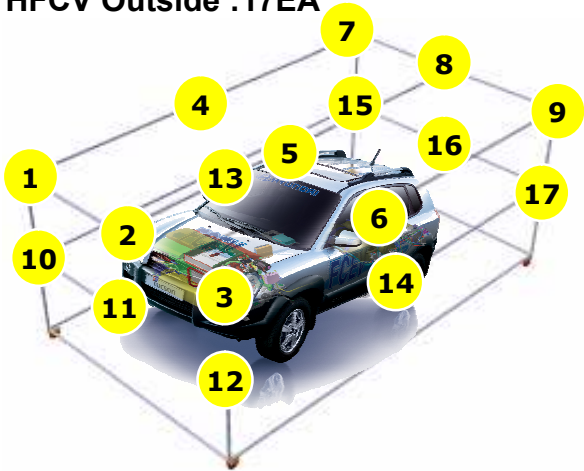
HFCV Outside :17EA

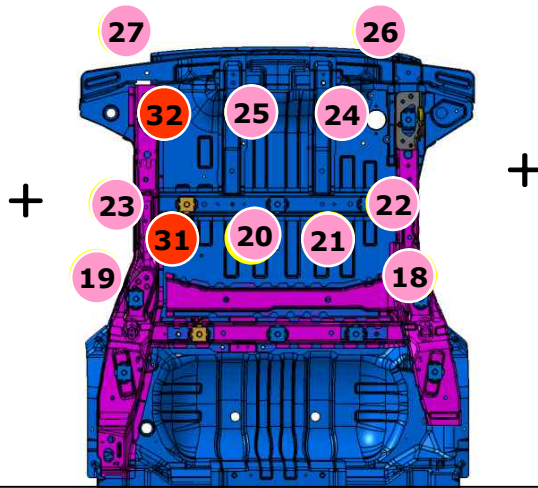
RR COMPLETE ASSY : 12EA

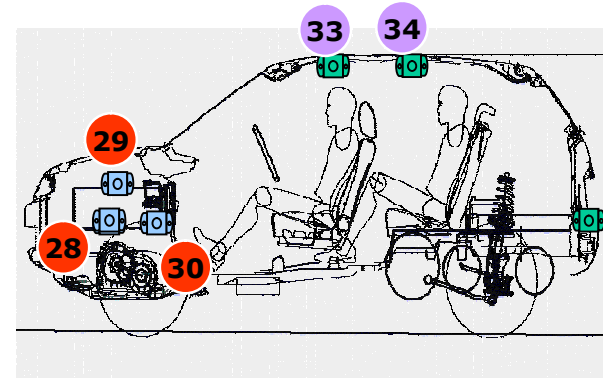
Engine Room : 3EA,  
Inside : 2EA

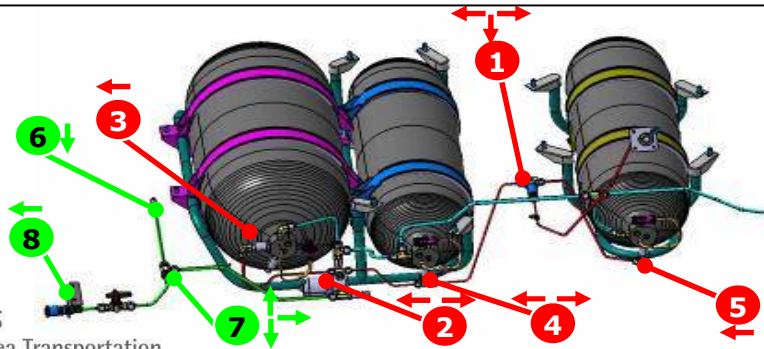
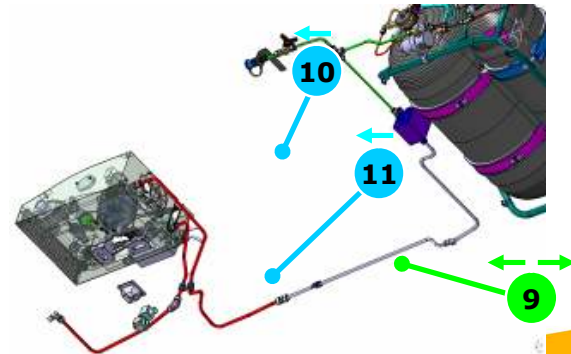
### • Hydrogen Leakage Point (High line 5 Points + Low line 4 Points + Engine room 2 Points)

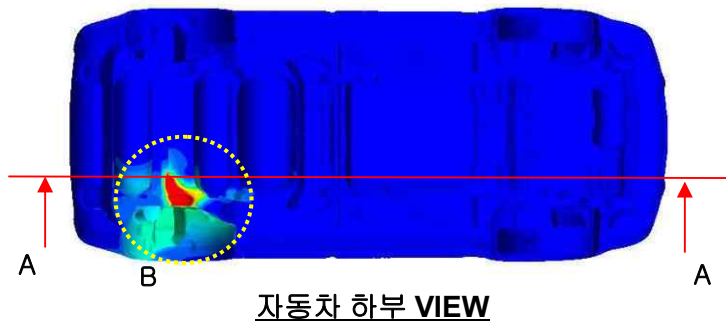
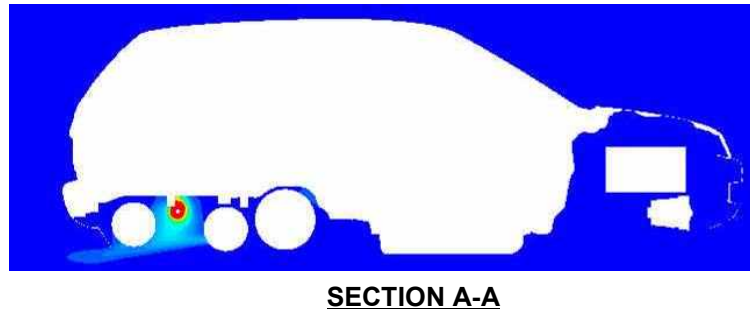
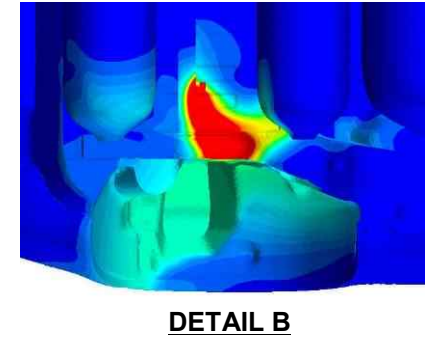
## Leakage Analysis for a moving vehicle

- when hydrogen leaks for a moving, the area of leakage exits hydrogen  
→ the hydrogen sensors of leakage point reach 4 % H<sub>2</sub>

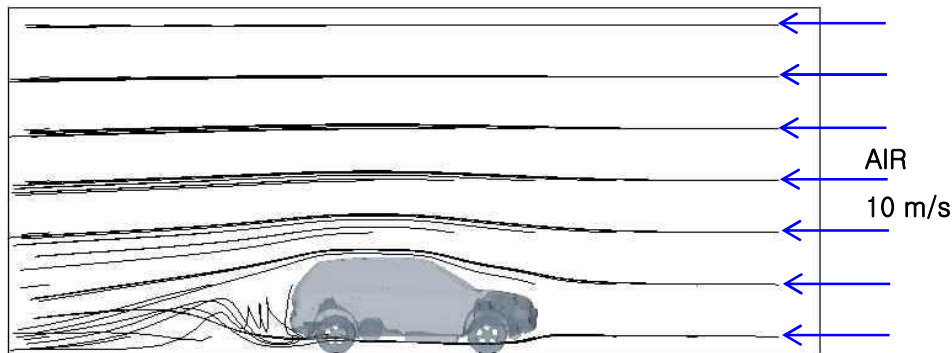
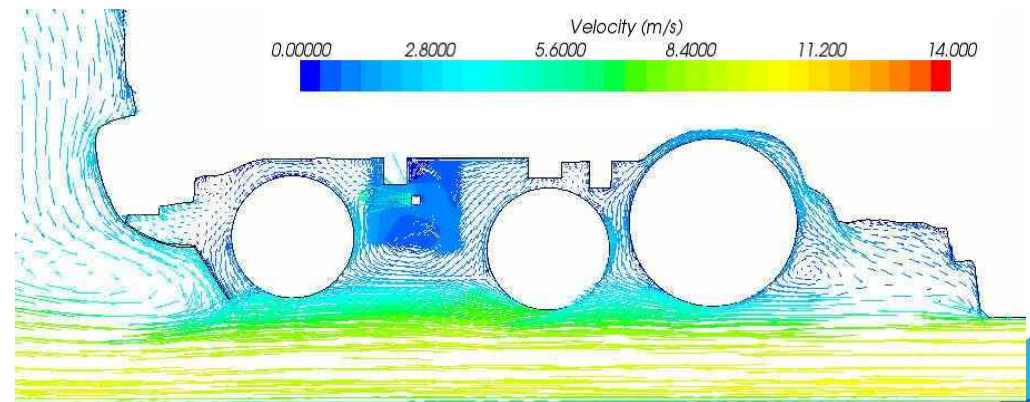
- when hydrogen leaks for a moving, Hydrogen leaked is diffusion to the outside by the outside air flow

The area of hydrogen container  
(SECTION A-A)

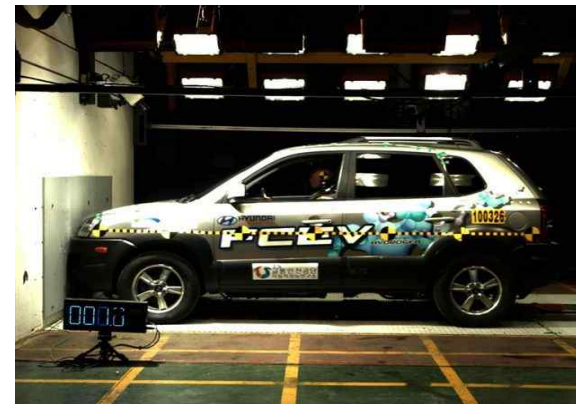
## Frontal Impact Test

- Verification of vehicle fuel system integrity, electrical safety and occupants safety

- Fuel cell vehicle (SUV)

- KMVSS article 91, 102
  - : 48 km/h full frontal impact test with hybrid III 50 %ile male dummies
- Filled with helium 90 % of normal working pressure (152 liter × 31.5 MPa)
- During the crash, opened storage valve (severe condition)

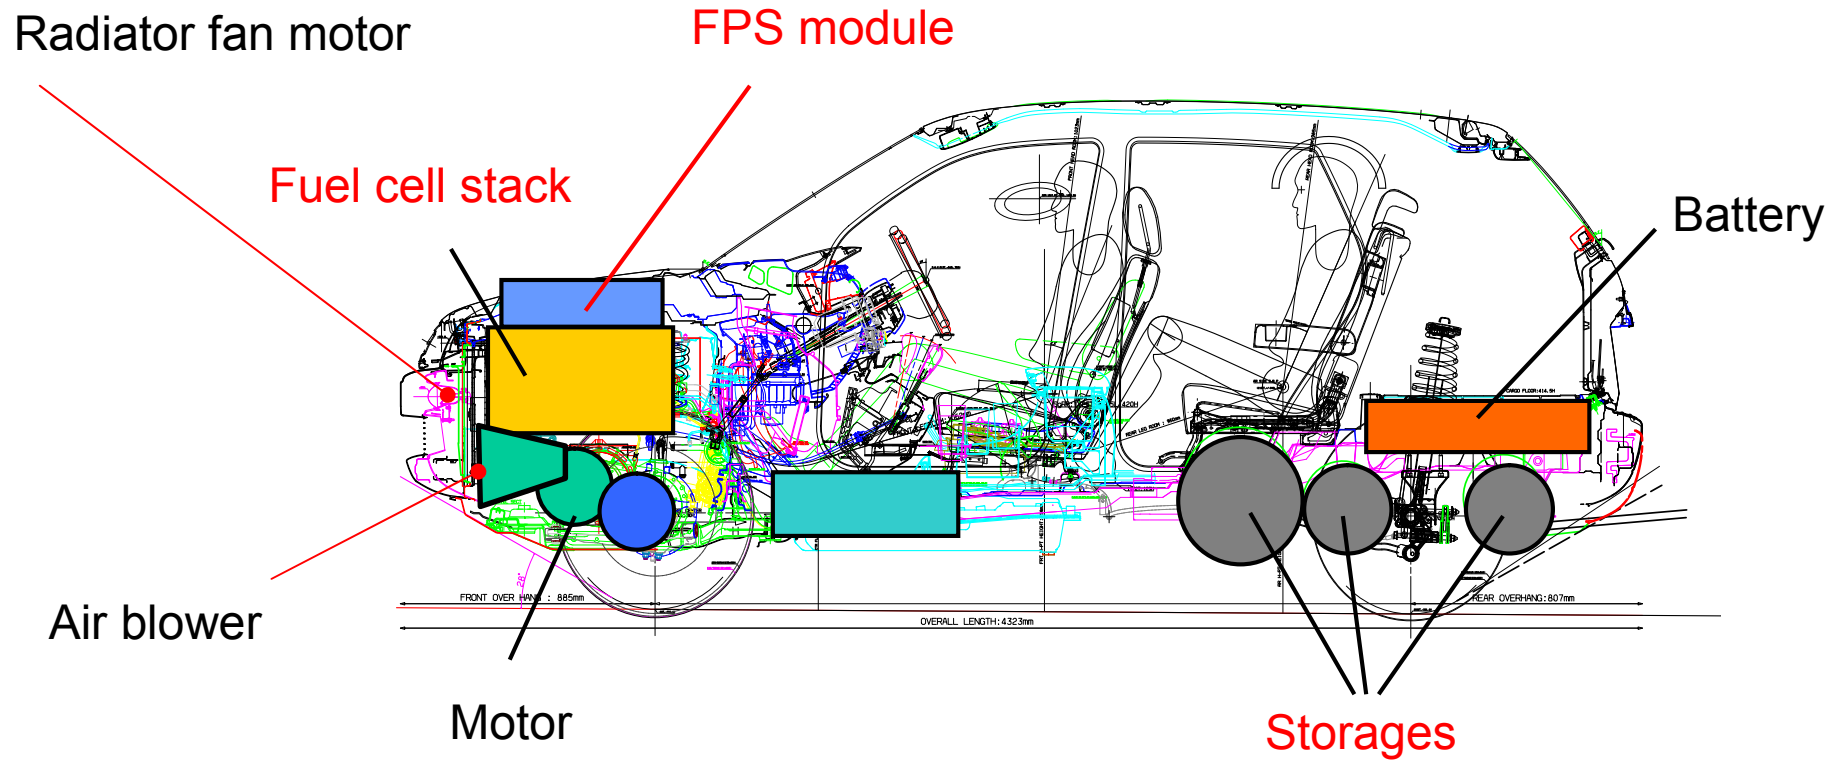
## Frontal Impact Test : Locations of acceleration sensors

FPS: Fuel Processing System

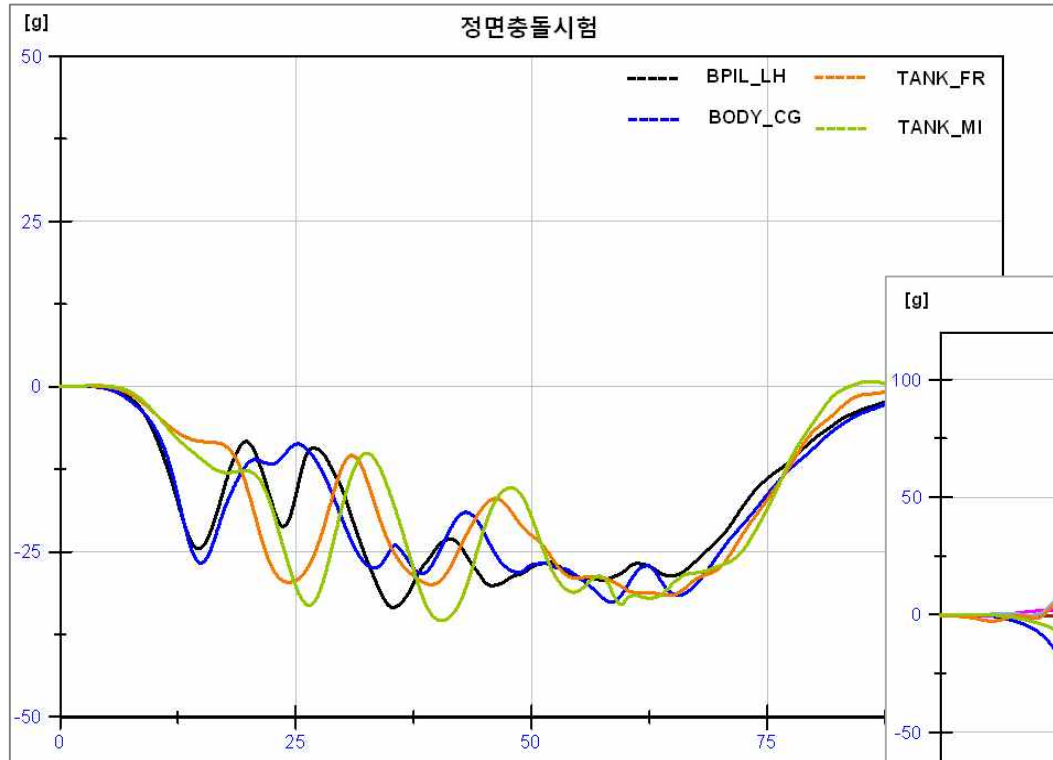
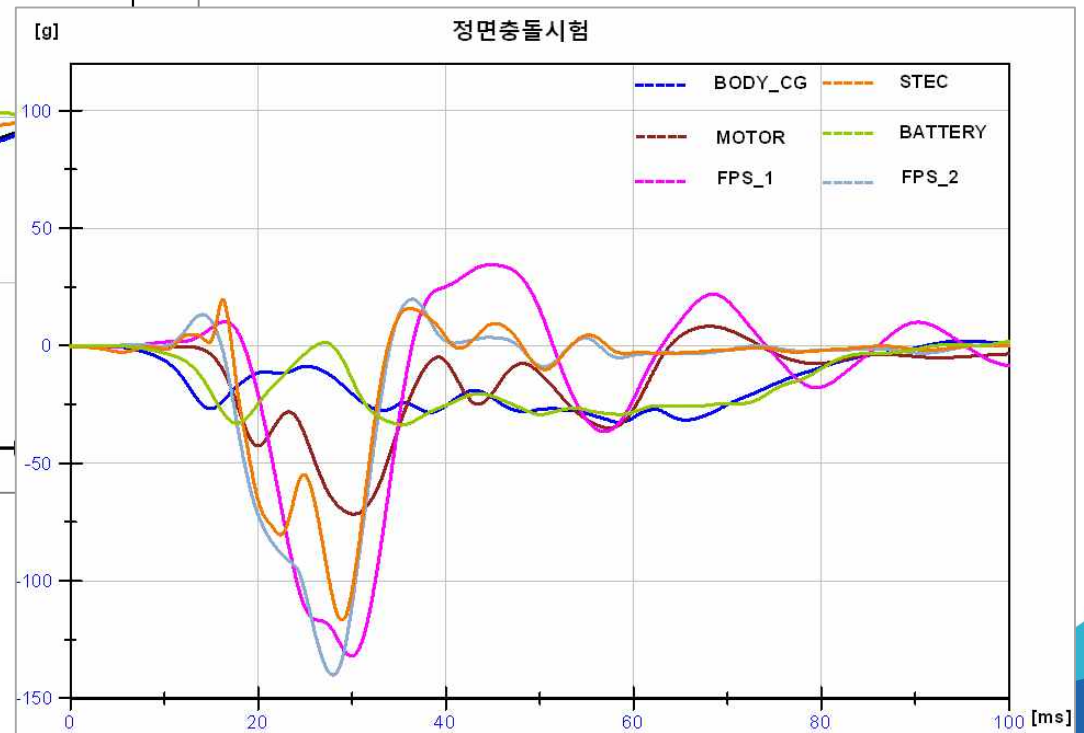
## Frontal Impact Test : Acceleration Curves

- At body, storages, battery: about 30 g
- At stack and FPS, located in front of vehicle, high : 120~140 g

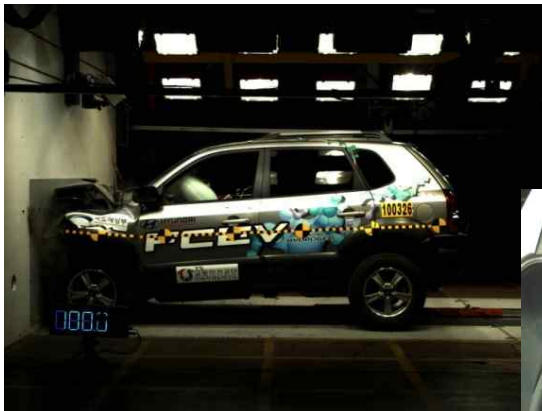
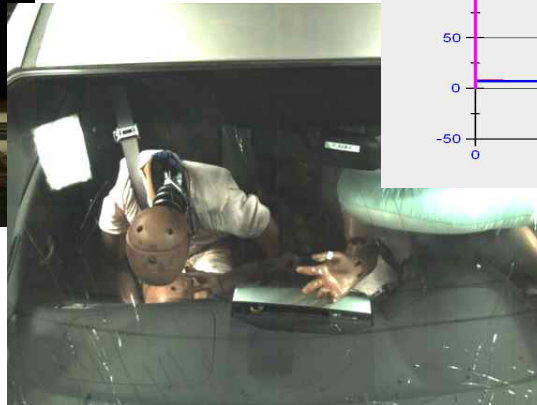
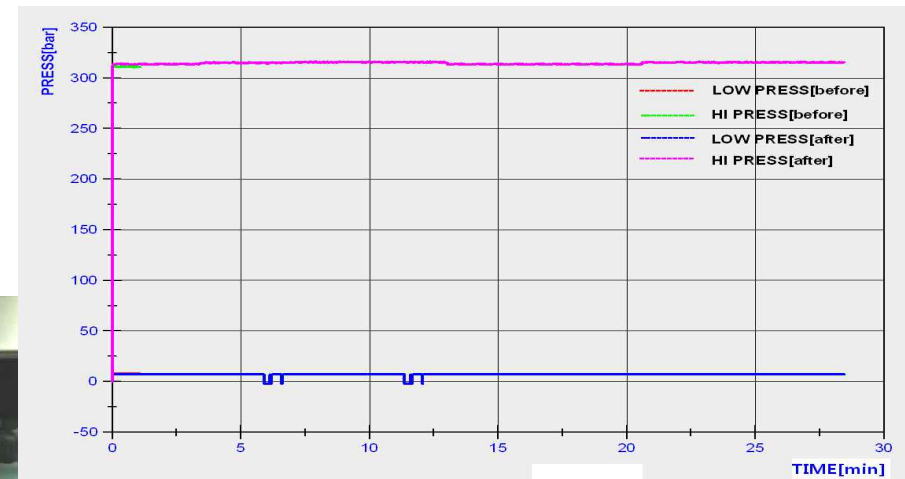
## Frontal Impact Test : Results

- ❑ After frontal impact, no helium leakage
  - High pressure sensor : 31.5 MPa
  - Low pressure sensor : 0.8 MPa
  - Even though FPS and stack were exposed to high acceleration(120~140 g), no helium leakage
  - Met occupant safety requirements

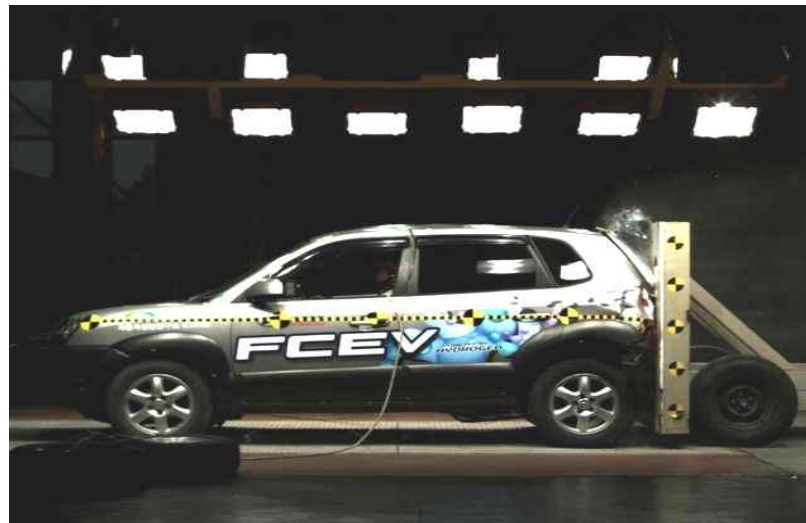
## Rear Impact Test

- Test Vehicle : SUV (2002kg)
- Test Condition : 48.1km/h, Moving barrier(1,805 kg)
- Test material and Pressure : Helium, high(33MPa)/Low(1MPa)
- Container Deformation sensors : 21 EA
- Locations of acceleration sensors : Body 3 EA / Container 4 EA
- Pressure sensors : High 1 / Low 1

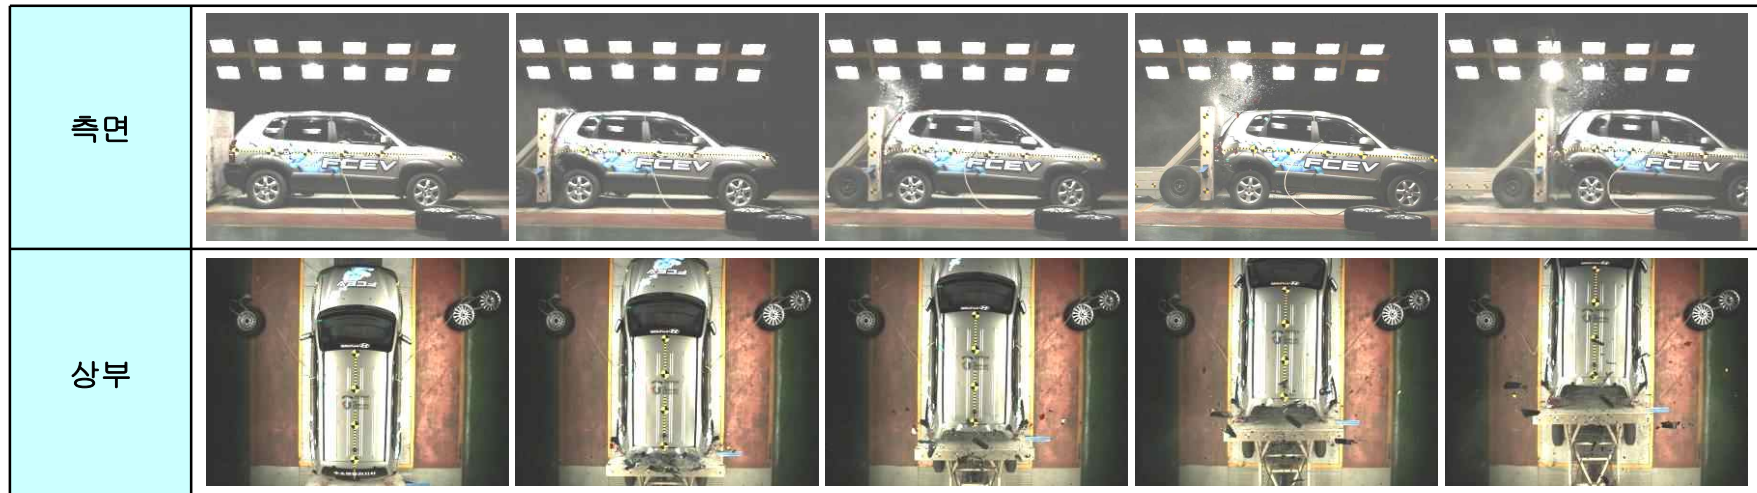
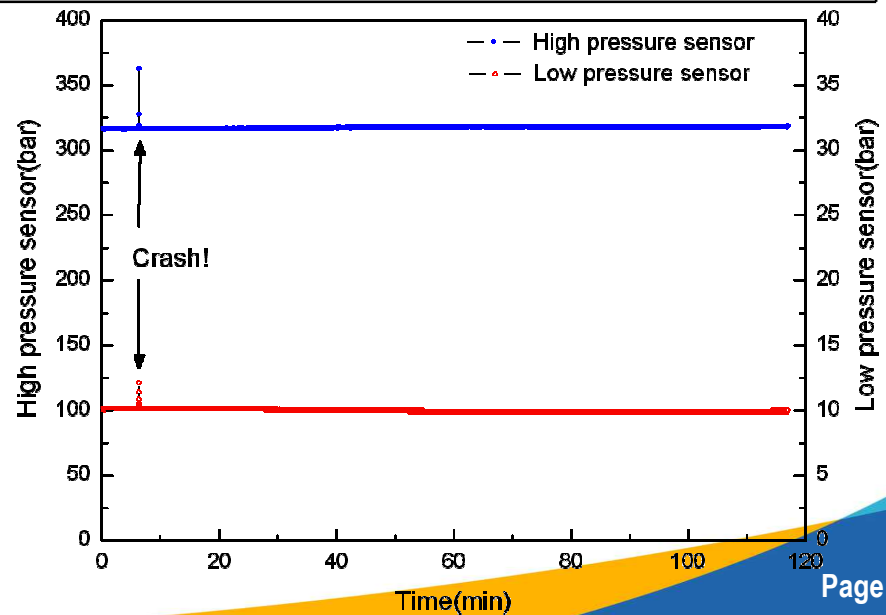
## Rear Impact Test : Results

### □ After frontal impact, no helium leakage

- High pressure sensor: 33 MPa
- Low pressure sensor: 1.0 MPa

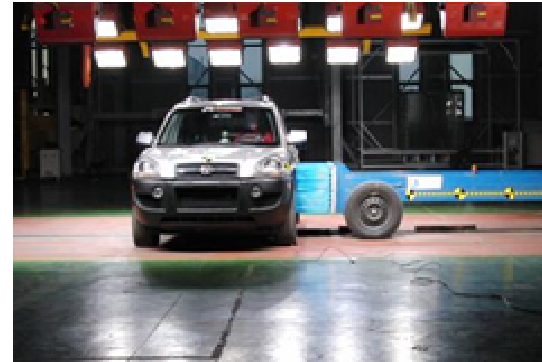
## Side Impact Test

- Verification of vehicle fuel system integrity, electrical safety and occupants safety

- Fuel cell vehicle (SUV)

- KMVSS article 102
  - : 50 km/h side impact test with deformable moving barrier (950 kg)
- Filled with helium 90 % of normal working pressure (152 liter × 31.5 MPa)
- During the crash, opened storage valve (severe condition)

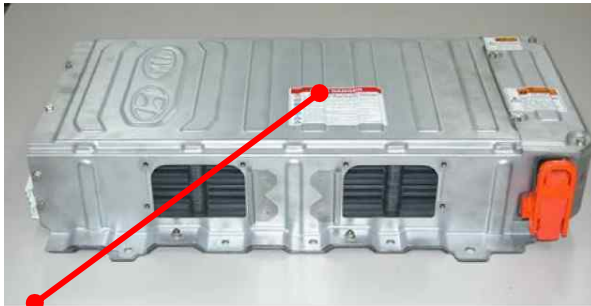
Battery

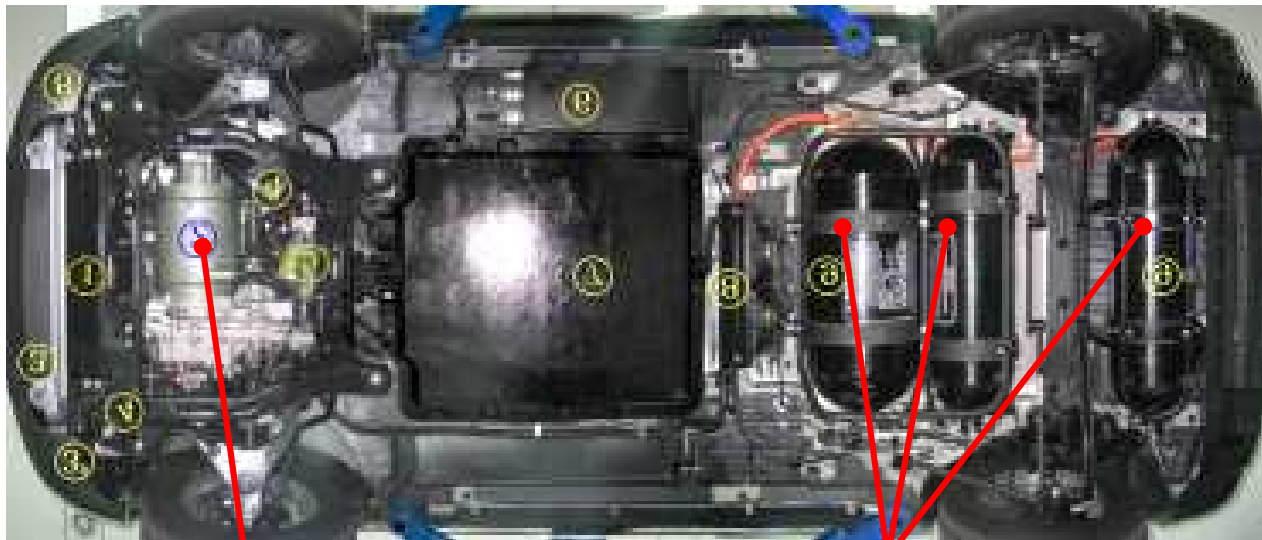
Motor

Storages

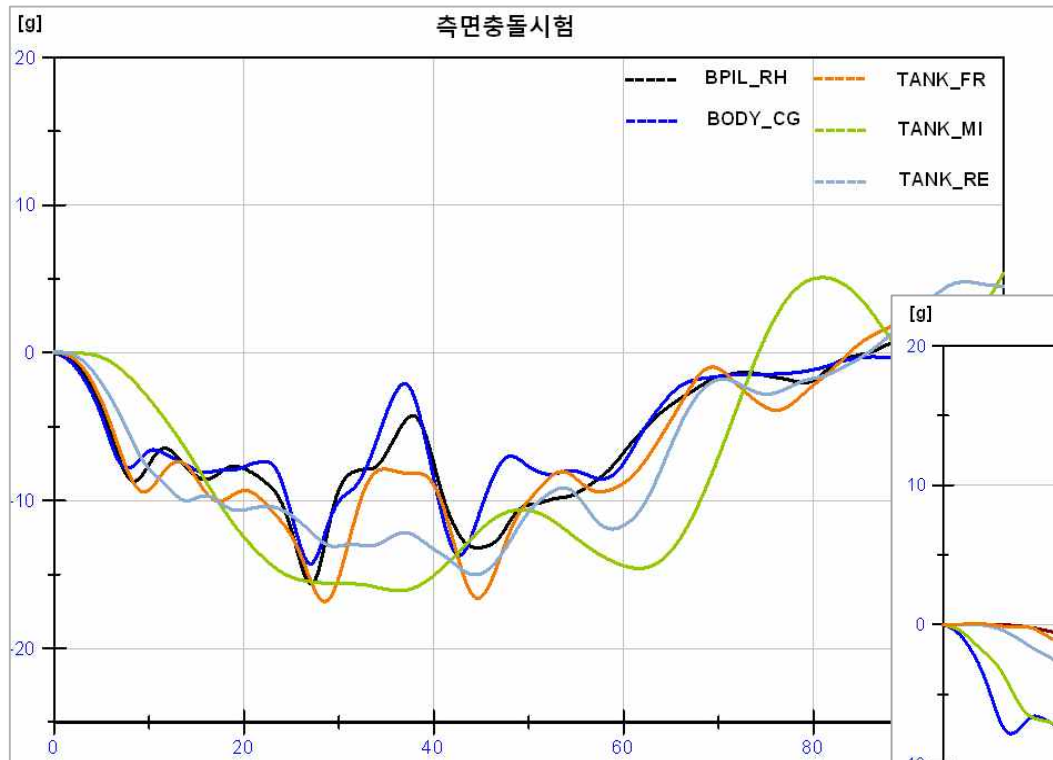
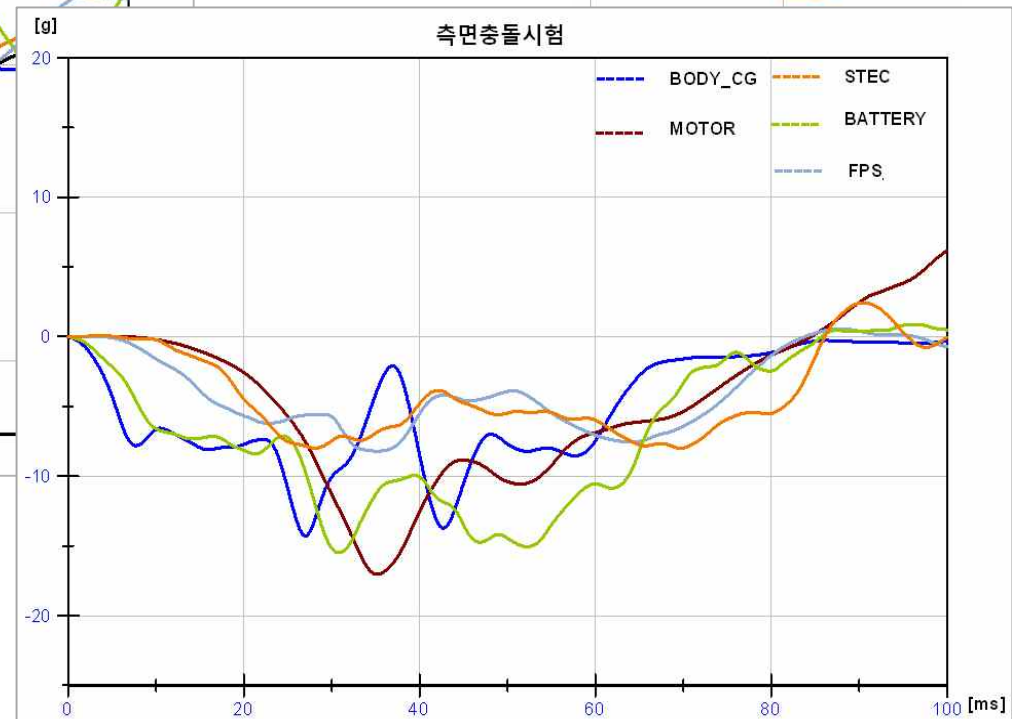
## Side Impact Test : Acceleration Curves

- Accelerations at body, storages, battery were similar
- Accelerations at stack and FPS were relatively lower because they were located in front of vehicle

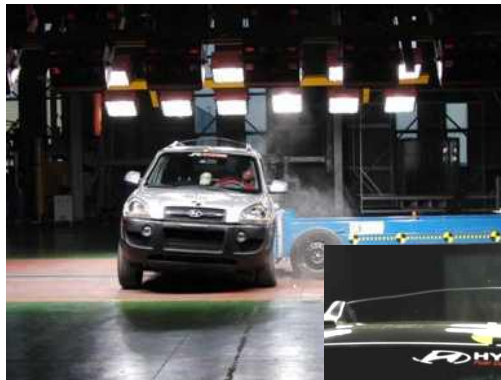
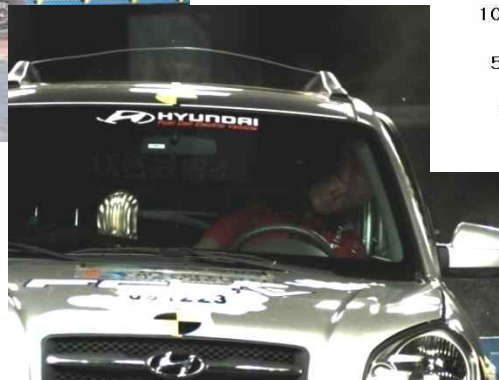
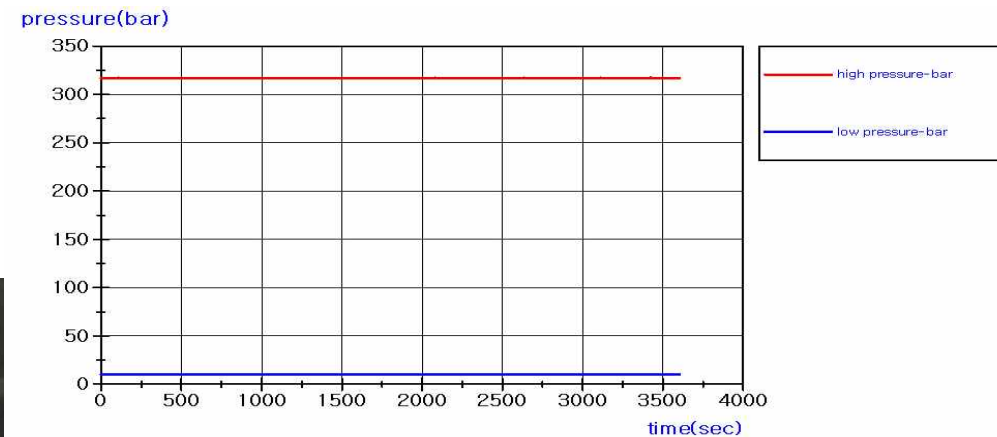
## Side Impact Test : Results

- ❑ After impact, no helium leakage
  - High pressure sensor: 31.5 MPa
  - Low pressure sensor: 0.8 MPa
  - Met occupant safety requirements

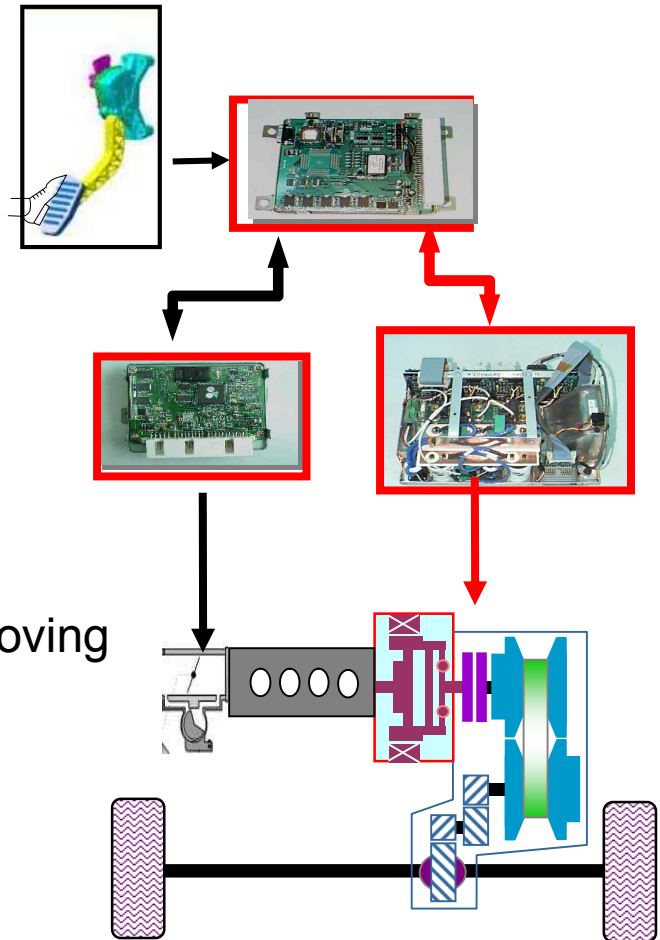
## Fail-safety Evaluation

- KMVSS article 87 & Test Procedure 25
- Fail condition : the normal state by wire cutting or removing
  - Prius : APS #1 GND, U-Phase Current Signal  
Motor Temperature
  - Verna : APS #1 GND, Resolver S1 Signal  
Motor Temperature

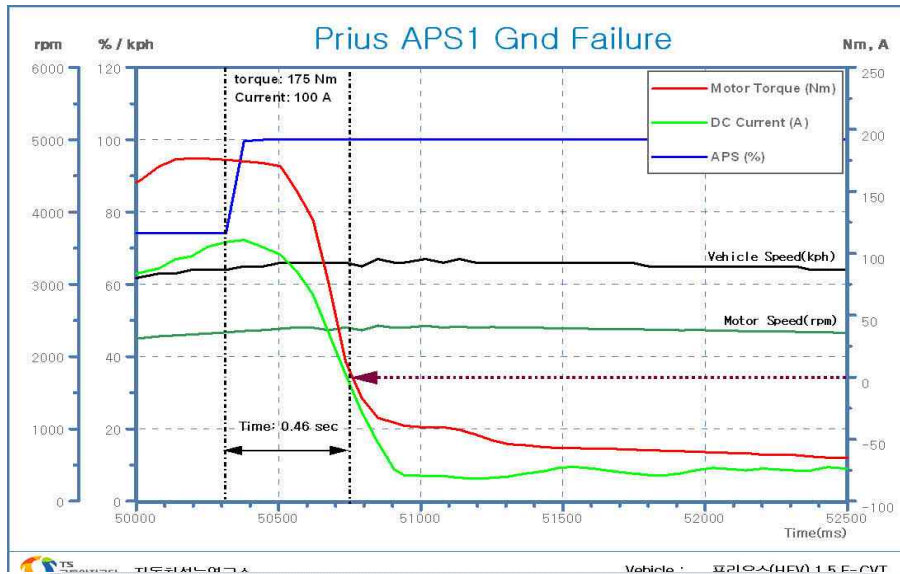
## Prius THS II (EV driving)

- APS 1 Gnd Failure
- Idle Return Time : 0.4 sec
- Max Torque :175Nm, Current :100A

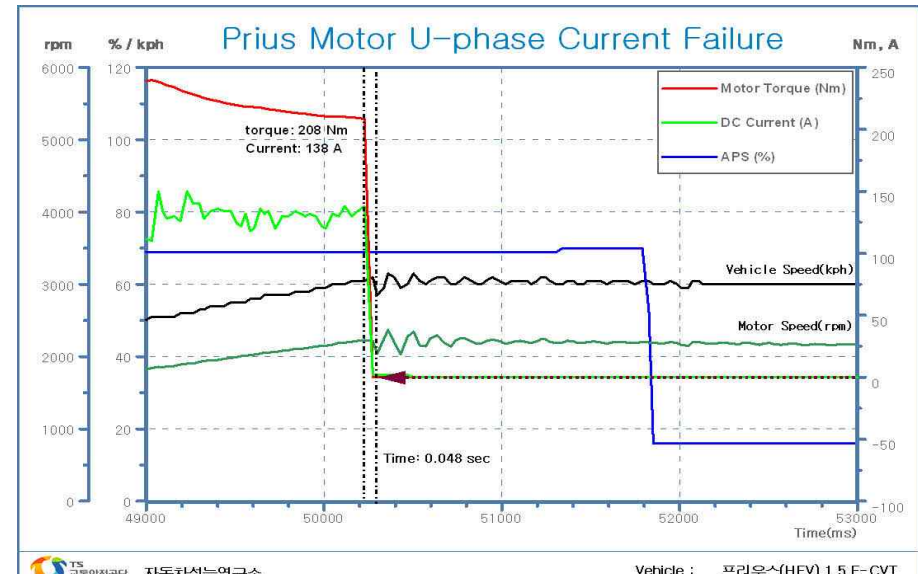
- U-Phase Current Signal Failure
- Idle Return Time : 0.04초
- Max Torque :208Nm , Current :138A

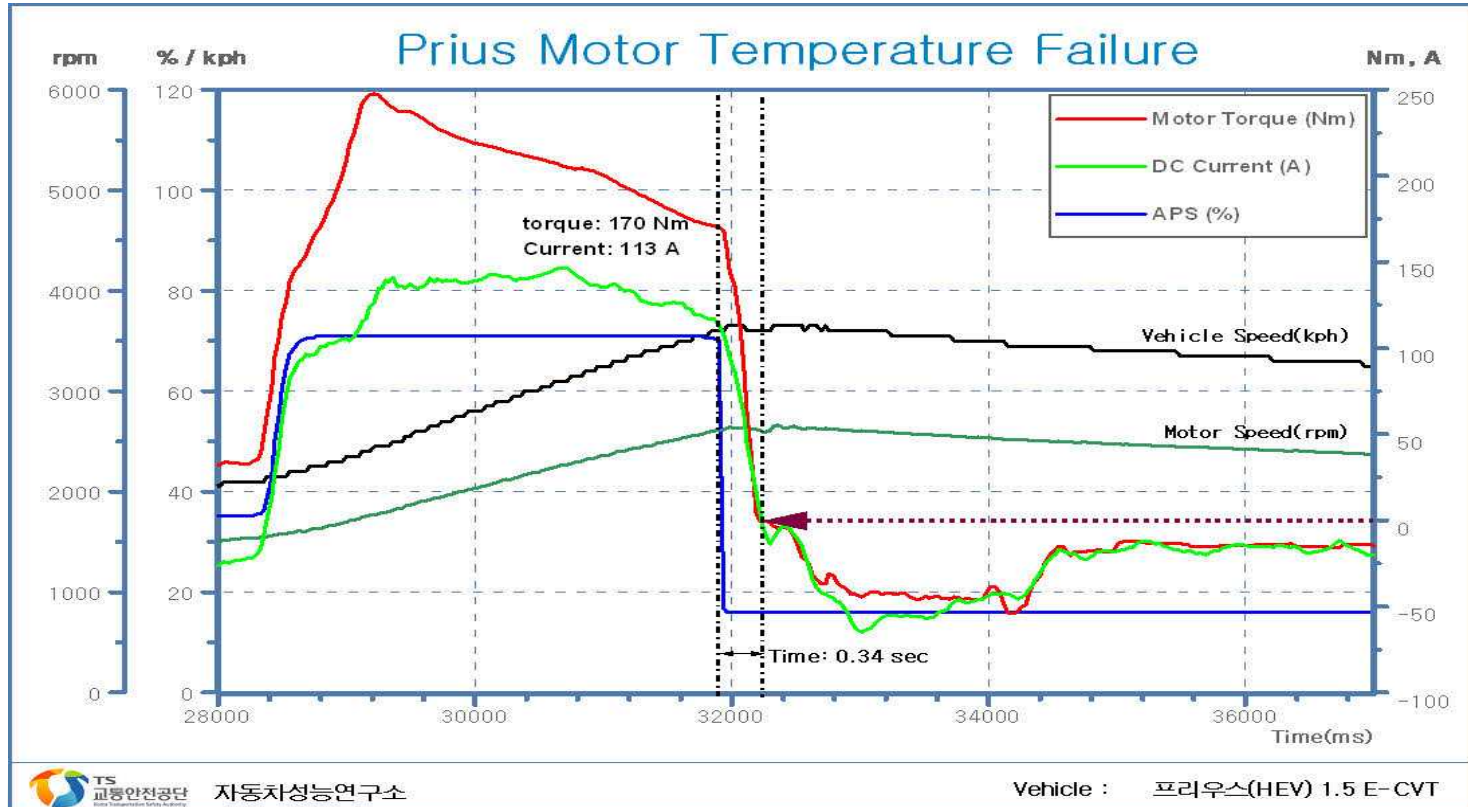
## Prius THS II (EV driving)

- Motor Temperature Sensor Failure
- After Failure, Normal Condition
- Max Torque : 170Nm , Current : 113 A

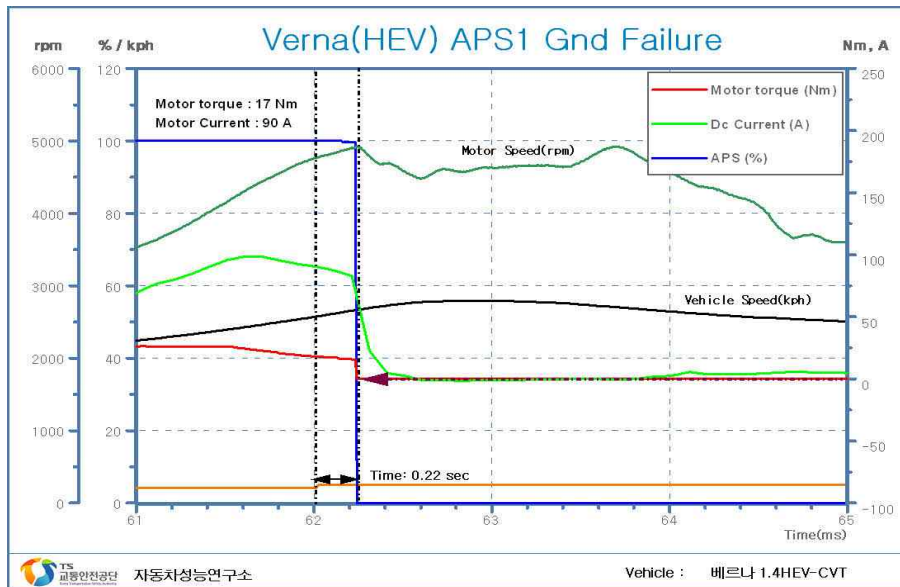
## Verna (HEV)

- APS 1 Gnd Failure
- Idle Return Time : 0.22 sec
- Max Torque : 17Nm, Current : 90A

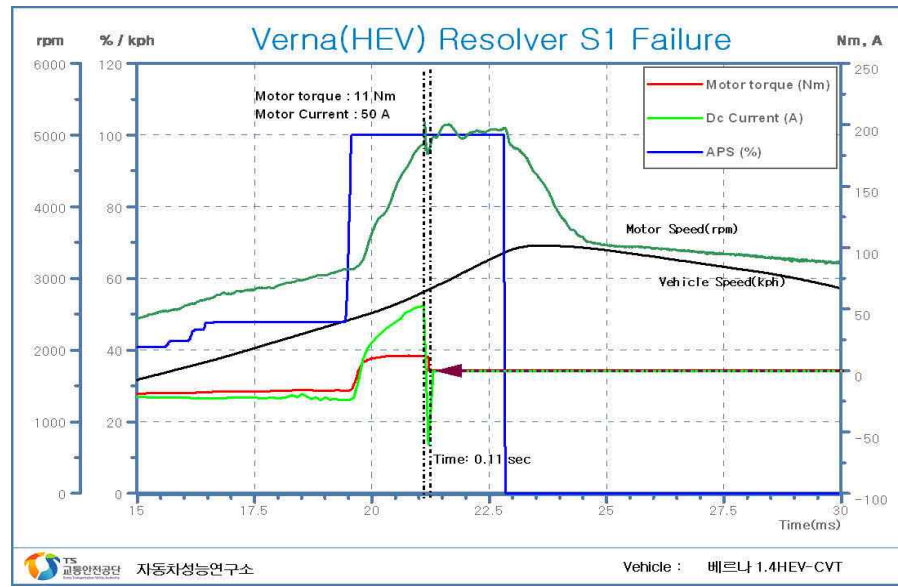
- Resolver S1 Signal Failure
- Idle Return Time : 0.11초
- Max Torque : 11Nm , Current : 50A

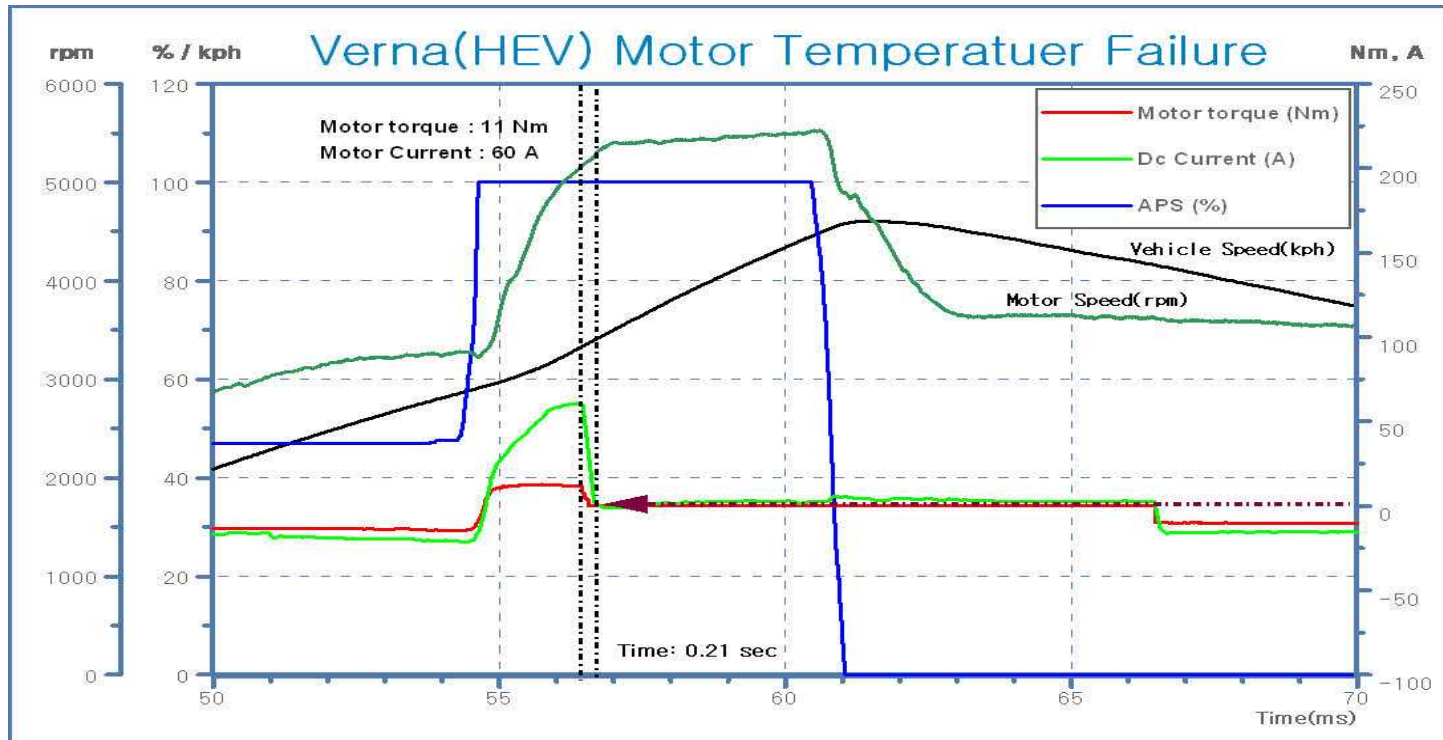
## Verna (HEV)

- Motor Temperature Sensor Failure
- After Failure, the motor power shut off
- Max Torque : 11Nm , Current : 60 A

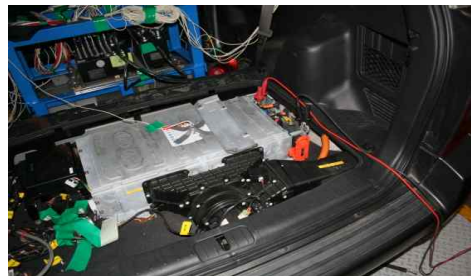
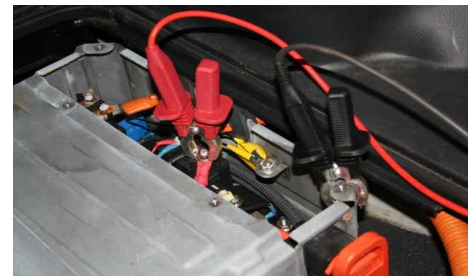
## Post Crash : Frontal Impact

- Traction battery ↔ vehicle body:  $4.8 \text{ k}\Omega / \text{V}$  (req.:  $100 \text{ }\Omega / \text{V}$ )
- Small amount of electrolyte spillage

- Because frontal part of vehicle was severely damaged, accessibility for Insulation resistance measurement was poor
- Poor accessibility may lead to electric shock
- Need to specify measurement method of electrolyte spillage (7%, 5 liters) and electrical energy (within 0.2 Joules)

- In-use and post-crash, electrical isolation and electrical continuity met GTR
- In case of frontal post-crash, because of severe damage to frontal part of vehicle, it is not easy to measure electrical continuity

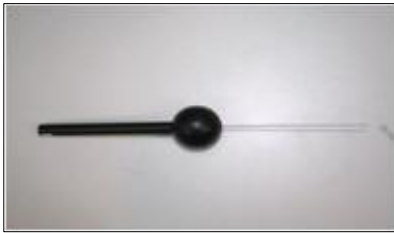
IPXXD (Test wire)

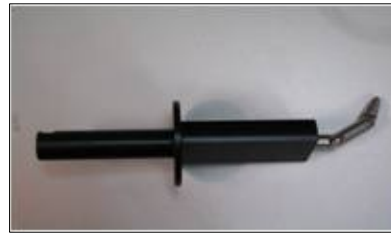
IPXXB (Test finger)

- IPXXB, IPXXD Evaluation : Pass
- Passenger/ Luggage compartment
- Bonnet/Underneath
- Connectors
- Marking and Color orange

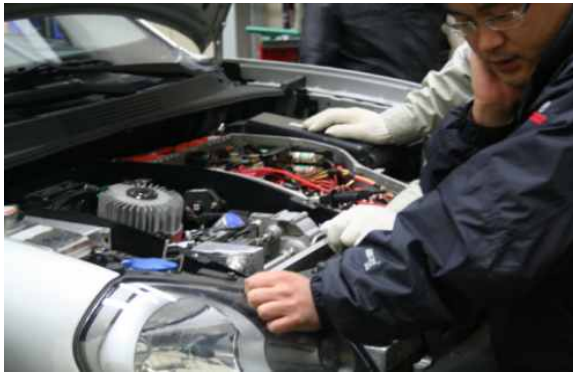
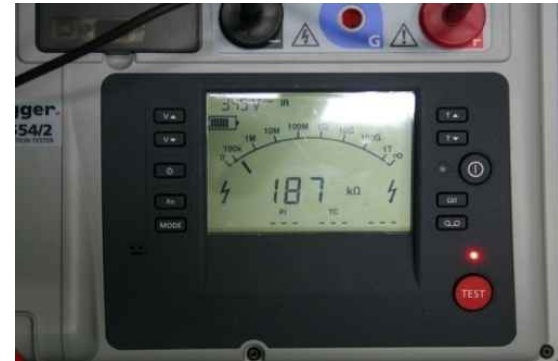
## IN-USE : Isolation Resistance

- Minimum Value : 100 ohms/volt of the working voltage for DC buses  
500 ohms/volt of the working voltage for AC buses
- lowest insulation resistance was between outer cover of stack and terminal of stack(-) : 1.28 kΩ/V

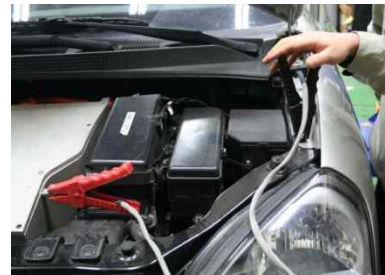
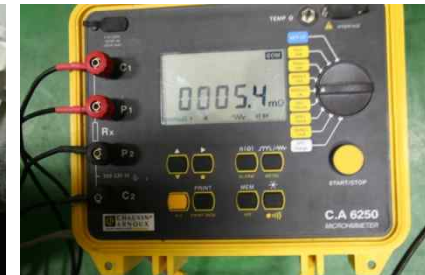
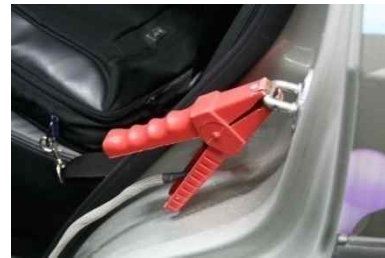
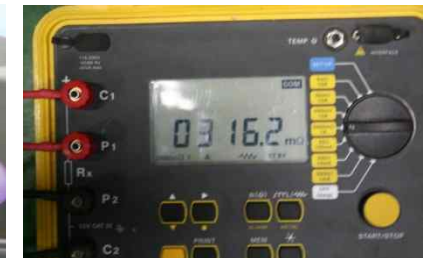
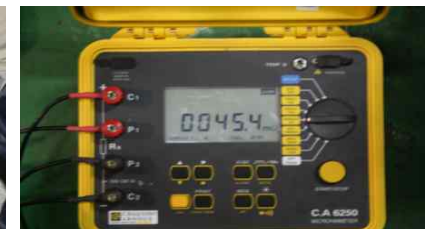
## IN-USE : Indirect Contact

- Criteria : less than  $100\text{ m}\Omega$
- High voltage box enclosure ↔  
Chassis :  **$5.4\text{ m}\Omega$**
- Supercapacitor enclosure ↔  
Door hinge :  **$316.2\text{ m}\Omega$**
- Supercapacitor enclosure ↔  
Chassis :  **$45.4\text{ m}\Omega$**
