Unusual Reformer Events and Modeling

Dorothy F. Maxwell Shaffer

Baker Engineering and Risk Consultants, Inc. Associate

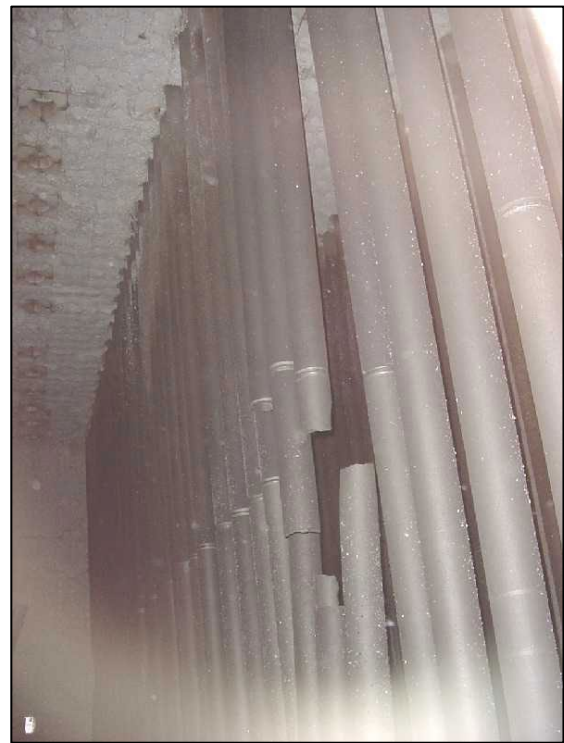
A false high steam flow indication to the controller led to loss of actual steam while process gas continued. The subsequent tube ruptures resulted in a firebox process fire. Fourteen tube failures resulted; some failures were from thermal shock when steam was reintroduced.

Figure 1. Tube failure from thermal shock

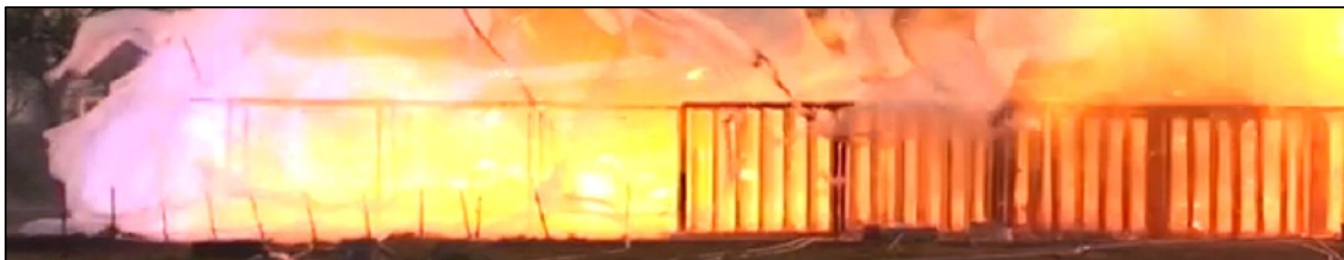
Figure 2. Flammability and explosion testing at BakerRisk test facilities
